INVESTIGATION NO. 2742
THE SOUTHERN RAILWAY SYSTEM
REPORT IN RE ACCIDENT
AT CORDOVA, ALA., ON
NOVEMBER 15, 1943

Railroad: Southern
Date: November 15, 1943
Location: Cordova, Ala.
Kind of accident: Rear-end collision
Trains involved: Freight : Freight
Train numbers: Extra 4543 West : First 53
Engine numbers: 4543 : 2421
Consist: 14 cars, cabooses : 18 cars, cabooses
Estimated speed: Standing : 8 m. p. h.
Operation: Timetable and train orders;
yard limits
Track: Single; 7°15' curve; 1.20 percent
ascending grade westward
Weather: Clear
Time: 11:05 p. m.
Casualties: 1 killed
Cause: Failure properly to control
speed of following train
moving within yard limits

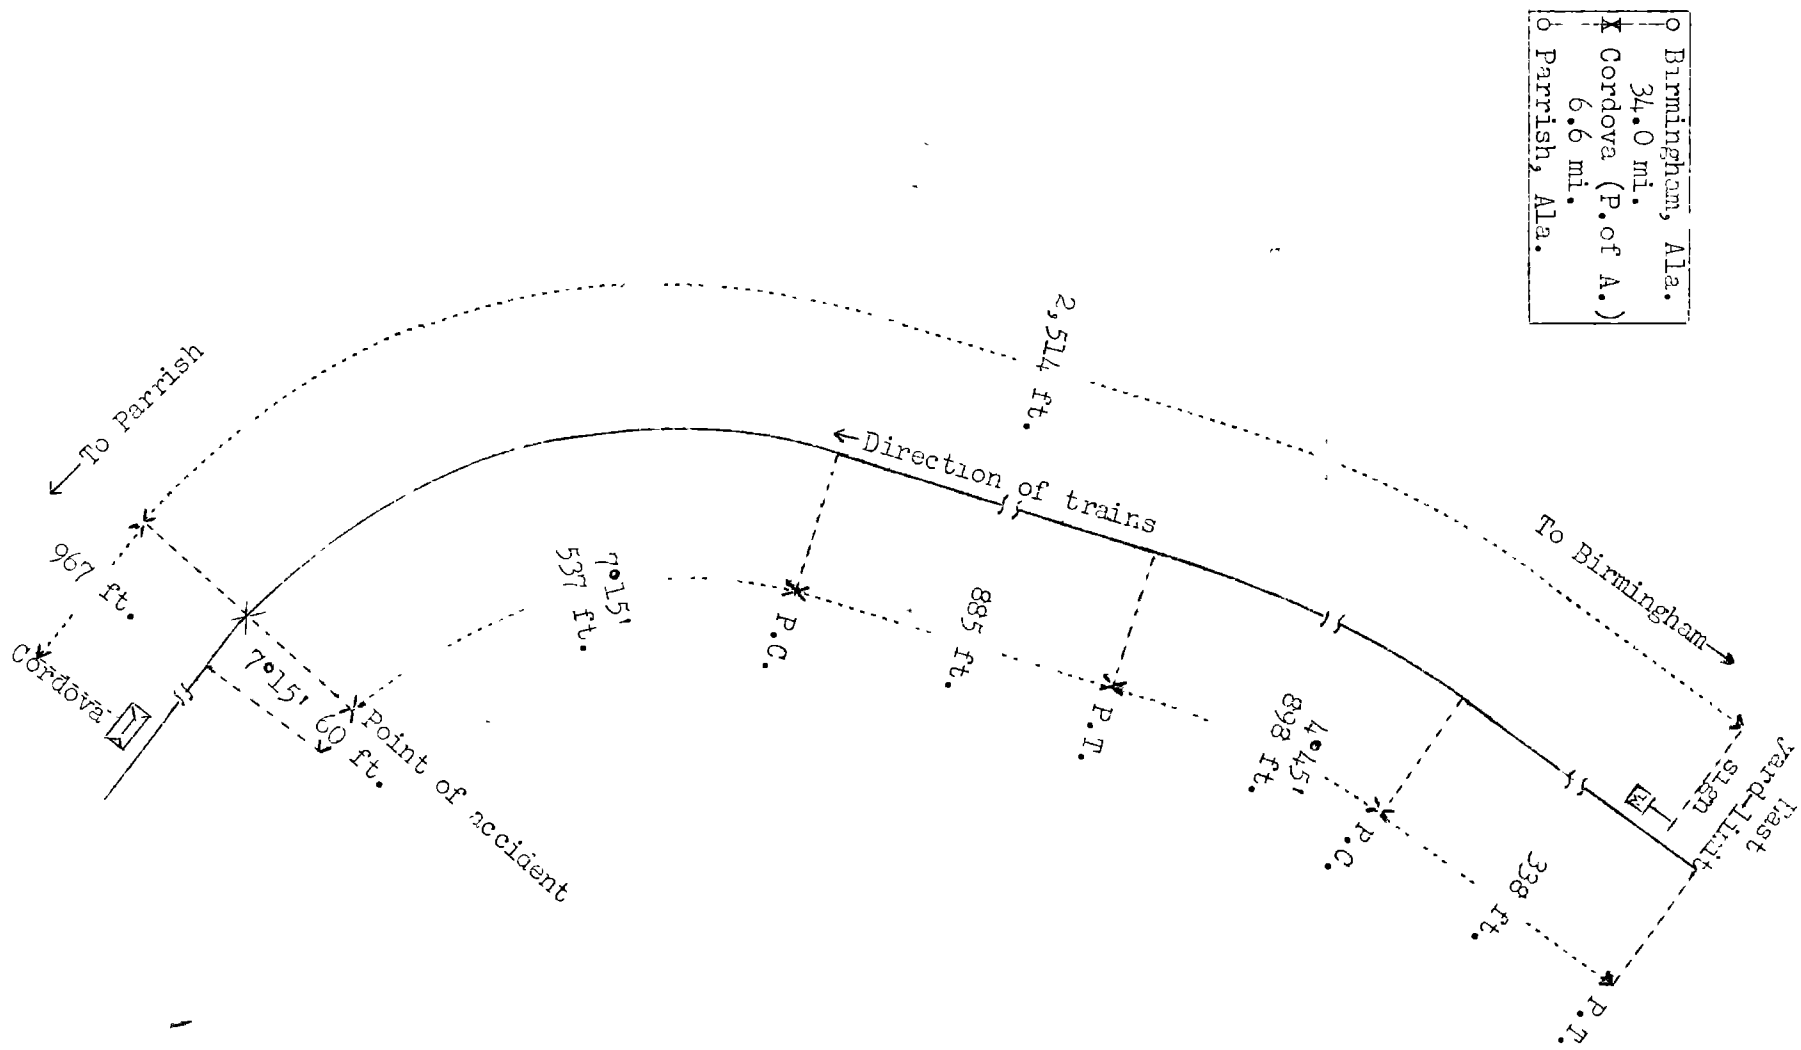
Inv. No. 2742
 Southern Railway System
 Cordova, Ala.
 November 15, 1943

Location of Accident and Method of Operation

This accident occurred on that part of the Birmingham Division extending between Birmingham and Parrish, Ala., 40.6 miles. In the vicinity of the point of accident this was a single-track line, within yard limits, over which trains were operated by timetable and train orders. There was no block system in use. The accident occurred 967 feet east of the station at Cordova and 2,514 feet west of the east yard-limit sign. From the east there were, in succession, a tangent 538 feet in length, a 4°45' curve to the left 898 feet, a tangent 885 feet and a 7°15' curve to the left 537 feet to the point of accident and 60 feet beyond. The grade for west-bound trains was 1.35 percent descending 900 feet, then there were, in succession, a vertical curve 1,100 feet, level track 250 feet, a vertical curve 1,000 feet and a 1.20-percent ascending grade 260 feet to the point of accident and 90 feet beyond.
