INVESTIGATION NO. 2904
SOUTHERN RAILWAY COMPANY
REPORT IN RE ACCIDENT
AT MONTVIEW, VA., ON
JUNE 28, 1945

Accident at Montview, Va., on June 28, 1945, caused by
failure properly to control the speed of the fol-
lowing train moving within yard limits.

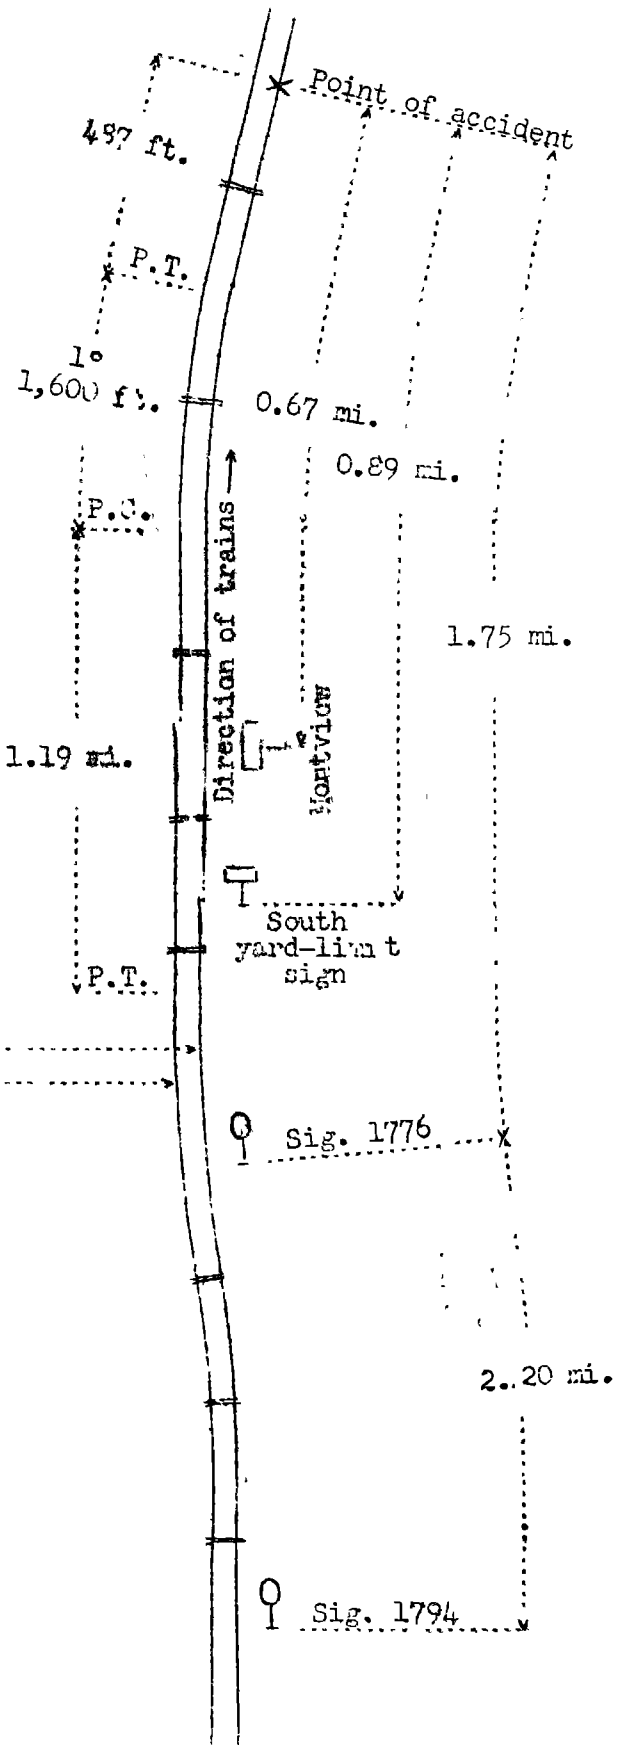
Inv. No. 2904
 Southern Railway
 Montview, Va.
 June 28, 1945

↑
To Monroe

- Monroe, Va. 11.5 mi.
- X Montview, Va. (P. of A.) 1.19 mi.
- Salisbury, N. C. 157.1 mi.

Northward main track →

Southward main track →

↓
To Salisbury

Location of Accident and Method of Operation

About 15 minutes after Extra 4906 North stopped at Montview the rear end was struck by Extra 4108 North about 0.89 mile north of the south yard-limit sign. As Extra 4108 North was approaching the point where the accident occurred the speed was about 18 miles per hour. The front brakeman was in the third Diesel-electric unit, and the fireman, who was in the engine compartment of the first unit, was engaged in inspecting the motors. The fireman said that he had last observed the engineer when the train stopped in the vicinity of signal 1776, and at that time the engineer appeared to be normal. Just before the accident occurred the fireman was entering the control
