ACCIDENT ON THE
SOUTHERN RAILWAY

PAINT ROCK, N. C.

FEBRUARY 3, 1939

INVESTIGATION NO. 2327

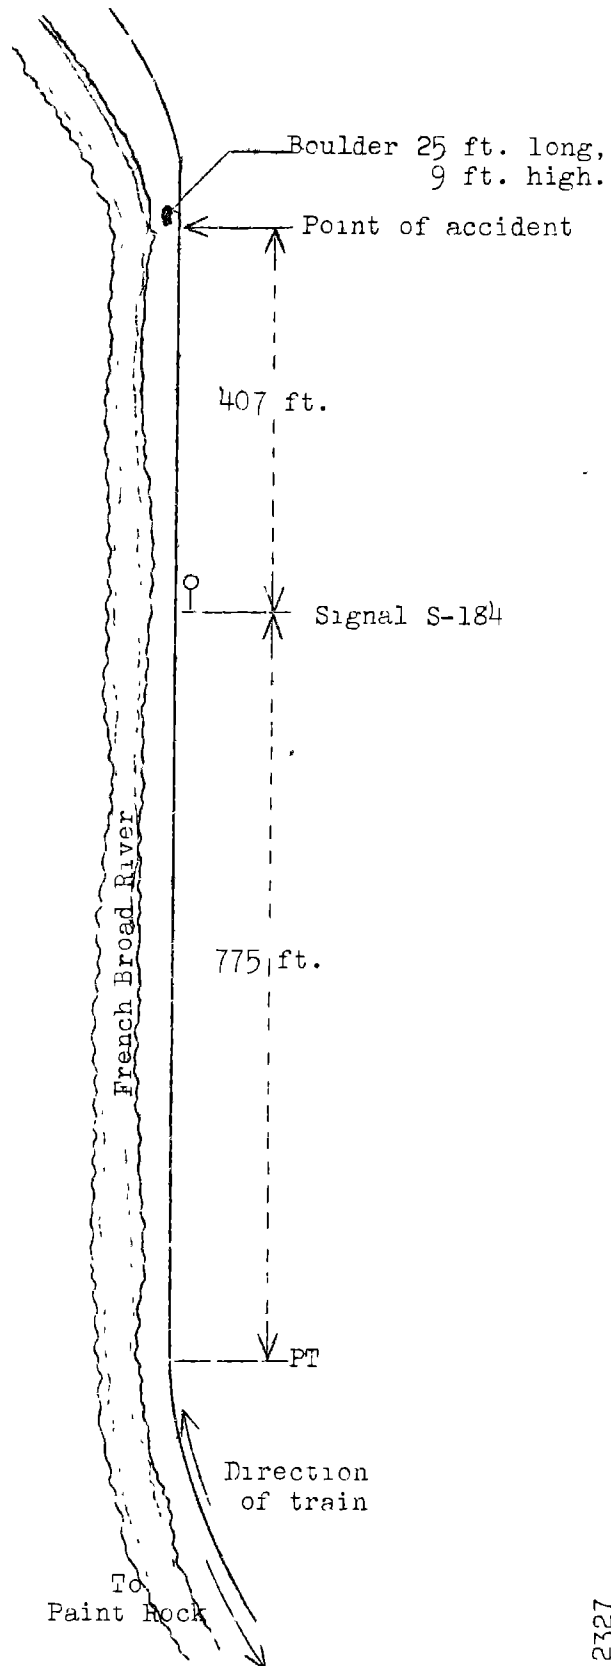
Inv. No. 2327
Southern Rwy.
Paint Rock, N.C.
February 3, 1970

o Asheville, N.C.
44.2 mi.
X Point of accident
o Paint Rock
4.0 mi.
o Wolf Creek
12.7 mi.
o Bridgeport
14.3 mi.
o Leadvale
32.3 mi.
o Bulls Gap, N.C.
