INTERSTATE COMMERCE COMMISSION

ACCIDENT ON THE

SOUTHERN RAILWAY

PEAK, TENN.

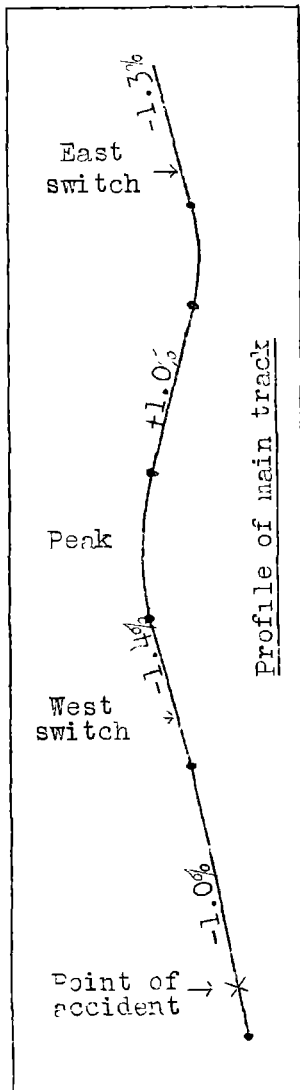
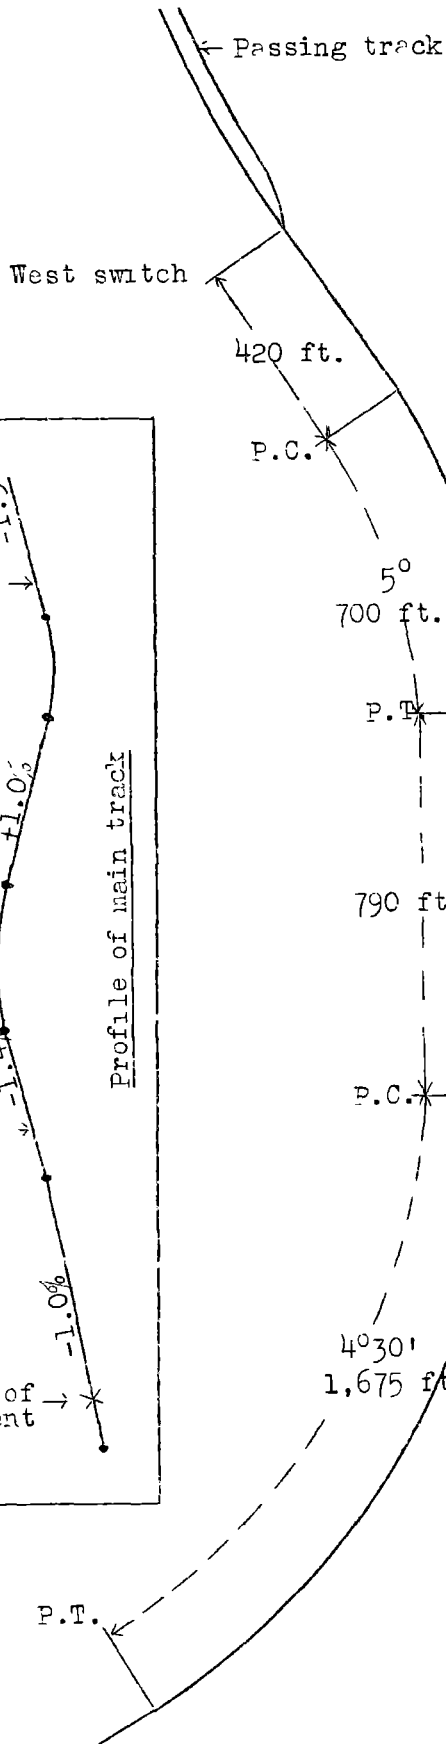
Inv. No. 2080
Southern Railway
Peak, Tenn.
July 11, 1936

o	Knoxville, Tenn.
	2.0 mi.
o	Coster
	11.4 mi.
o	Heiskell
	2.2 mi.
o	Chestnut Ridge
	1.9 mi.
o	Peak
X	(Point of accident)
	37.7 mi.
o	Oakdale, Tenn.

This accident occurred on that part of the Knoxville Division extending between Knoxville and Oakdale, Tenn., a distance of 55.2 miles; in the vicinity of the point of accident this is a single-track line over which trains are operated by time table and train orders, no block-signal system being in use. The accident occurred on a fill at a point 2,209 feet west of the west switch of the passing track at Peak; approaching this point from the east, beginning at the west switch of the passing track, the track is tangent for a distance of 420 feet, followed by a 5° curve to the right 700 feet in length, then tangent for 790 feet, and a $4^{\circ}30'$ curve to the right 1,675 feet in length, the accident occurring on this last mentioned curve at a point 299 feet from its eastern end. The grade for west-bound trains in this vicinity is descending, varying from 0.9 to 1.4 percent, being 1 percent at the point of accident.
