INTERSTATE COMMERCE COMMISSION
WASHINGTON

REPORT OF THE DIRECTOR
BUREAU OF SAFETY

ACCIDENT ON THE
SOUTHERN RAILWAY SYSTEM

SALVISA, KY.

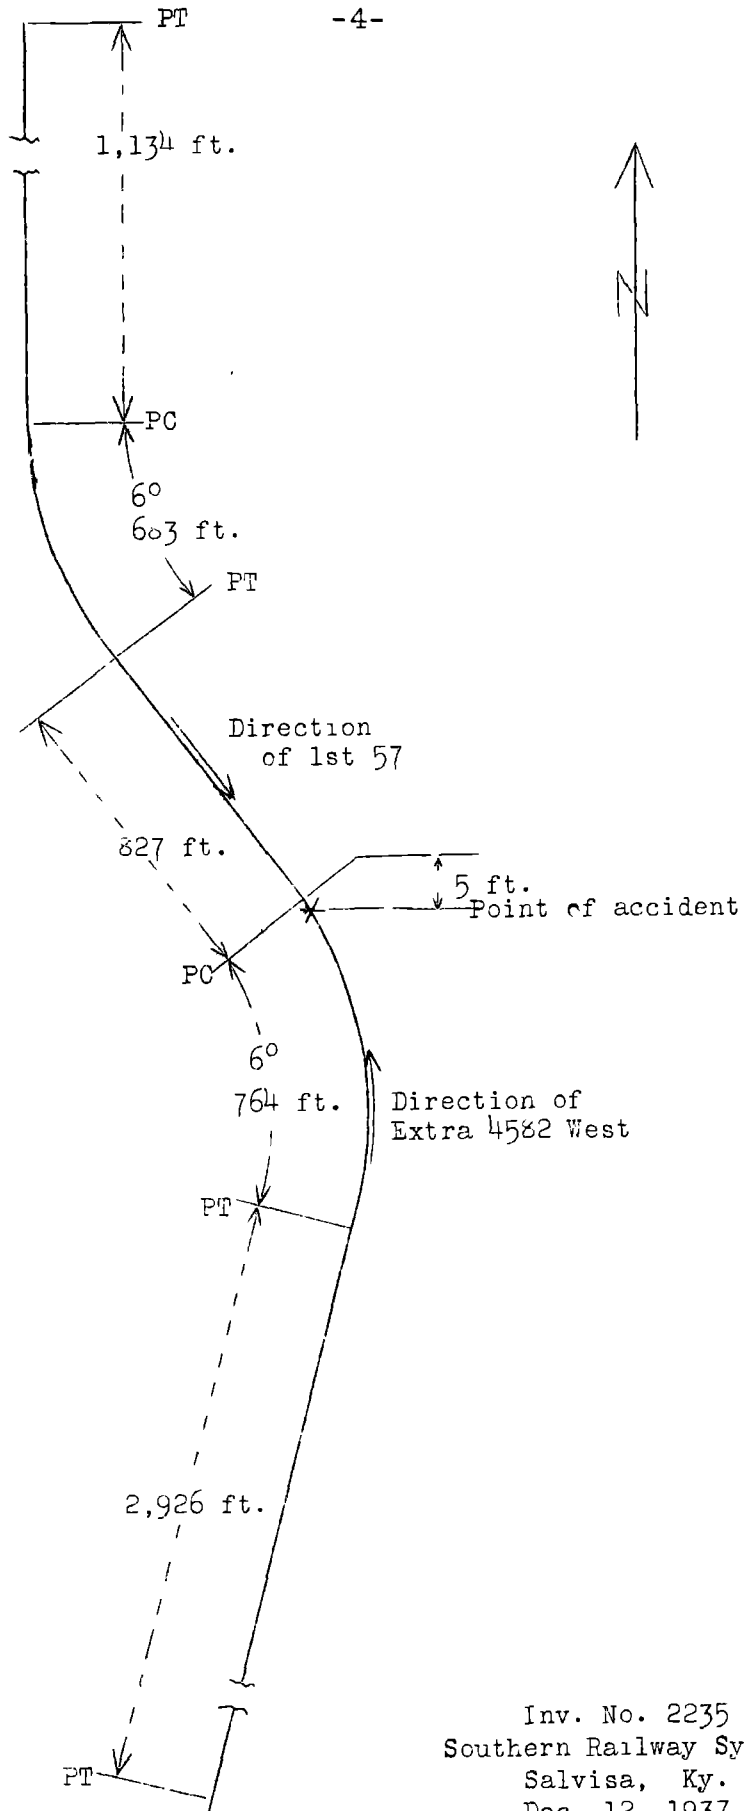
Inv. No. 2235
 Southern Railway System
 Salvisa, Ky.
 Dec. 12, 1937

o	Louisville, Ky.	
	63.3 mi.	
o	Lawrenceburg	
	8.4 mi.	
o	Salvisa	
x	Point of accident	
	5.0 mi.	
o	Talmage	
	4.5 mi.	
o	Judd	
	2.8 mi.	
o	Harrodsburg	
	6.1 mi.	
o	S.J. Tower	
	3.1 mi.	
o	Danville, Ky.

This accident occurred on that part of the Louisville Division which extends between Danville and Louisville, Ky., a distance of 93.2 miles. This is a single-track line over which trains are operated by timetable and train orders, no block-signal system being in use. The accident occurred at a point 2,540 feet east of the east switch of the siding at Salvisa. Approaching this point from the west the track is tangent for a distance of 1,134 feet, followed by a 6° curve to the left 683 feet in length, then tangent track for 827 feet, and a 6° curve to the right 764 feet in length; the accident occurred on this latter curve at a point 5 feet from its western end. Approaching from the east there is tangent track for a distance of 2,926 feet followed by the curve on which the accident occurred. The grade is 1.29 percent ascending for west-bound trains. Due to the track curvature and trees nearby, the view to be had from the engines of two opposing trains approaching the point of the accident was restricted to a distance of 900 feet.
