INVESTIGATION NO. 2719

THE SOUTHERN RAILWAY SYSTEM

REPORT IN RE ACCIDENT

AT VALENTINE, S. C., ON

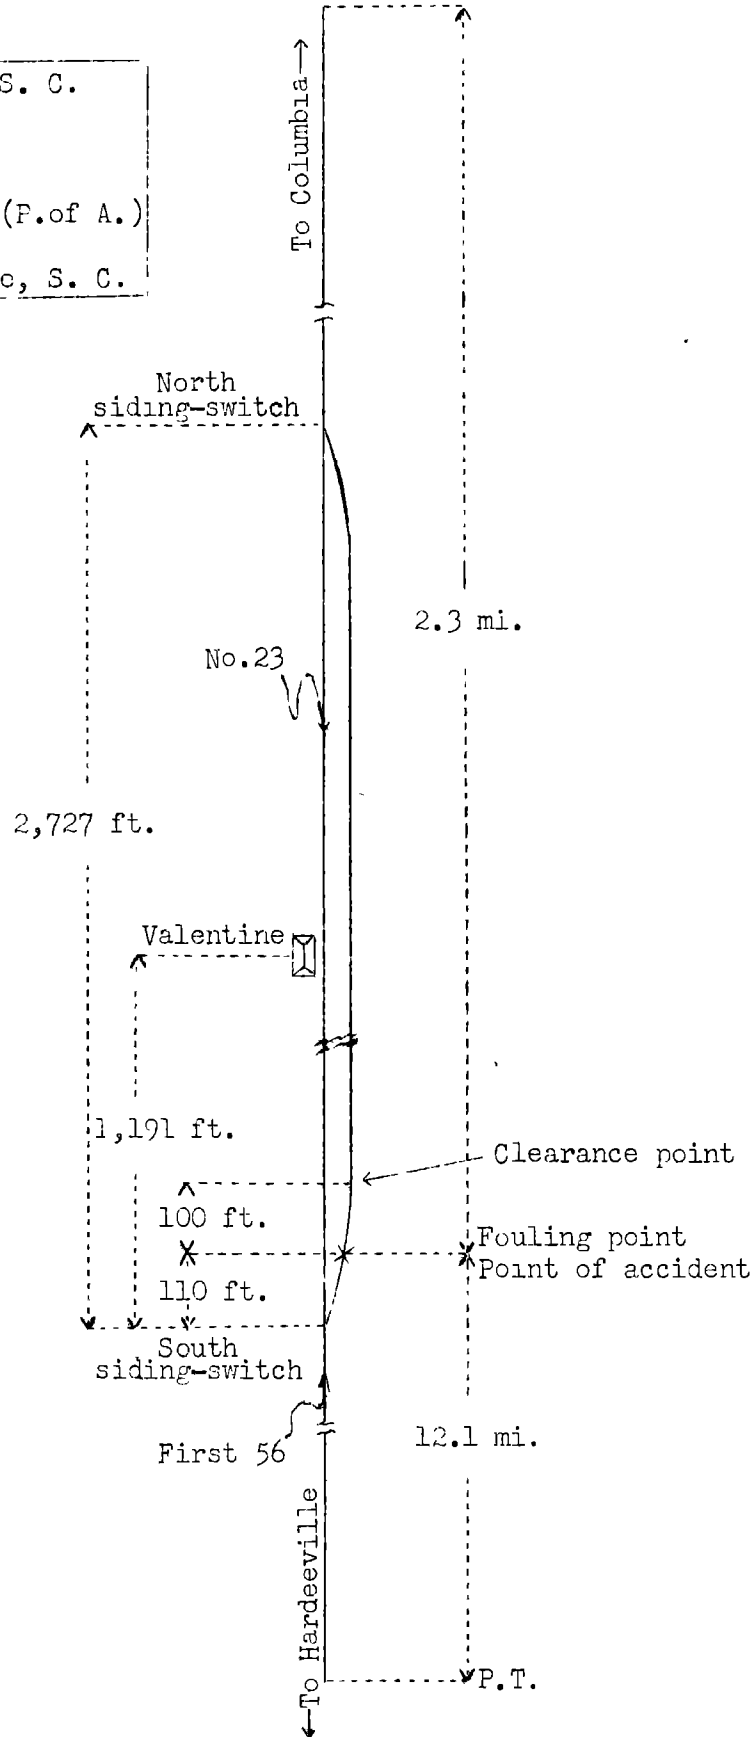
Inv. No. 2719
 Southern Railway System
 Valentine, S. C.
 August 11, 1943

| ○ | Columbia, S. C. | 78.5 mi. |
| ○ | Allendale | 13.4 mi. |
| X | Valentine (P. of A.) | 38.7 mi. |
| ○ | Hardeeville, S. C. | |
