INVESTIGATION NO. 2710
THE SOUTHERN RAILWAY SYSTEM
REPORT IN RE ACCIDENT
AT WHITESEBURG, TENN., ON
JULY 17, 1943

Kind of accident: Head-end collision

Accident at Whitesburg, Tenn., on July 17, 1945, caused
by switch being opened immediately in front of an
approaching train.

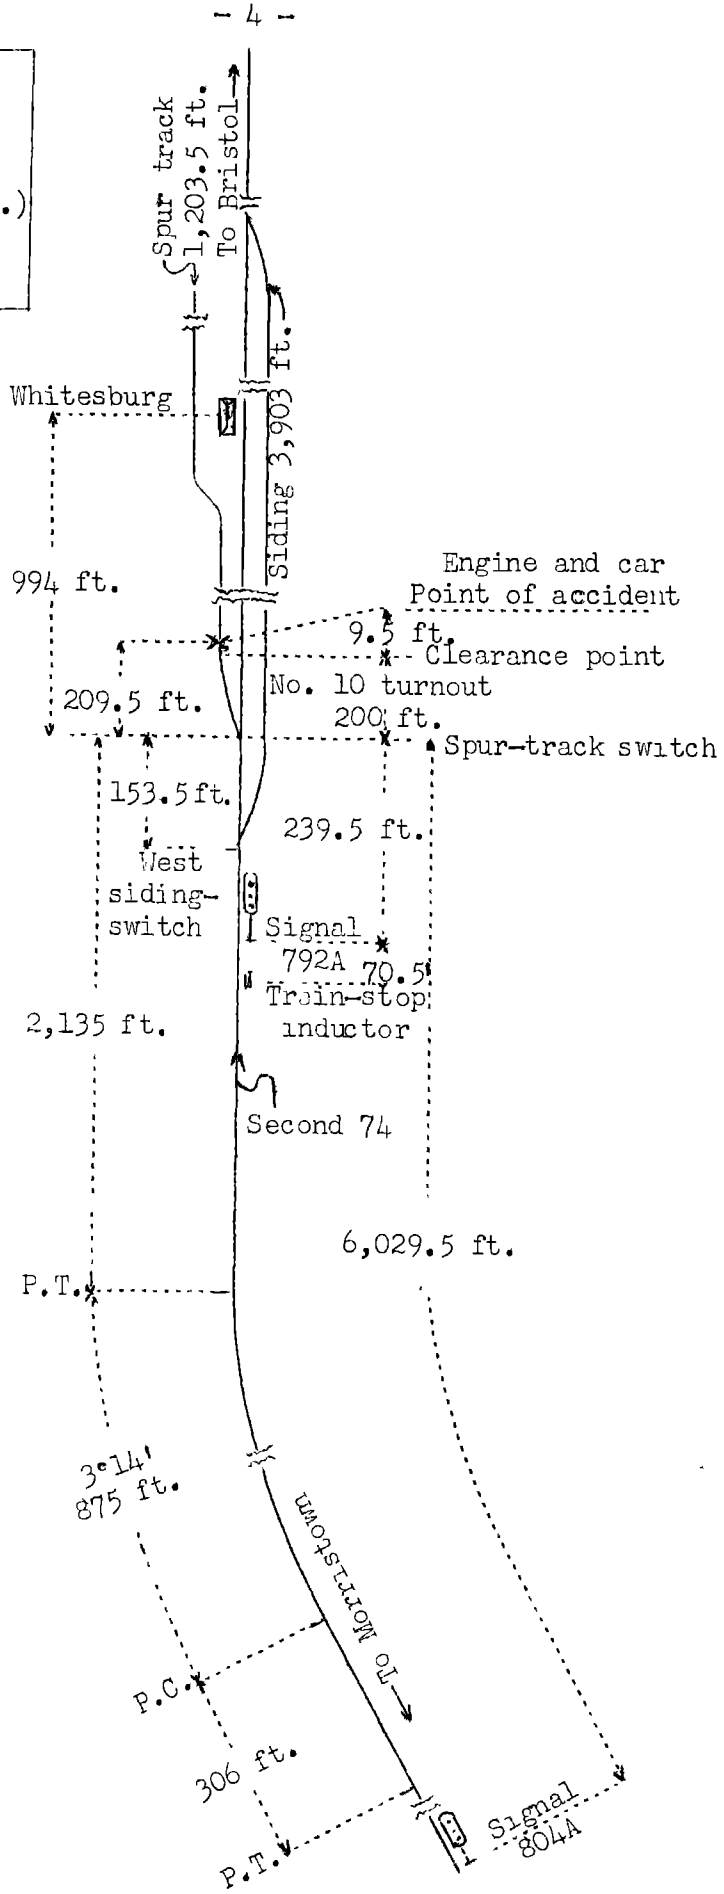
Inv. No. 2710
 Southern Railway System
 Whitesburg, Tenn.
 July 17, 1943

- o Bristol, Va.
75.7 mi.
- o Bulls Gap, Tenn.
3.3 mi.
- X Whitesburg (P. of A.)
10.0 mi.
- o Morristown, Tenn.
