REPORT OF THE DIRECTOR
BUREAU OF SAFETY

ACCIDENT ON THE
SPOKANE, PORTLAND & SEATTLE RY.

LYLE, WASH.

INVESTIGATION NO. 2027

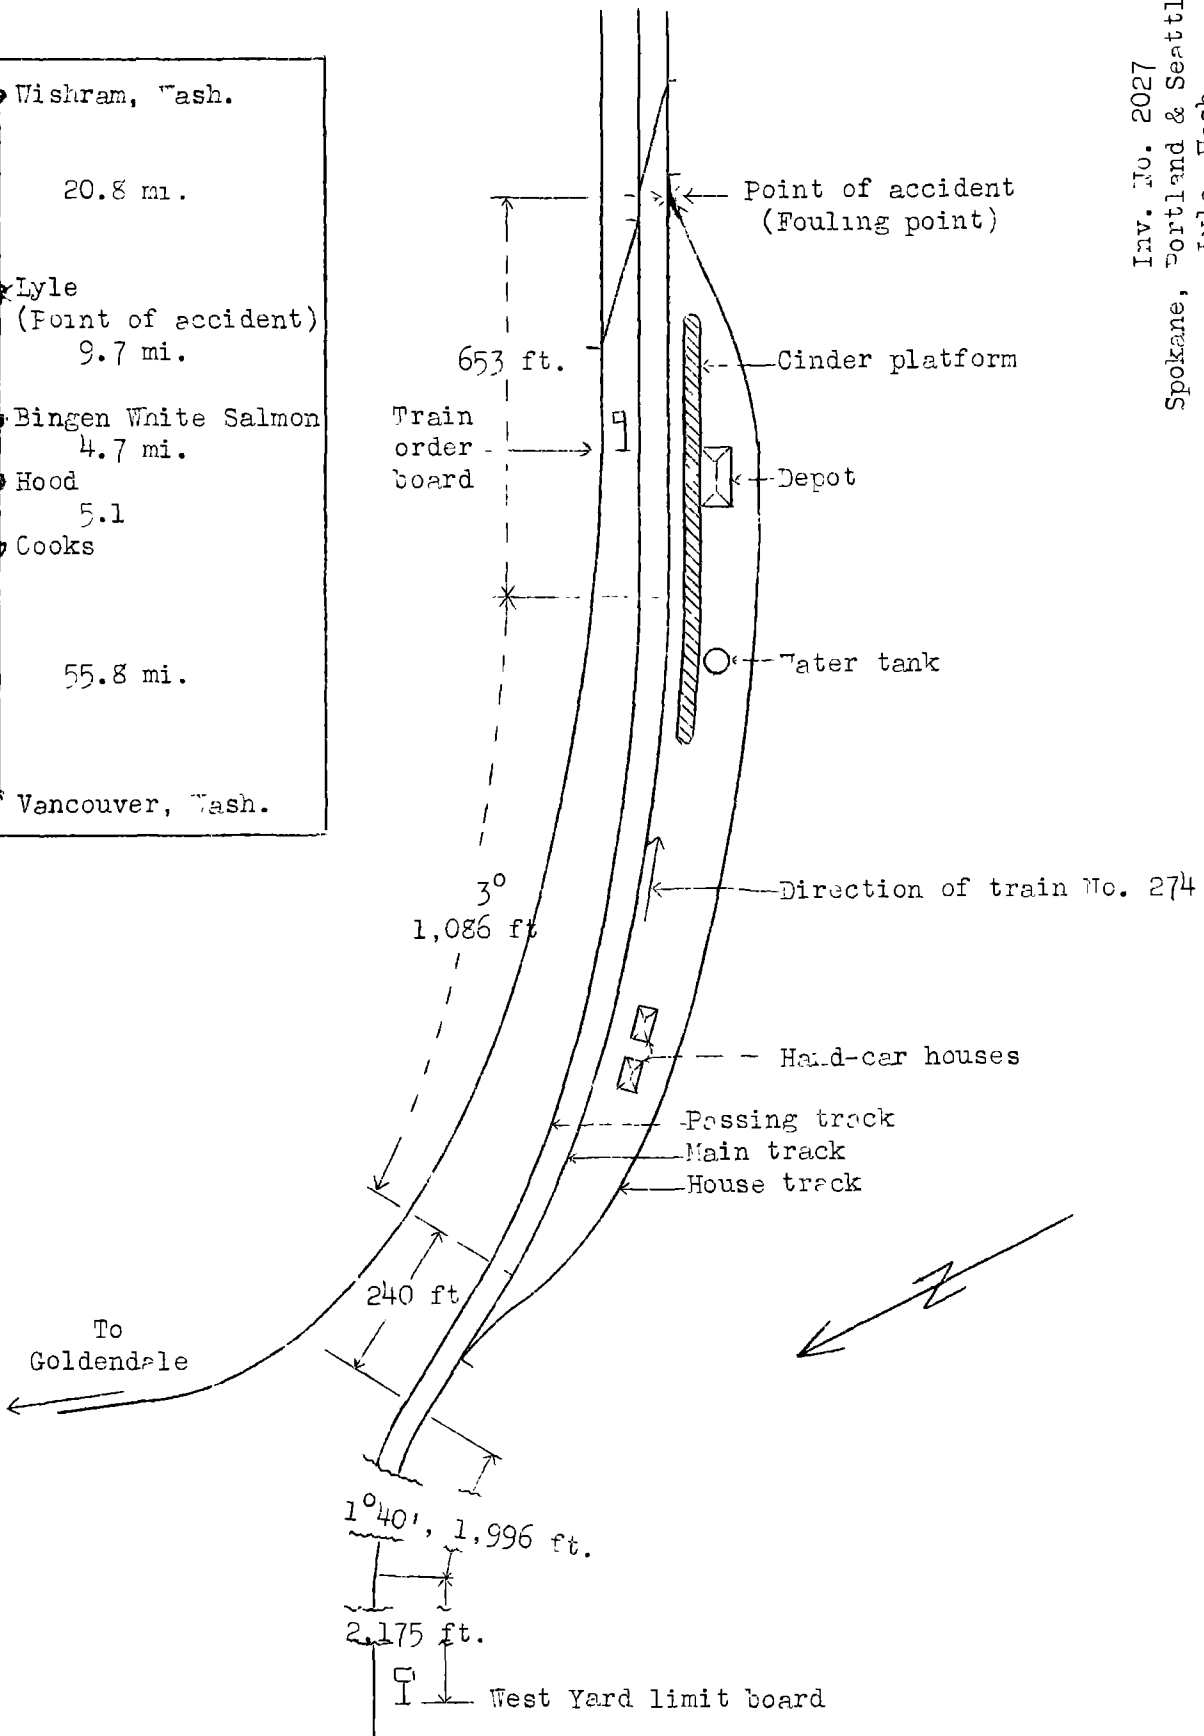
Inv. No. 2027
Spokane, Portland & Seattle Ry.
Lyle, Wash.
Dec. 17, 1935

Wishram, Wash.	
20.8 mi.	
Lyle (Point of accident)	9.7 mi.
Bingen White Salmon	4.7 mi.
Hood	5.1
Cooks	
55.8 mi.	
Vancouver, Wash.
