INTERSTATE COMMERCE COMMISSION

INVESTIGATION NO. 2573

THE SPOKANE, PORTLAND & SEATTLE RAILWAY COMPANY

REPORT IN RE ACCIDENT

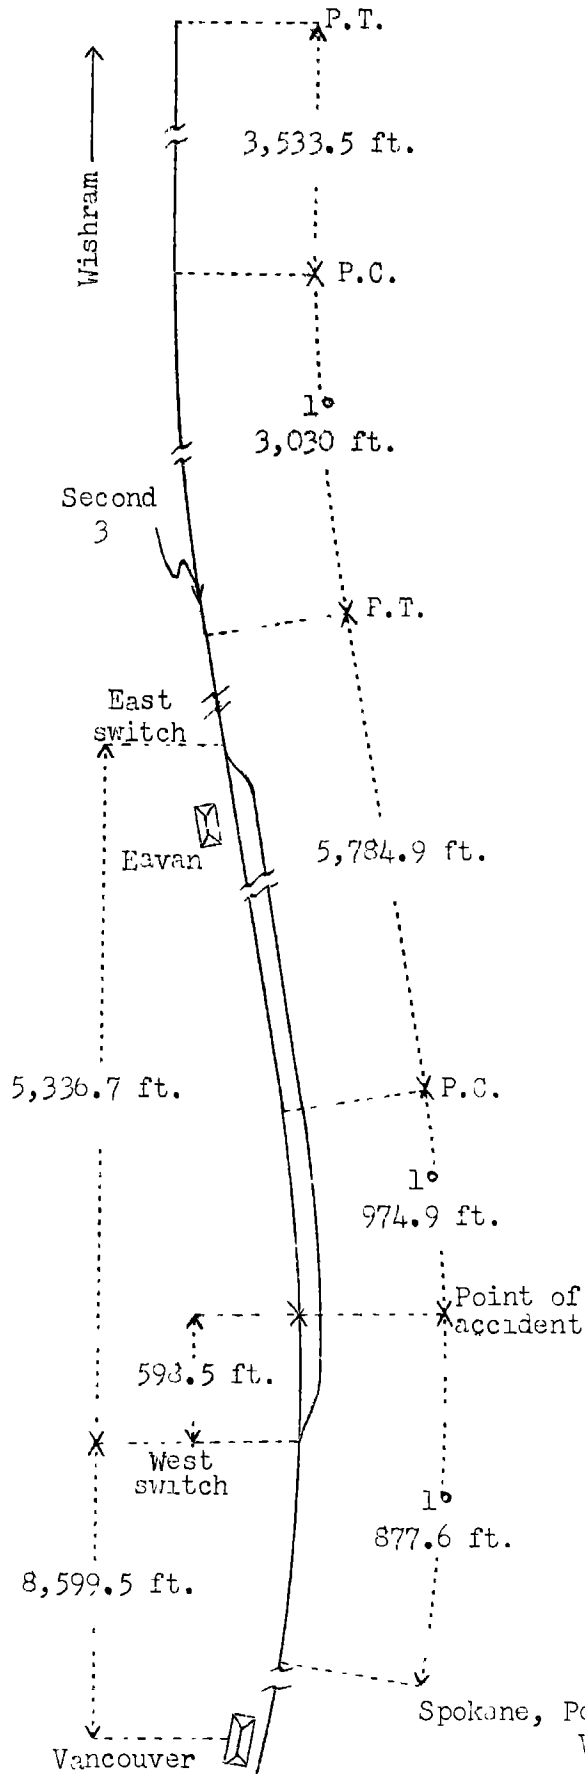
Inv. No. 2578
Spokane, Portland & Seattle Ry.,
Vancouver, Wash.
March 22, 1942.

o	Wishram, Wash.
	81.70 mi.
o	Camas
	9.9 mi.
o	McLaughlin
	2.76 mi.
x	Point of accident
	1.74 mi.
o	Vancouver, Wash.

Location of Accident and Method of Operation
