INVESTIGATION NO. 2797
THE ST. JOHNSBURY & LAKE CHAMPLAIN
RAILROAD COMPANY

REPORT IN RE ACCIDENT
NEAR GREENSBORO, VT., ON

MAY 5, 1944

Accident near Greensboro, Vt., on May 5, 1944, caused by
failure to deliver a meet order.

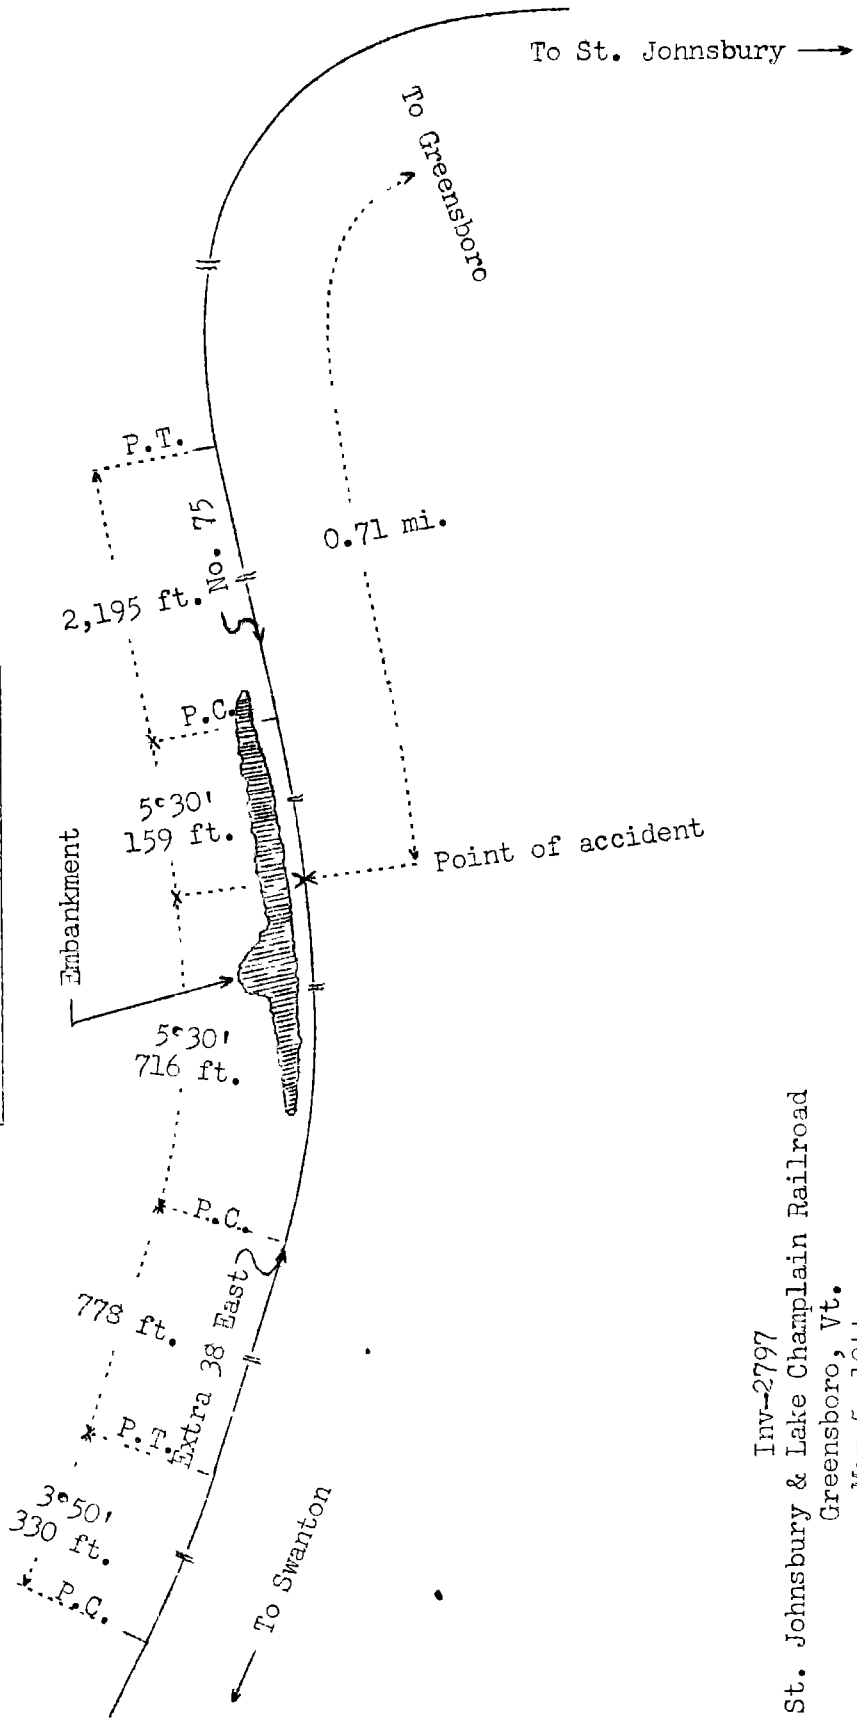
Inv-2797
 St. Johnsbury & Lake Champlain Railroad
 Greensboro, Vt.
 May 5, 1944

○	St. Johnsbury, Vt.	11.48 mi.
○	Danville	16.32 mi.
○	Greensboro	0.71 mi.
X	Point of accident	2.52 mi.
○	Lamoille	3.70 mi.
○	Hardwick	61.37 mi.
○	Swanton, Vt.

Location of Accident and Method of Operation
