INVESTIGATION NO. 2793
THE UNION RAILWAY COMPANY
AND
THE ST. LOUIS - SAN FRANCISCO RAILWAY COMPANY
REPORT IN RE ACCIDENT
AT MEMPHIS, TENN., ON
APRIL 21, 1944

Accident at Memphis, Tenn., on April 21, 1944, caused by
failure properly to control the speed of the S. L.-
S. F. train moving within yard limits.

Inv. No. 2793
 Union Railway
 and
 St. Louis - San Francisco Railway
 Memphis, Tenn.
 April 21, 1944

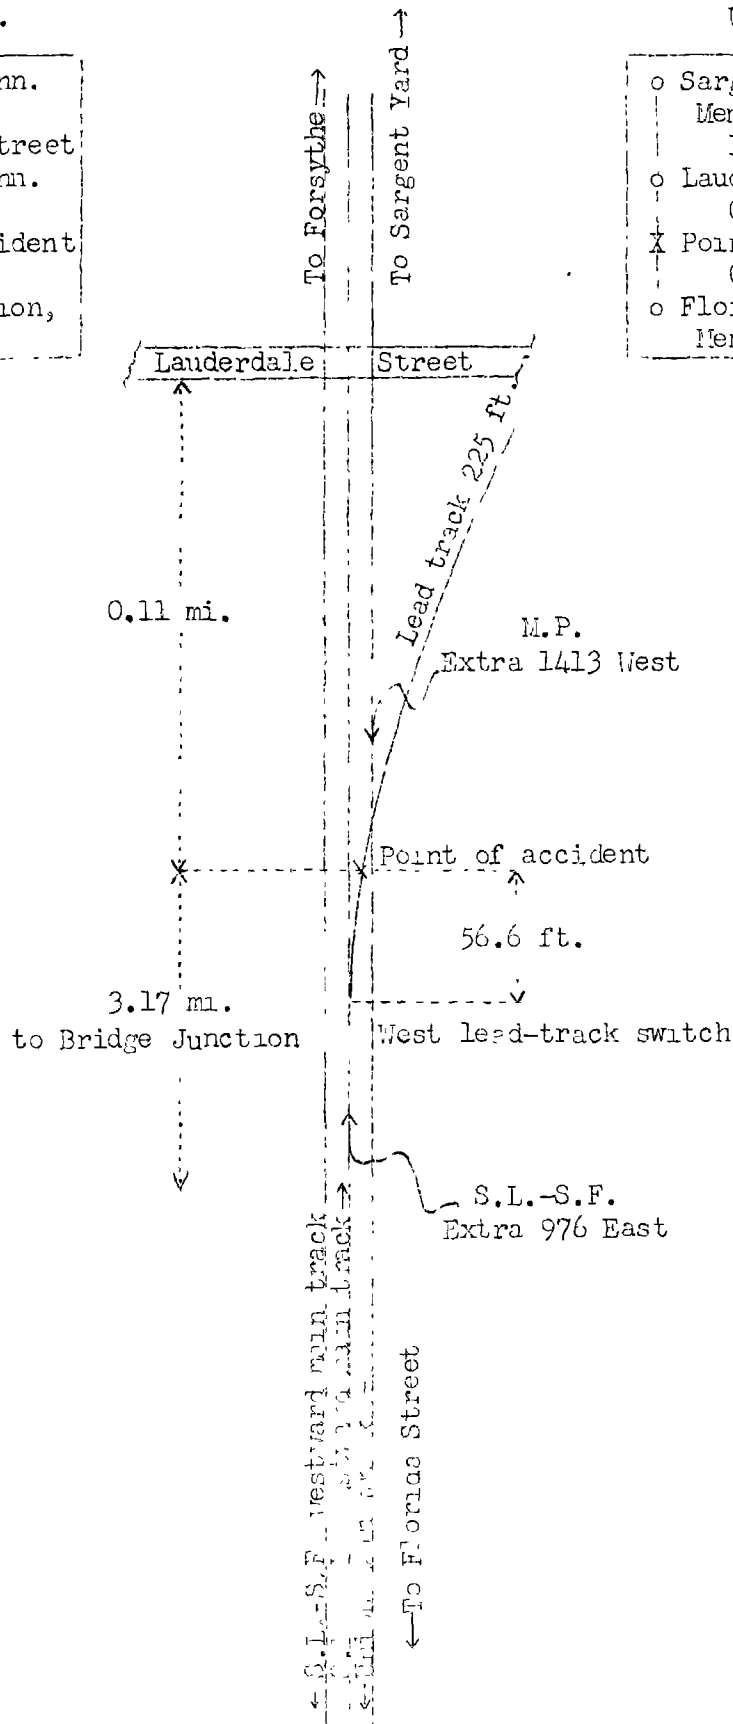
- o Forsythe, Tenn. 7.52 mi.
- o Lauderdale Street Memphis, Tenn. 0.11 mi.
- X Point of accident 3.17 mi.
- o Bridge Junction, Ark.

- o Sargent Yard, Memphis, Tenn. 1.53 mi.
- o Lauderdale Street 0.11 mi.
- X Point of accident 0.86 mi.
- o Florida Street, Memphis, Tenn.
