REPORT OF THE DIRECTOR

ACCIDENT ON THE  
ST. LOUIS SOUTHWESTERN RAILWAY

BUCKNER, ARK.

INVESTIGATION NO. 2122

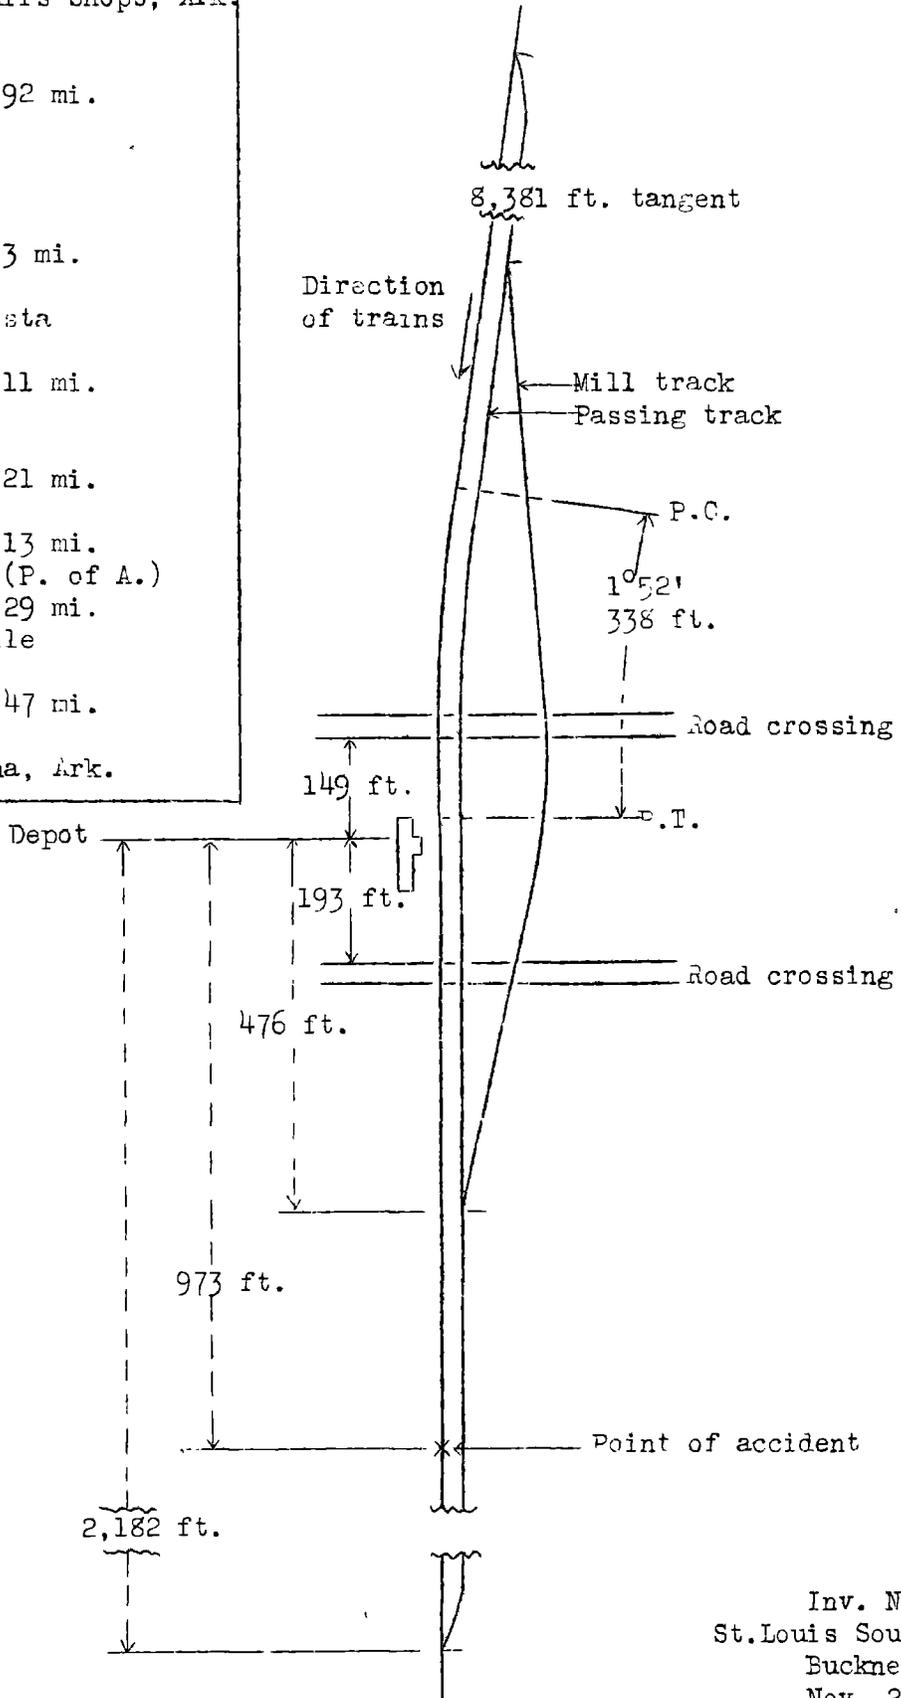
Inv. No. 2122  
St. Louis Southwestern Ry.,  
Buckner, Ark.  
Nov. 25, 1936

o Pine Bluffs Shops, Ark.
70.92 mi.
o Camden
11.3 mi.
o Dunn Vista
19.11 mi.
o McNeil
5.21 mi.
o Waldo
8.13 mi.
x Buckner (P. of A.)
8.29 mi.
o Lewisville
29.47 mi.
o Texarkana, Ark.

This accident occurred on the Pine Bluff Subdivision of the Northern Division, extending between Pine Bluff Shops and Texarkana, Ark., a distance of 152.43 miles; in the vicinity of the point of accident this is a single-track line over which trains are operated by timetable and train orders, no block-signal system being in use. The accident occurred at a point 973 feet south of the depot at Buckner; approaching this point from the north the track is tangent for a distance of 8,381 feet, then there is a  $1^{\circ} 52'$  curve to the left 338 feet in length, followed by 1,002 feet of tangent to the point of accident, this tangent extending for more than 1 mile beyond. The grade for south-bound trains is 0.60 percent ascending for a distance of 3,833 feet, level for 967 feet, and then 0.20 percent descending for 87 feet to the point of accident.
