INVESTIGATION NO. 2965

ST. LOUIS SOUTHWESTERN RAILWAY COMPANY

REPORT IN RE ACCIDENT

NEAR GARLAND CITY, ARK., ON

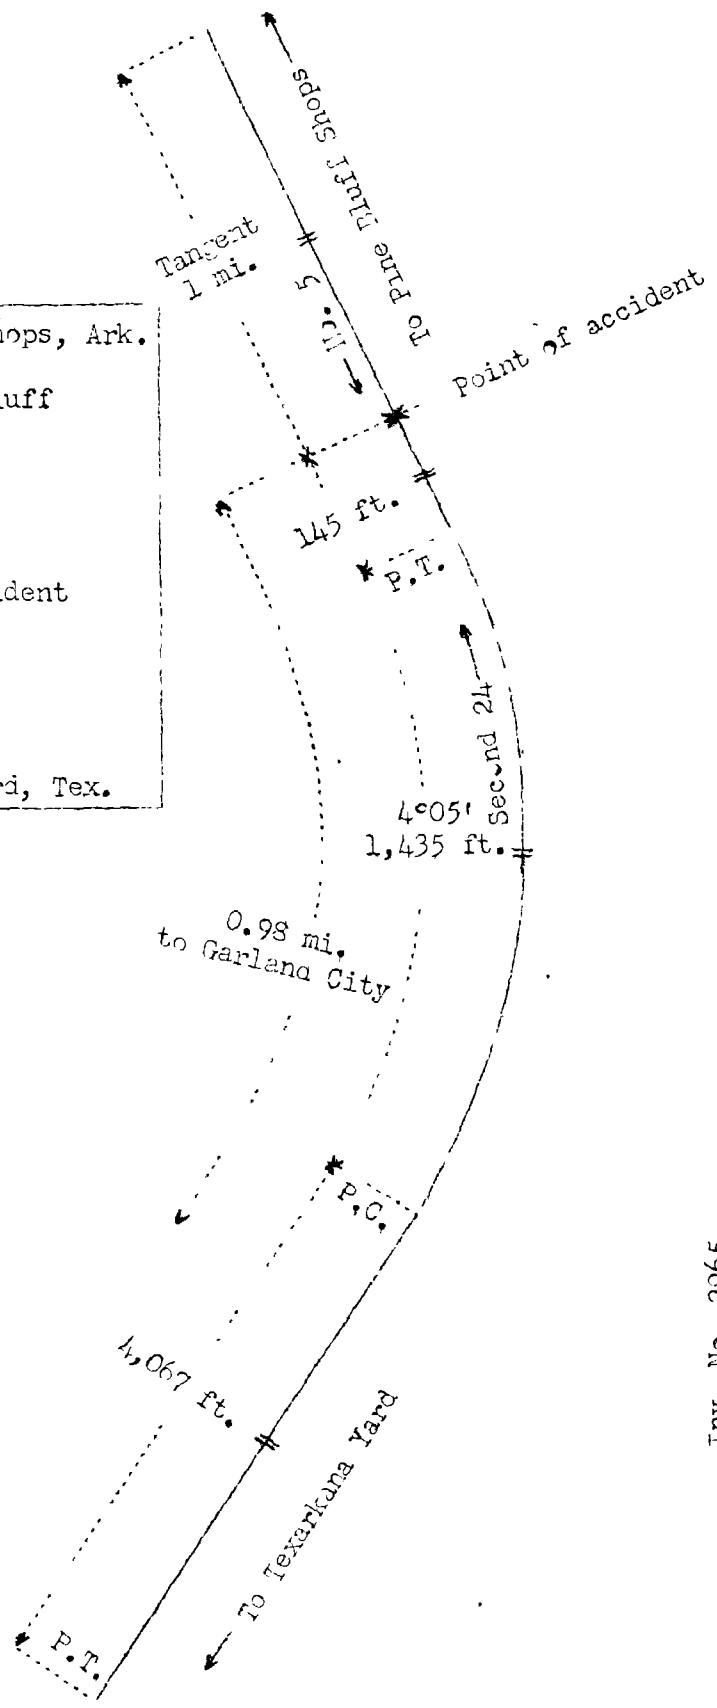
Inv. No. 2965
 St. Louis Southwestern Railway
 Garland City, Ark.
 January 6, 1946

- o Pine Bluff Shops, Ark.
2.59 mi.
- o South Pine Bluff
120.37 mi.
- o Lewisville
4.20 mi.
- o Spirit Lake
2.77 mi.
- X Point of accident
0.98 mi.
- o Garland City
12.56 mi.
- o Genoa, Ark.
8.96 mi.
- o Texarkana Yard, Tex.

Location of Accident and Method of Operation
