INVESTIGATION NO. 2631
THE ST. LOUIS SOUTHWESTERN RAILWAY COMPANY
REPORT IN RE ACCIDENT
NEAR OGEMAW, ARK., ON
OCTOBER 3, 1942

Accident near Ogemaw, Ark., on October 3, 1942, caused by
failure properly to control speed of following train
after it had been flagged.

Inv. No. 2631
 St. Louis Southwestern Railway
 Ogemaw, Ark.
 October 3, 1942

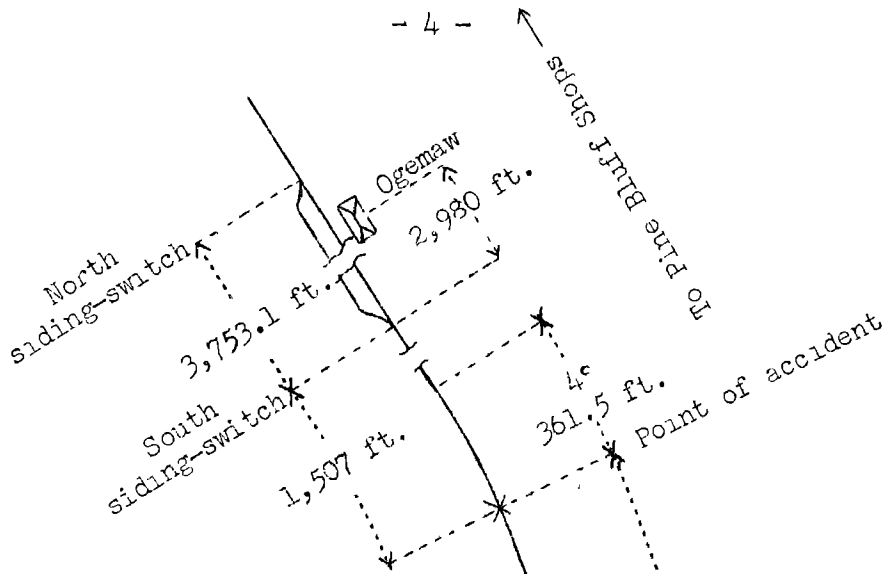
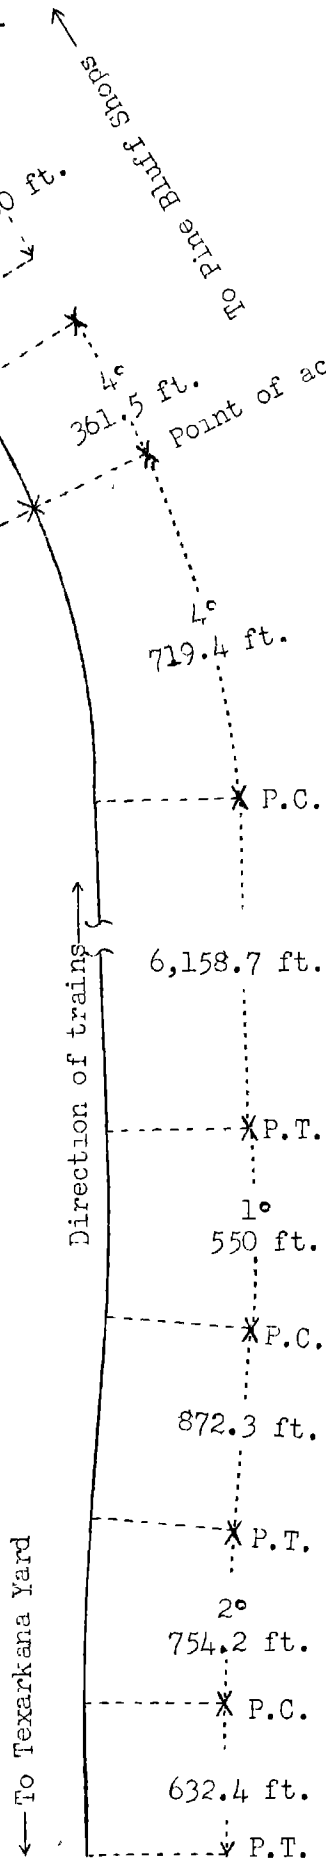
○	Pine Bluff Shops, Ark.	87.00 mi.
○	Ogemaw	0.85 mi.
✕	Point of accident	13.48 mi.
○	McNeil	21.63 mi.
○	Lewisville, Ark.	29.47 mi.
○	Texarkana Yard, Texas

This accident occurred on that part of the Northern Division designated as the Pine Bluff Subdivision and extending between Pine Bluff Shops, Ark., and Texarkana Yard, Texas, a distance of 152.43 miles. In the vicinity of the point of accident this is a single-track line over which trains are operated by timetable and train orders. There is no block system in use. At Ogemaw a siding 3,753.1 feet in length parallels the main track on the west. The south switch of this siding is 2,930 feet south of the station. The accident occurred on the main track 1,507 feet south of the south siding-switch. Approaching from the south there are, in succession, a tangent 632.4 feet in length, a 2° curve to the right 754.2 feet, a tangent 872.3 feet, a 1° curve to the left 550 feet, a tangent 6,158.7 feet and a 4° curve to the left 719.4 feet to the point of accident and 361.5 feet beyond. The grade for north-bound trains varies between 0.91 and 1.0 percent descending throughout a distance of 5,200 feet, which is followed, in succession, by a vertical curve 400 feet, level grade 1,200 feet, a vertical curve 400 feet, a 1-percent ascending grade 1,700 feet and a 0.875-percent ascending grade 720 feet to the point of accident.
