REPORT OF THE DIRECTOR
BUREAU OF SAFETY

ACCIDENT ON THE
ST. LOUIS SOUTHWESTERN RAILWAY

ROE, ARK.

INVESTIGATION NO. 2253

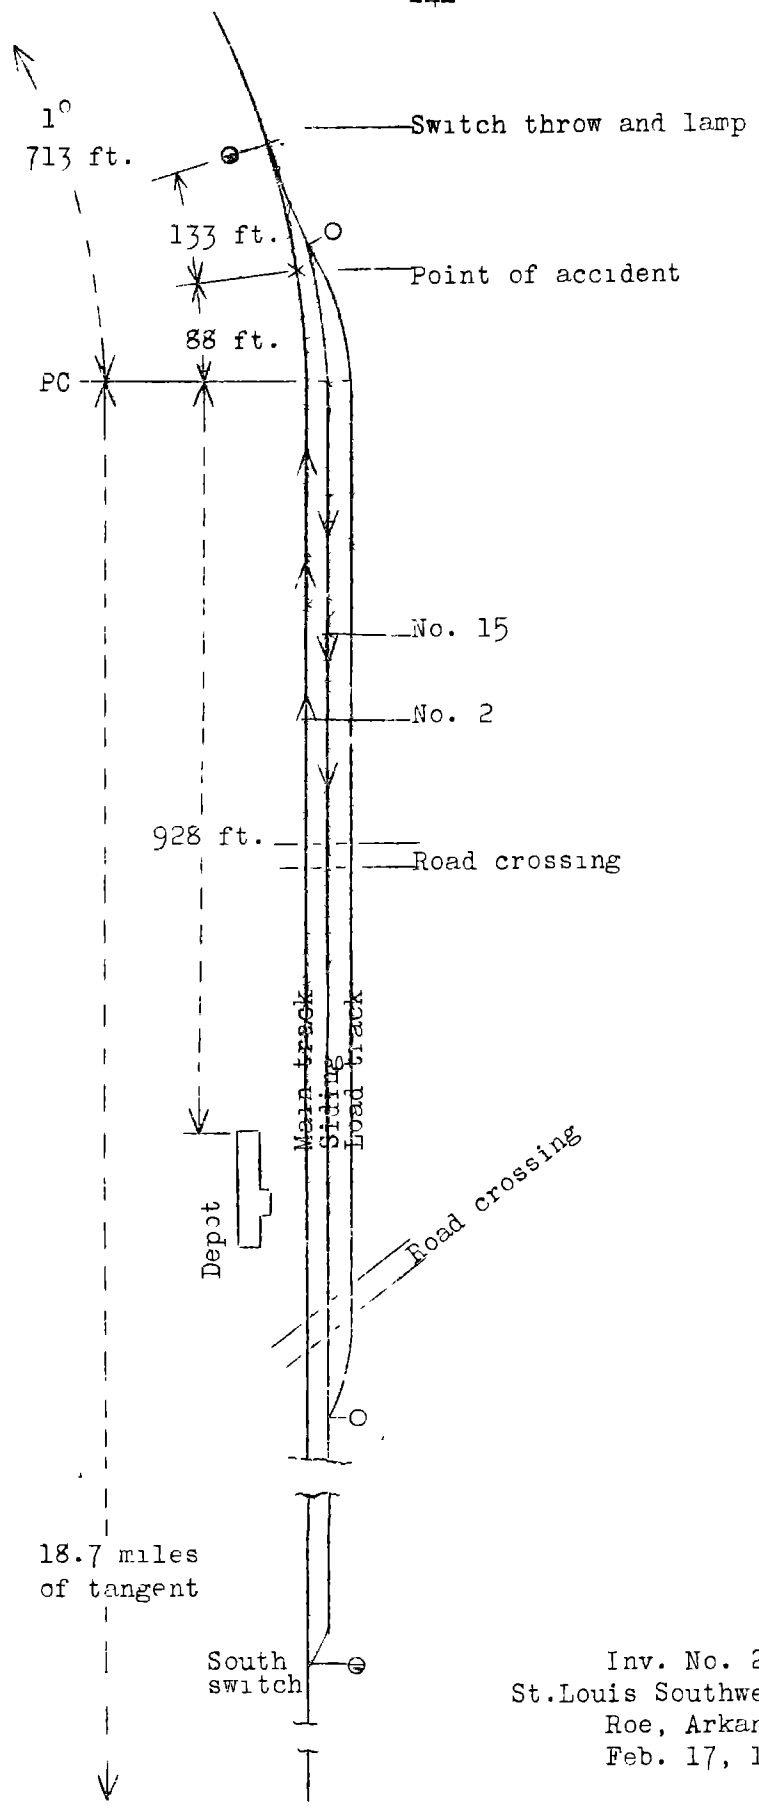
Inv. No. 2253
 St. Louis Southwestern Ry.
 Roe, Arkansas
 Feb. 17, 1938

o Jonesboro, Ark.	
	74.17 mi.
o Brinkley	
	21.62 mi.
x Roe (P of A)	
	12.69 mi.
o Stuttgart	
	33.41 mi.
o Pine Bluff Shops, Ark.

The siding at Roe is 4,859 feet in length and parallels the main track on the east. Roe Station is located 1,150 feet south of the north switch of the siding. The target mast of the north switch of the siding is located on the west side of the track, 7 feet $\frac{1}{2}$ inch from the gauge side of the west rail, while the switch-throw device is on the east side of the track; the target is 18 inches in diameter. A Handlan standard type switch lamp is mounted on top of the mast; the center of the lens is 7 feet $2\frac{1}{8}$ inches above the ties.
