INTERSTATE COMMERCE COMMISSION
WASHINGTON

INVESTIGATION NO. 3124
ST. LOUIS SOUTHWESTERN RAILWAY COMPANY
REPORT IN RE ACCIDENT
AT SALINE, ARK., ON
AUGUST 23, 1947

Accident at Saline, Ark., on August 23, 1947, caused by
failure properly to control the speed of the
following train moving on a siding.

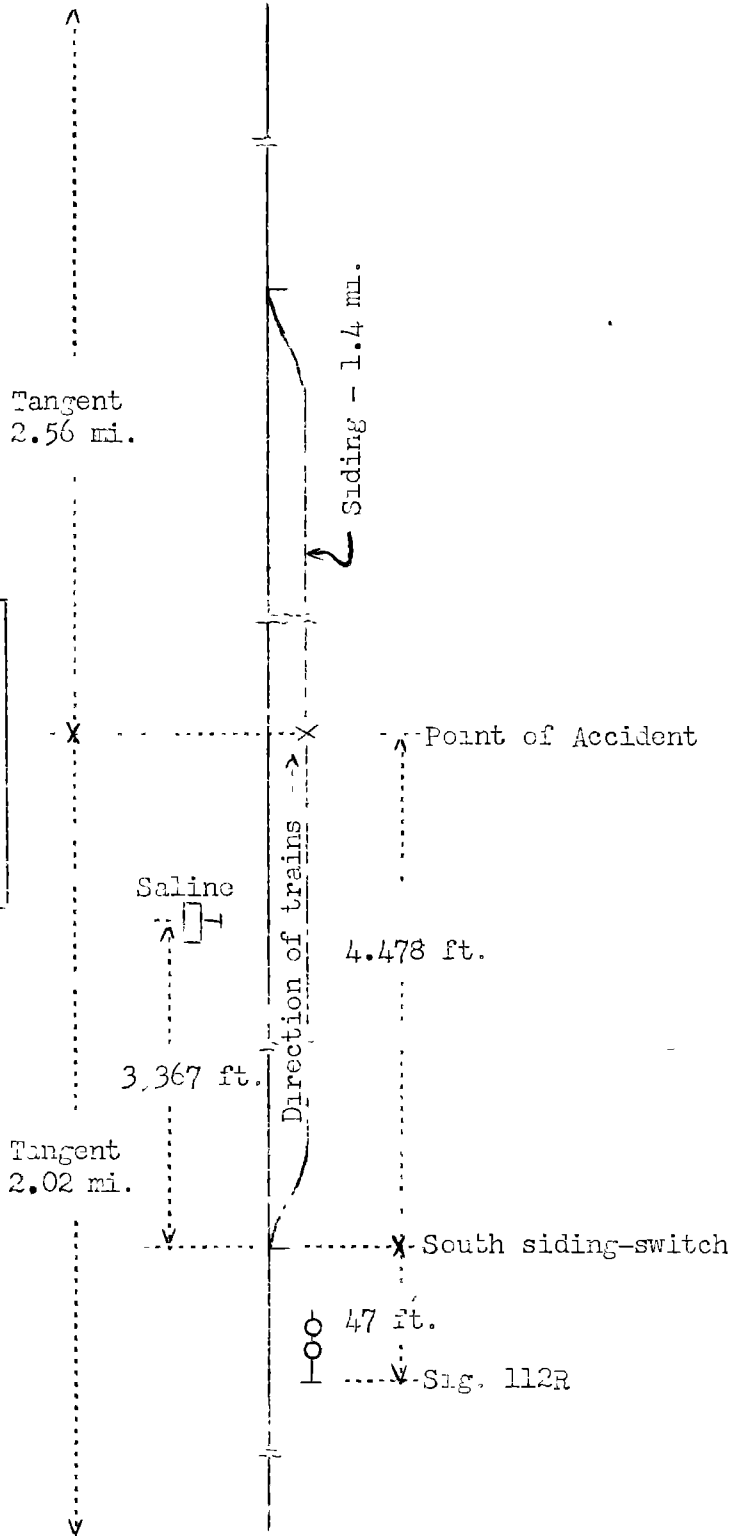
Inv. No. 3124
 St. Louis Southwestern Railway Company
 Saline, Ark.
 August 23, 1947

- Pine Bluff Shops, Ark.
30.34 mi.
- X Saline
(Point of Accident)
10.34 mi.
- Fordyce, Ark.
111.75 mi.
- Texarkana Yard, Tex.

Location of Accident and Method of Operation
