INVESTIGATION NO. 2906
ST. LOUIS, SAN FRANCISCO AND TEXAS
RAILWAY COMPANY
REPORT IN RE ACCIDENT
AT SHERMAN, TEX., ON
JUNE 30, 1945

Railroad: St. Louis, San Francisco and Texas
Date: June 30, 1945
Location: Sherman, Tex.
Kind of accident: Head-end collision
Trains involved: Freight : Yard engine
Train number: Extra 1024-1039 :
North
Engine numbers: 1024-1039 : 3747
Consist: 37 cars, 2 : 3 cars
caboose
Estimated speed: 5 m. p. h. : 5 m. p. h.
Operation: Timetable and train orders;
yard limits
Track: Single; tangent; 0.7 percent
ascending grade northward
Weather: Clear
Time: 7:20 p. m.
Casualties: 1 injured
Cause: Failure properly to control
speed of both movements
within yard limits

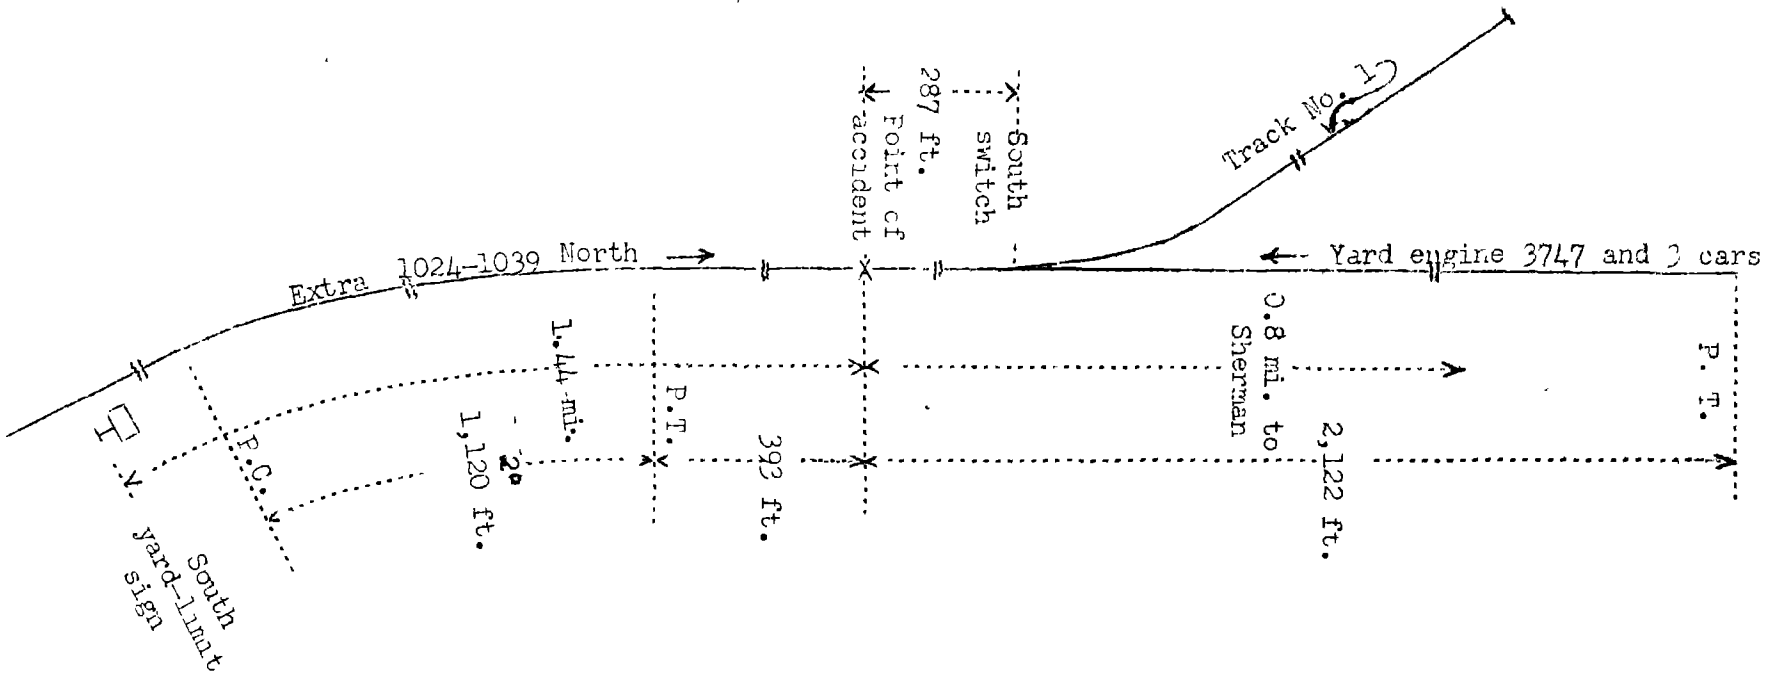
Inv. No. 2906
St. Louis, San Francisco and Texas Railway
Sherman, Tex.
June 30, 1945

← To Irving

To Sherman →

X Sherman, Tex.
(Point of accident)
54.3 mi.
Carrollton
10.2 mi.
Irving, Tex.
