REPORT NO. 3499

ST. LOUIS-SAN FRANCISCO RAILWAY COMPANY

IN RE ACCIDENT

NEAR CEDARS, OKLA., ON

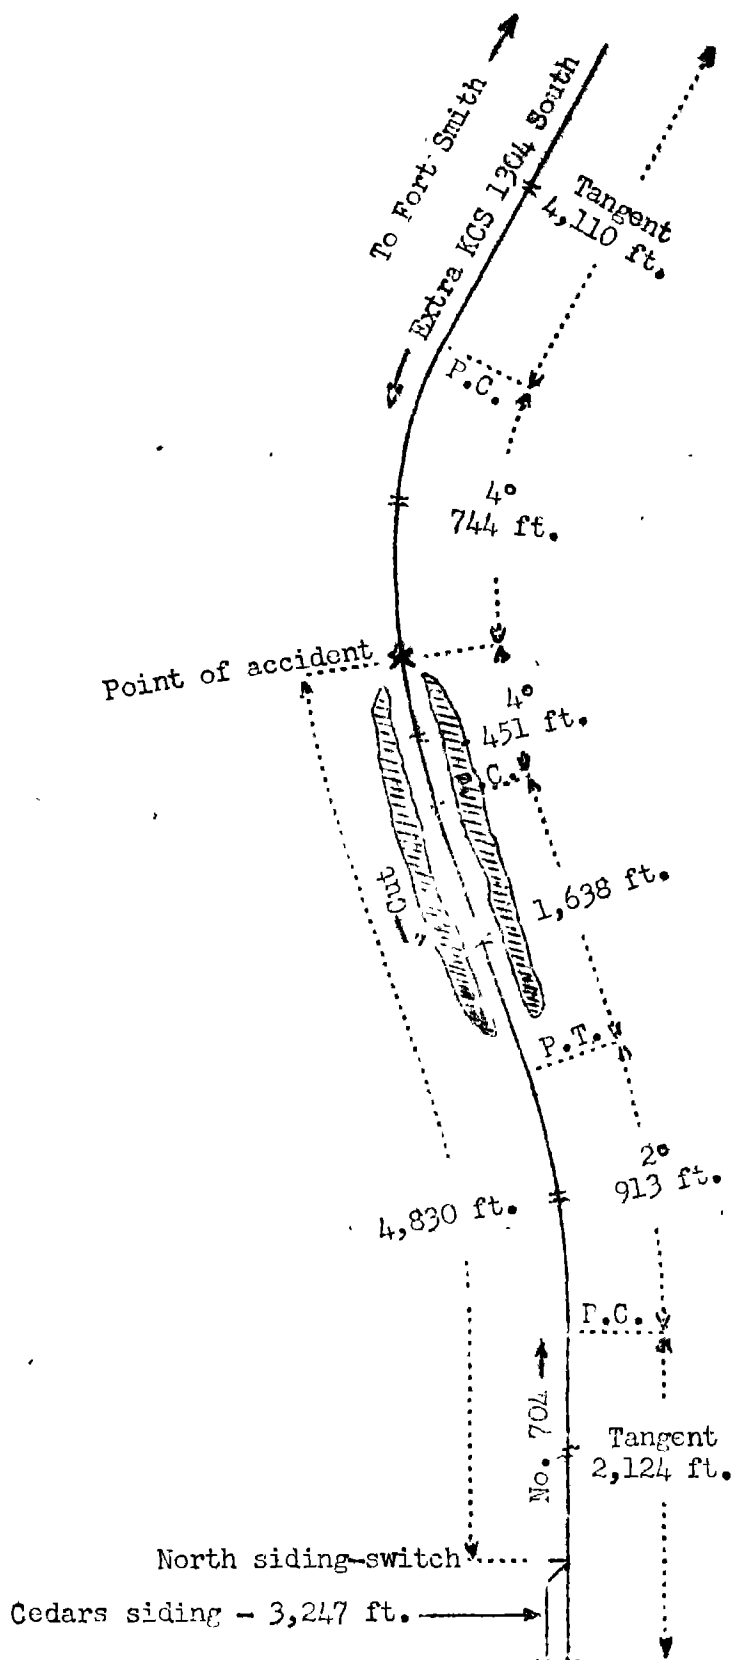
Report No. 3499  
St. Louis-San Francisco Railway  
Cedars, Okla.  
December 30, 1952

o	Fort Smith, Ark.
	1.60 mi.
o	S.F. Junction, Ark.
	5.68 mi.
X	Point of accident
	0.82 mi.
o	Cedars, Okla.
	2.80 mi.
o	Bonanza, Ark.
	10.30 mi.
o	Cameron, Okla.
	7.90 mi.
o	Poteau
	62.20 mi.
o	Clayton, Okla.
	52.30 mi.
o	Hugo, Tex.
	24.80 mi.
o	Paris, Tex.
