REPORT OF THE DIRECTOR
BUREAU OF SAFETY

ACCIDENT ON THE
ST. LOUIS-SAN FRANCISCO RAILWAY

COLUMBUS, KANS.

INVESTIGATION NO. 2299

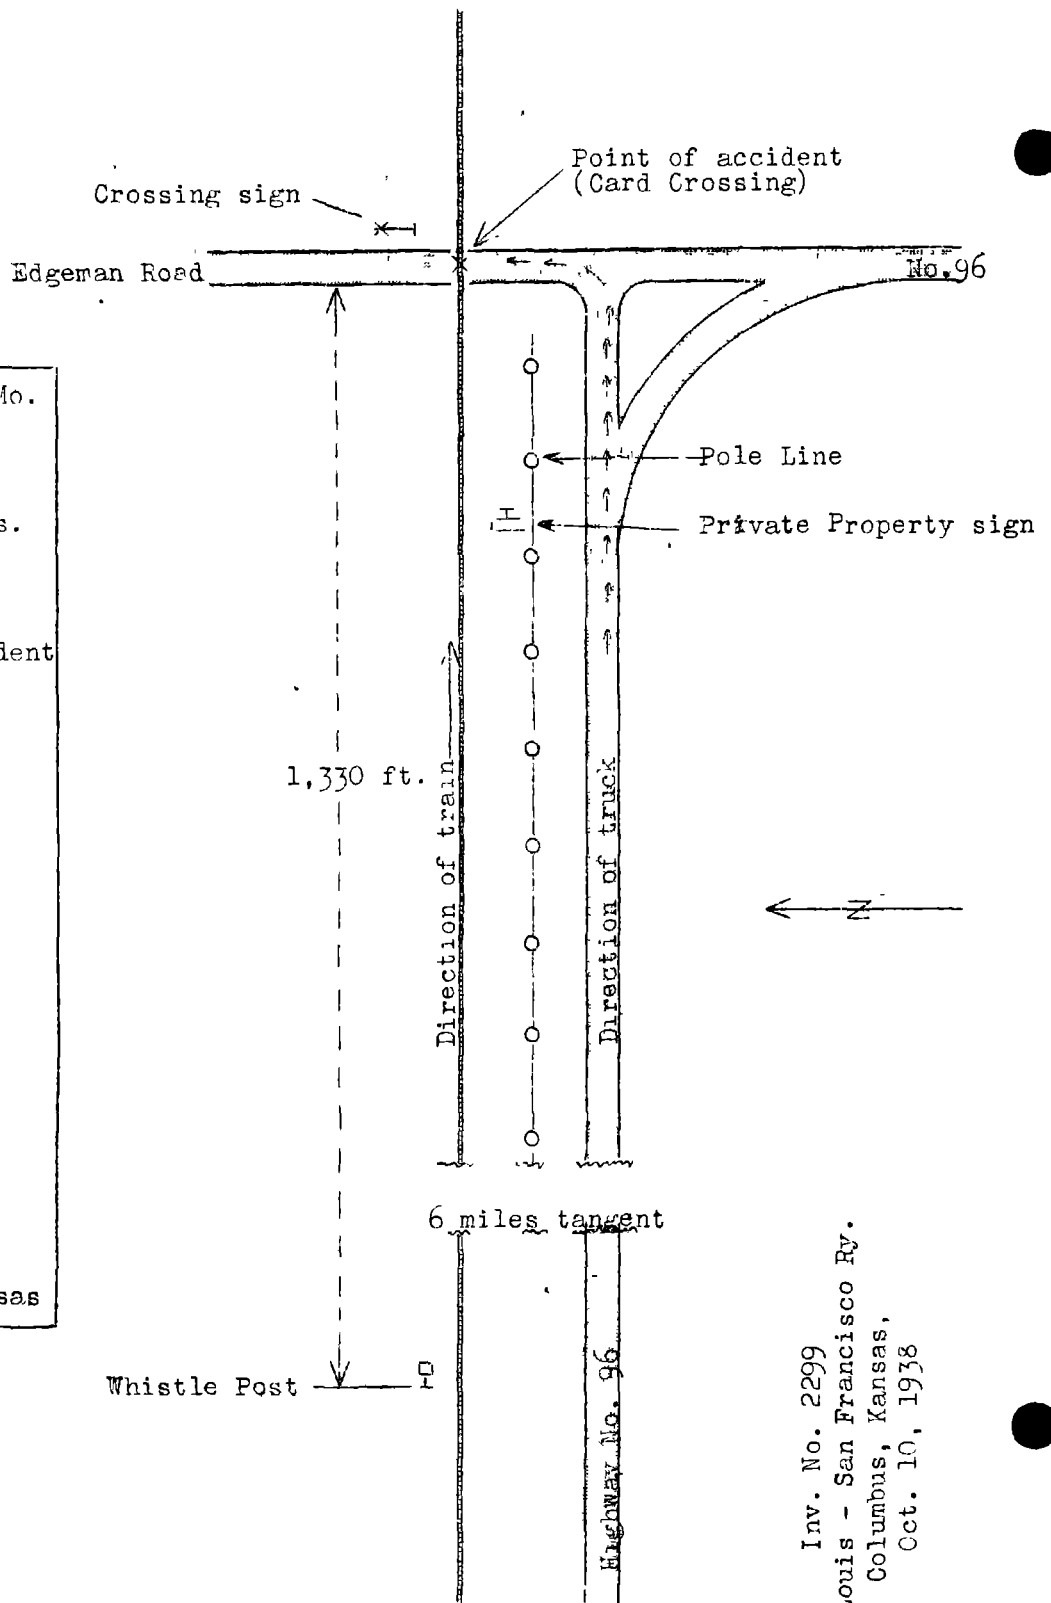
Inv. No. 2299
 St. Louis - San Francisco Ry.
 Columbus, Kansas,
 Oct. 10, 1938

o	Pierce City, Mo.
	57.2 mi.
o	Columbus, Kans.
	2.0 mi.
x	Point of accident
	3.6 mi.
o	Sherwin
	2.8 mi.
o	Hallowell
	7.4 mi.
o	Oswego
	27.1 mi.
o	Cherryvale
	14.4 mi.
o	Neodesha, Kansas

This accident occurred on that part of the Northern Division designated as the Carthage Sub-division which extends between Neodesha, Kans., and Pierce City, Mo., a distance of 114.5 miles. In the vicinity of the point of accident this is a single-track line over which trains are operated by timetable and train orders, no block-signal system being in use. The accident occurred about 2 miles west of Columbus where a road, known as Edgeman Cemetery Road, crosses the track at right angles at Card Crossing. Approaching from the west the track is tangent for approximately 6 miles to the crossing, and for a considerable distance beyond. The grade for east-bound trains is 0.5 percent ascending at the crossing. The maximum speed limit for passenger trains in this vicinity is 50 miles per hour.

A standard cross-buck sign, with the words "RAILROAD CROSSING" on the sign, and the words "SAFETY FIRST" vertically on the post, is located in the northeast corner of Card Crossing 23 feet from the center of the track and 19 feet east of the center of Edgeman Road; the top of the post is 11 feet 2 inches above the top of the rails. The entire sign had been recently repainted. The country is open and there is nothing except a

private property sign and a telephone-telegraph pole line to obstruct the view of the track to be had by the driver of a motor vehicle approaching the railroad. The private property sign, 4 feet wide and 1 foot 5 inches high, the bottom of which is 7 feet 5½ inches above the ground, is located 149 feet west of the crossing and 21 feet south of the track. The telephone-telegraph pole line is located 25 feet south of the track center. From points 75 and 50 feet, respectively, south of the track center, the view of an approaching eastward train is unobstructed, except for the pole line, for approximately 1½ miles.
