RAILROAD ACCIDENT INVESTIGATION

Report No 3784

ST LOUIS-SAN FRANCISCO RAILWAY COMPANY

OCTOBER 14, 1957

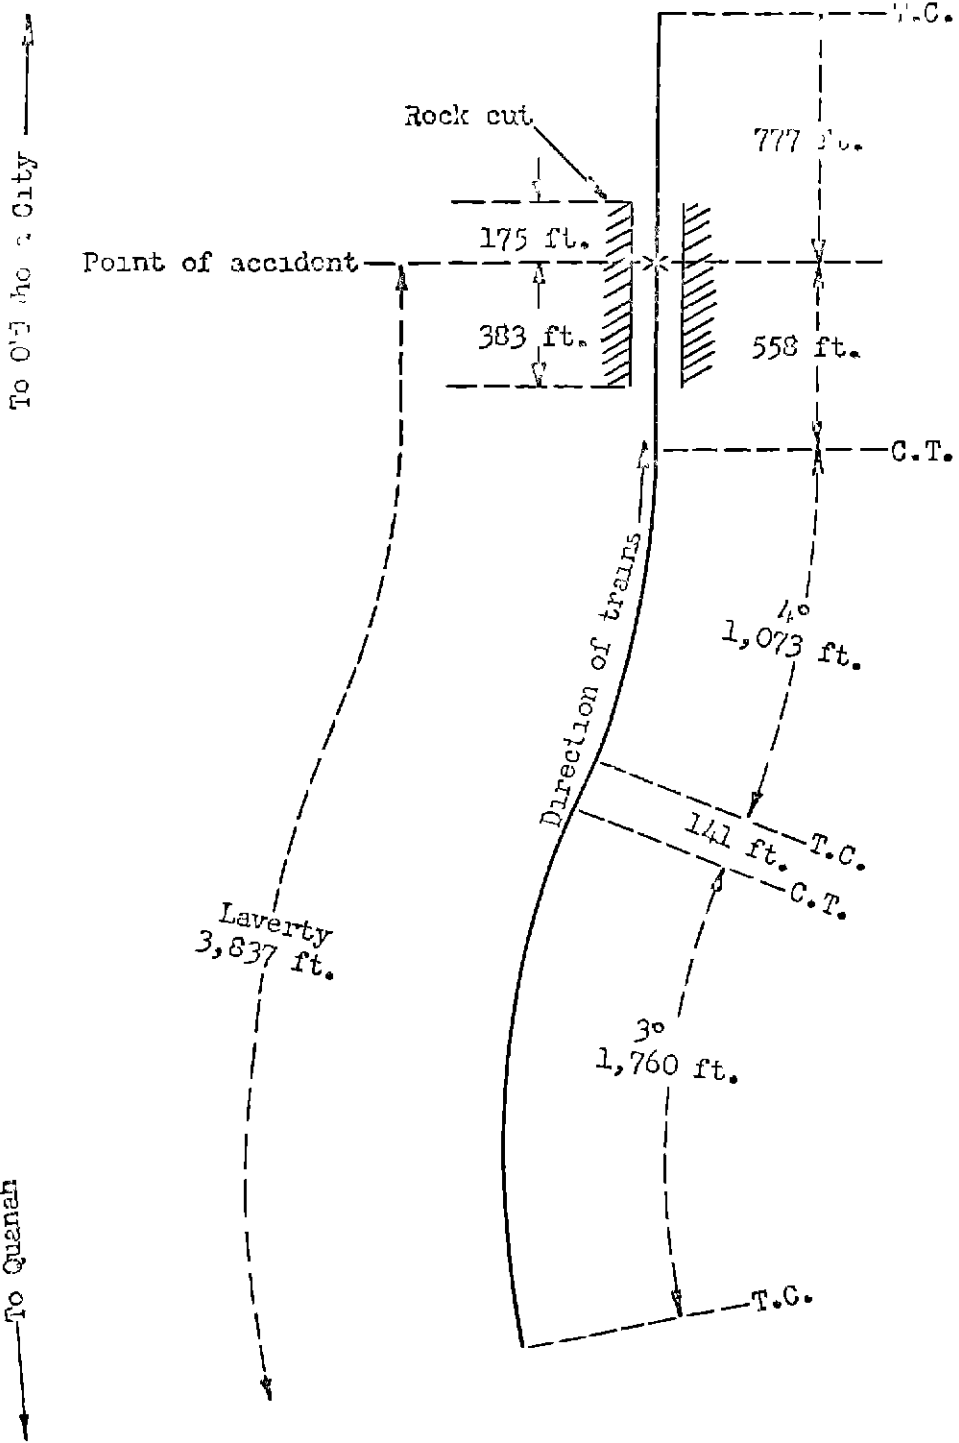
St. Louis-San Francisco Railway Company
 Laverty, Okla.
 October 14, 1957

○	Oklahoma City Okla.	46.4 mi.
○	Norge	4.8 mi.
X	Point of accident	0.72 mi.
○	Laverty	7.1 mi.
○	Cenent	5.5 mi.
○	Cyril	9.6 mi.
○	Elgin	15.6 mi.
○	Larton	94.0 mi.
○	Quanah, Tex.

This accident occurred on that part of the Southwestern Division extending between Quanah, Texas and Oklahoma City, Okla., 183.7 miles. In the vicinity of the point of accident this is a single-track line over which trains are operated by timetable and train orders. There is no block system in use. The accident occurred on the main track at a point 132.5 miles east of Quanah and 3,837 feet east of the station at Laverty. From the west there are, in succession, a 3° curve to the right 1,760 feet in length, a tangent 141 feet, a 4° curve to the left 1,073 feet, a tangent 558 feet to point of accident and 777 feet eastward. The grade for eastbound trains approaching the point of accident is 0.15 percent ascending and at the point of the accident it is level.
