REPORT NO. 3704

ST. LOUIS-SAN FRANCISCO RAILWAY COMPANY

IN RE ACCIDENT

NEAR NETTLETON, MISS., ON

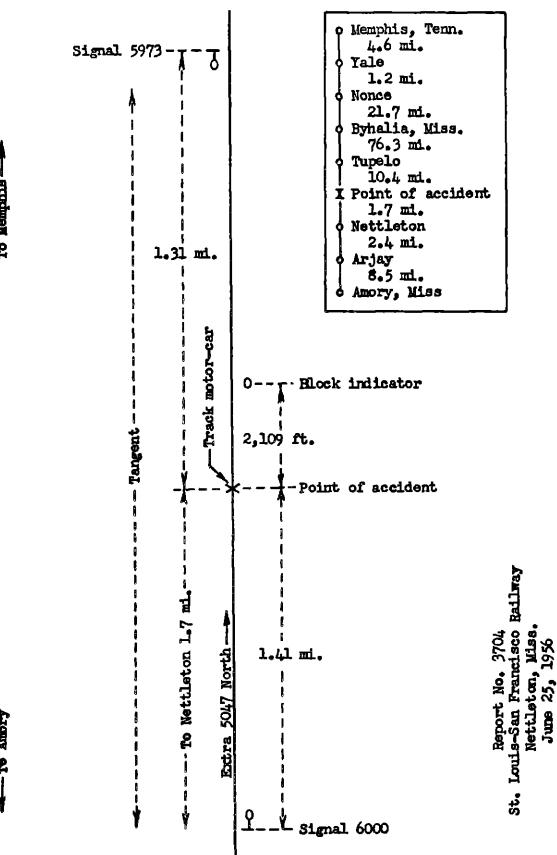
To Memphia ---

FIONA OT -----

Track motor-car RC-1970, occupied by a section foreman and three sectionmen, departed south-bound from Tupelo, Miss., 103.8 miles south of Memphis, about 7:15 a.m. It was stopped and set off the track at a point 8.6 miles south of Tupelo to permit a north-bound freight train to pass. After this train passed, the track motor-car was replaced on the track and proceeded southward. It was stopped a second time at a point 10.4 miles south of Tupelo and 1.7 miles north of Nettleton and was then moved northward a distance of about 300 feet to a motor-car set-off. It was struck by Extra 5047 North before it could be removed from the track.

The track motor-car stopped 27 feet west of the track and 66 feet north of the point of accident. It was demolished. Extra 5047 North stopped with the front of the locomotive about 1,050 feet north of the point of accident. The front of the locomotive was slightly damaged.
