ST. LOUIS-SAN FRANCISCO RAILWAY COMPANY

REPORT IN THE ACCIDENT

AT NICHOLS, MO., ON

OCTOBER 5, 1947

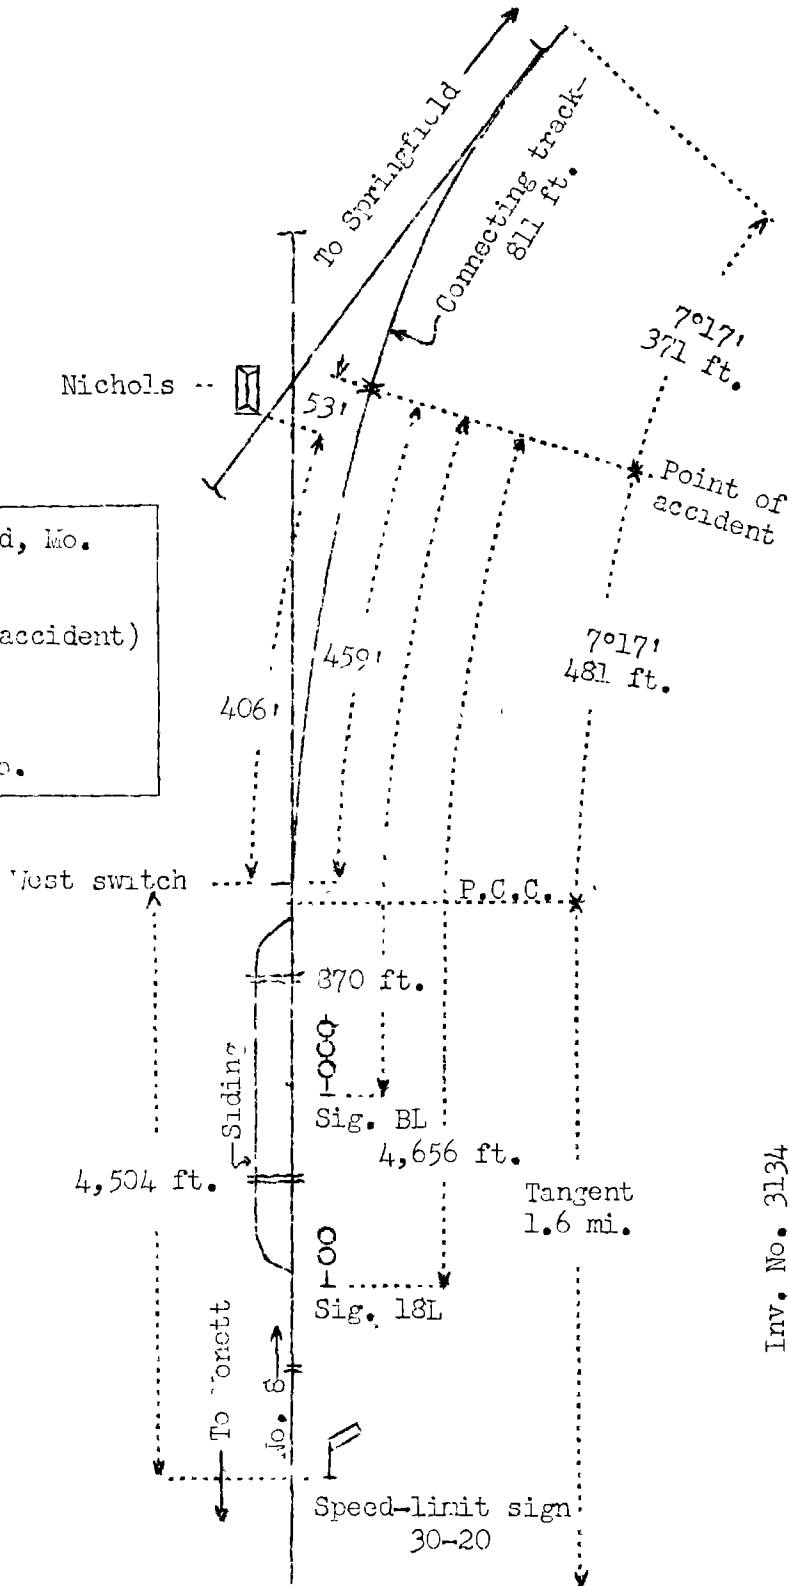
Inv. No. 3134  
 St. Louis-San Francisco Railway  
 Nichols, Mo.  
 October 5, 1947

- Springfield, Mo.  
2.9 mi.
- X Nichols  
(Point of accident)  
26.9 mi.
- Aurora  
13.1 mi.
- Monnett, Mo.

Location of Accident and Method of Operation
