REPORT OF THE DIRECTOR
BUREAU OF SAFETY

ACCIDENT ON THE
ST. LOUIS-SAN FRANCISCO RAILWAY

PICKENSVILLE, ALA.

INVESTIGATION NO. 2373

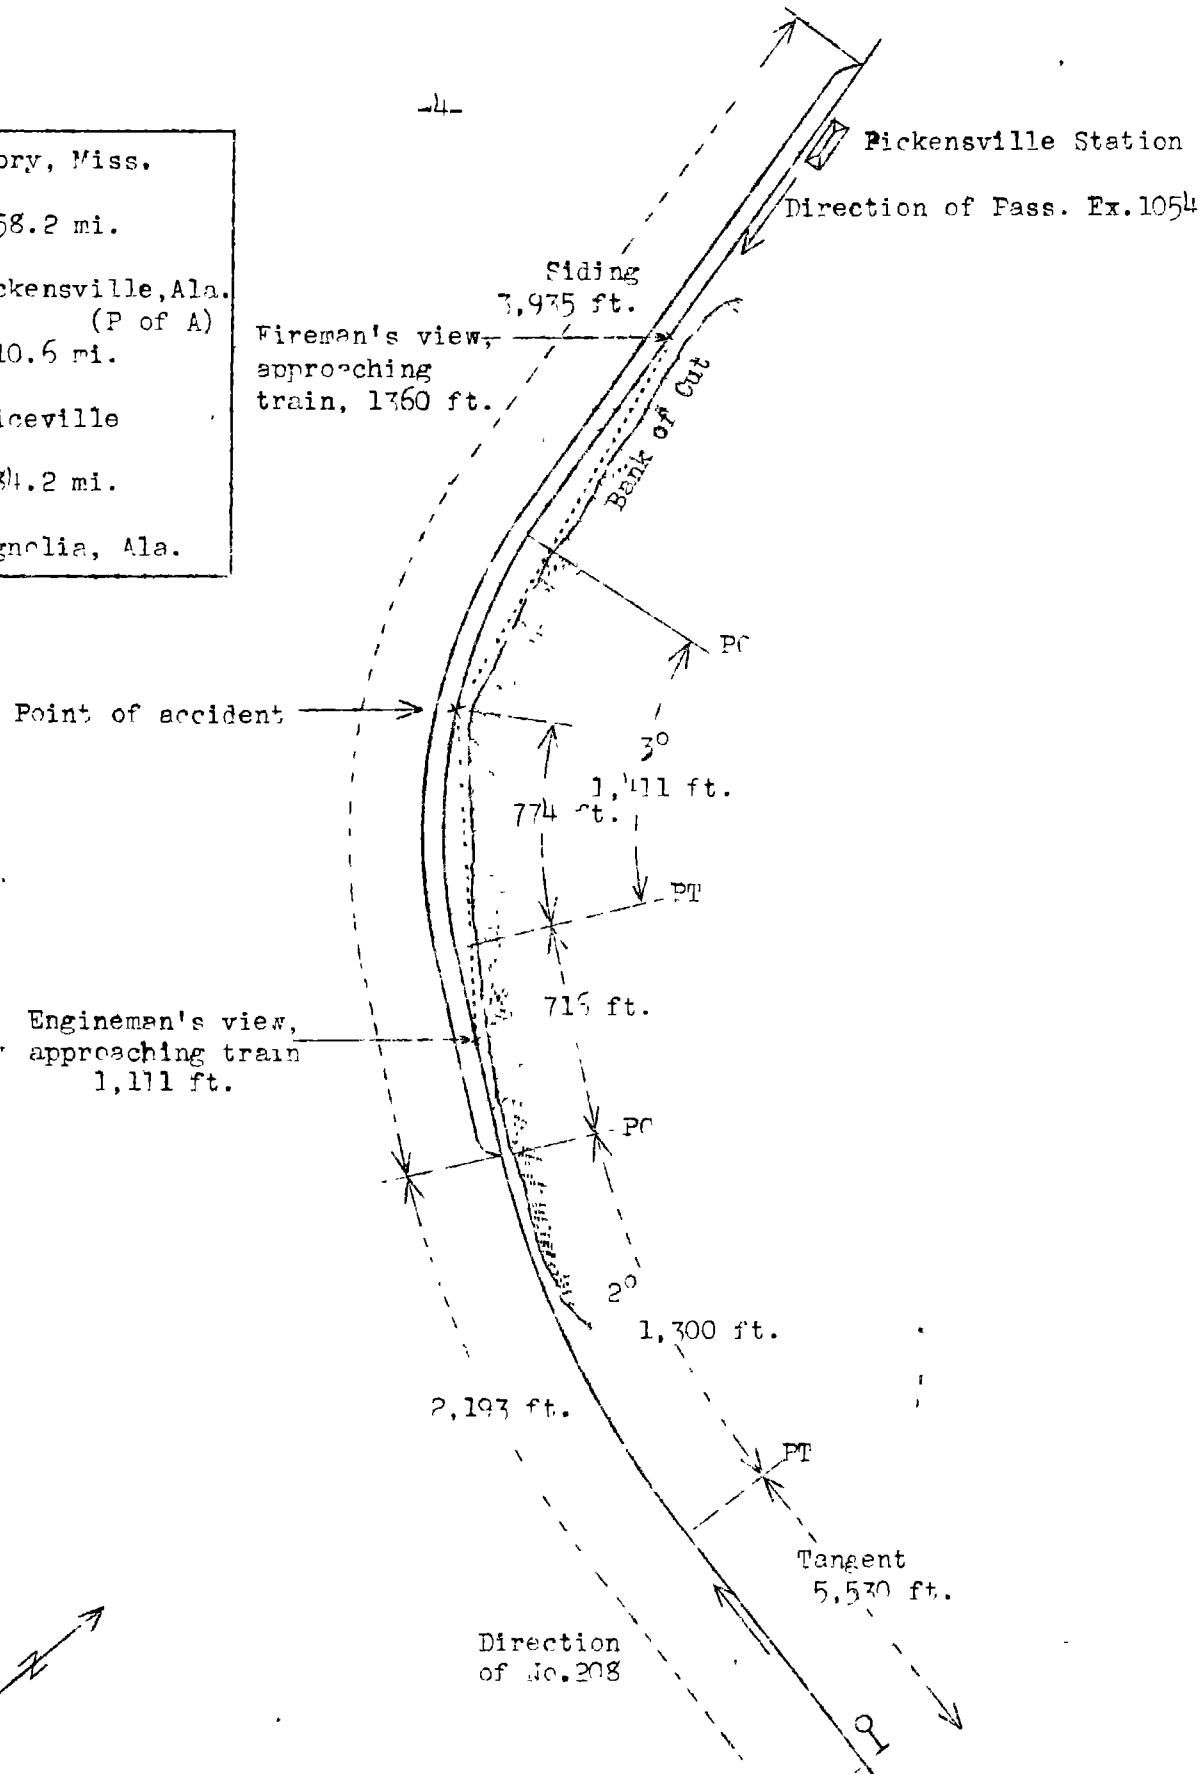
Inv. No. 2373
 St.L.-S.F. Ry
 Pickensville, Ala.
 August 10, 1939

o	Amory, Miss.
	58.2 mi.
⊗	Pickensville, Ala. (P of A)
	10.6 mi.
o	Aliceville
	84.2 mi.
o	Magnolia, Ala.

Station mile board

This accident occurred on that part of the Southern Division designated as the Columbus Sub-Division which extends between Amory, Miss., and Magnolia, Ala., a distance of 153 miles. In the vicinity of the point of accident this is a single-track line over which trains are operated by timetable and train orders, no block system being in use. The accident occurred on the main track at a point 1,741 feet south of the station at Pickensville. A siding 3,935 feet in length parallels the main track on the west; its south switch is located 3,203 feet south of the station at Pickensville and 1,462 feet south of the point of accident. Approaching from the south there is a tangent 5,530 feet in length followed by a 2° curve to the right 1,300 feet long, a tangent 716 feet long, and a 3° curve to the right 1,411 feet long. The accident occurred on this latter curve at a point 774 feet from its south end. Approaching from the north the track is tangent more than 2 miles followed by the 3° curve on which the accident occurred. The grade for north-bound trains varies between 0.3 and 0.42 percent descending a distance of 1,455 feet to the point of accident. The grade for south-bound trains varies between 0.30 and 0.5 percent ascending more than 2,000 feet to the point of accident. In this vicinity the track is laid in a side-hill cut, the east side of which rises to a maximum height of 9 feet and extends approximately 500 feet north and 300 feet south of the point of accident. The view to be had by an engineman of a north-bound train is restricted to 1,111 feet; the view to be had by a fireman of a south-bound train is restricted to 1,360 feet.

A station mile-board for north-bound trains is located 2,193 feet south of the south siding-switch at Pickensville.
