REPORT OF THE DIRECTOR
BUREAU OF SAFETY

ACCIDENT ON THE
ST. LOUIS-SAN FRANCISCO RAILWAY

PIERCE CITY, MO.

INVESTIGATION NO. 2221

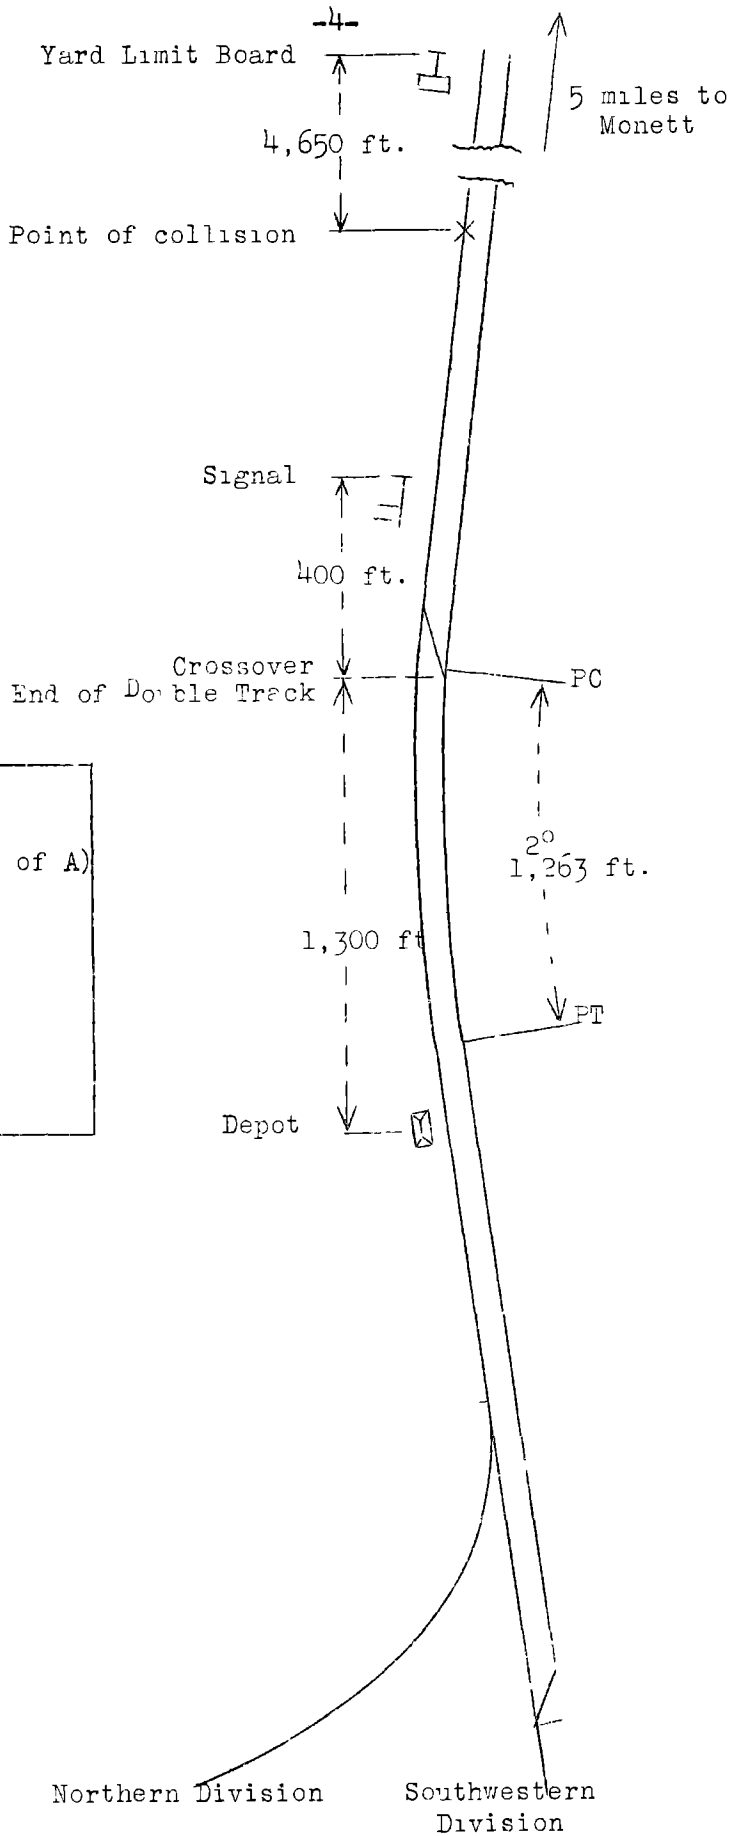
Inv. No. 2221
 St. Louis - San Francisco Ry.
 Pierce City, Mo.
 Nov. 9, 1937

o	Monett, Mo.
	5 miles
x	Pierce City (P of A)
	150.2 mi.
o	Sapulpa, Okla.

This accident occurred on the Cherokee Subdivision of the Southwestern Division, which extends between Monett, Mo., and Sapulpa, Okla., a distance of 155.2 miles. In the vicinity of the point of accident this is a double-track line over which trains are operated by timetable, train orders and an automatic block-signal system. The runaway started in Monett yard, and the collision occurred on the west-bound main track at a point approximately 5 miles farther west, within yard limits at Pierce City. Proceeding westward from the point where the cars started away at Monett, the track is composed of six stretches of tangent and five curves, the maximum curvature being 2°; the collision occurred on the last stretch of tangent at a point about 3,500 feet west of its eastern end. With the exception of two stretches of level track, 100 and 700 feet in length, the grade for this entire distance is descending westward, the maximum gradient being 0.76 percent; for a distance of 2,150 feet to the point of accident the grade is 0.41 percent descending.

Pierce City is at the west end of double-track, and the cross-over switch at the end of double-track is located 1,300 feet east of the depot. West of this point there is a continuation of the west-bound main track to a point about 1,300 feet west of the depot where a track diverges to the right to the line of the Northern Division. The grade at the entrance of the Northern Division is sharply ascending. The switches at Pierce City are operated by remote control, handled by operators located in the depot. A two-arm semaphore signal located 400 feet east of the end of double-track governs the movement of west-bound trains; one arm is for trains moving on to the Southwestern Division while the other arm is for trains entering the Northern Division. The east yard limit board at Pierce City is located 4,650 feet east of the point of accident.
