REPORT NO. 3300
ST. LOUIS-SAN FRANCISCO RAILWAY COMPANY
IN RE ACCIDENT
NEAR PRESTON, OKLA., ON
DECEMBER 2, 1949

Accident near Preston, Okla., on December 2, 1949, caused
by failure to provide adequate protection for the
movement of a track motor-car.

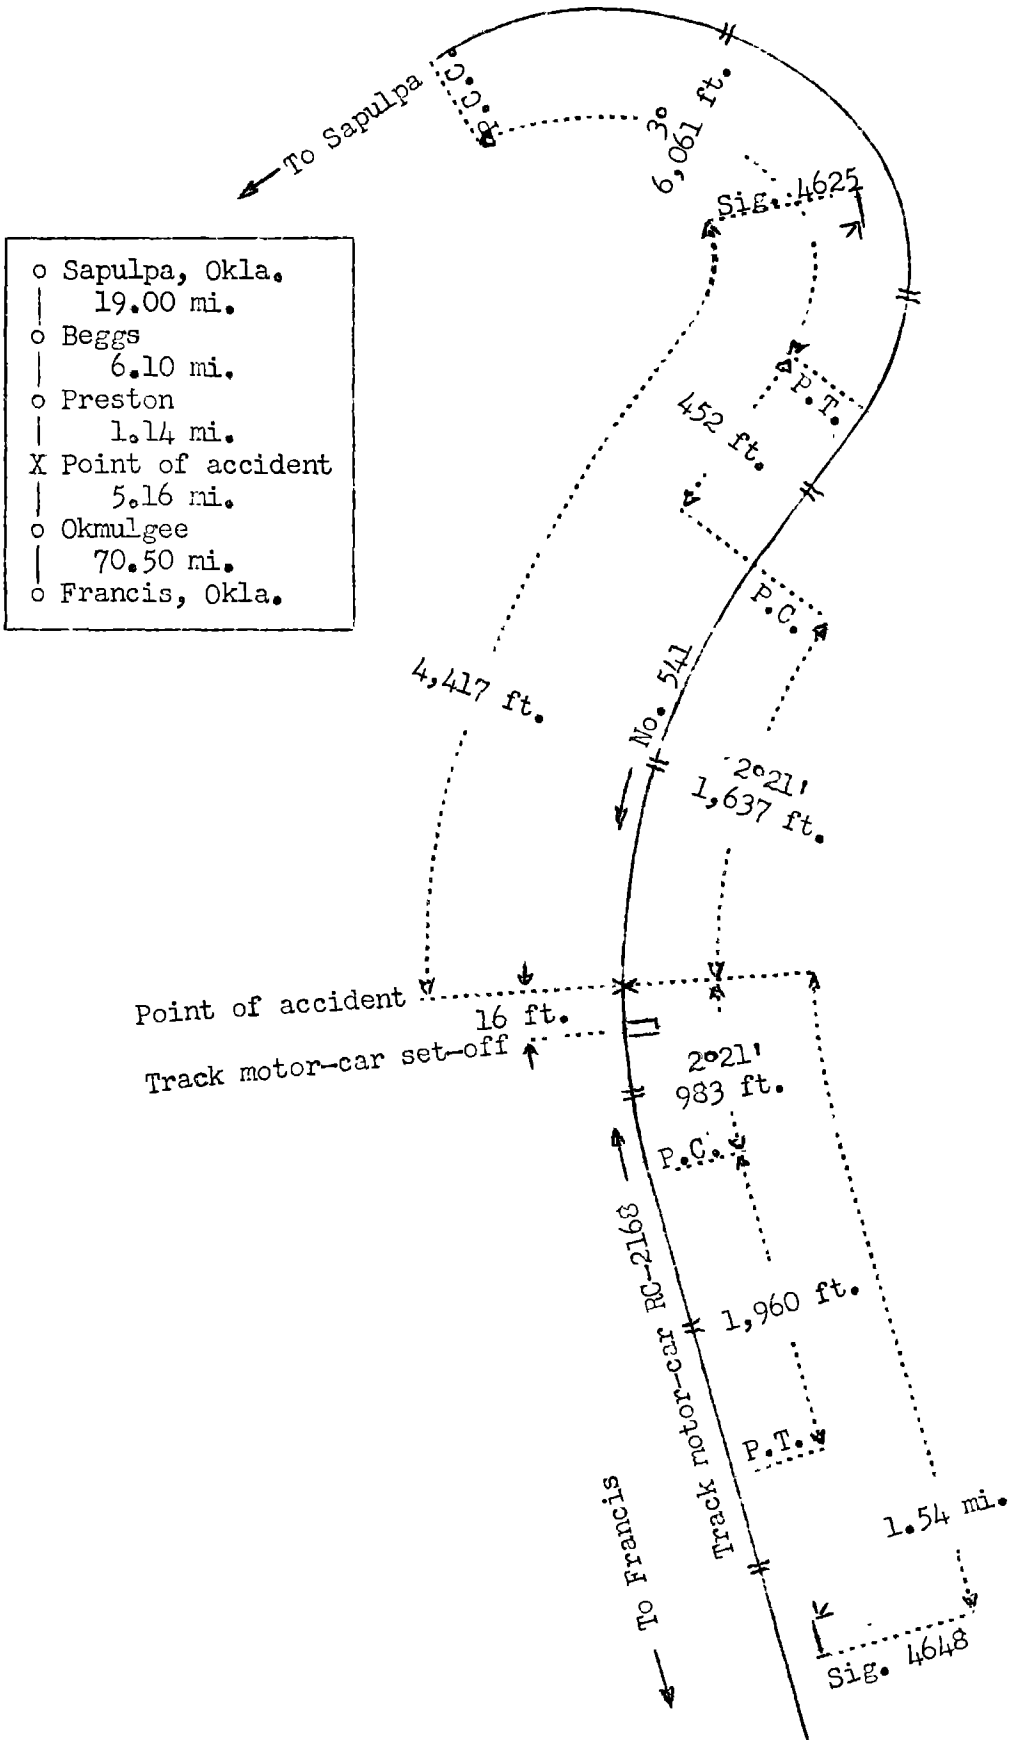
Report No. 3300
 St. Louis-San Francisco Railway
 Preston, Okla.
 December 2, 1949

No. 541 stopped with the front end of the engine approximately 1,350 feet south of the point of accident. None of the equipment of this train was derailed or damaged. The track motor-car was slightly damaged. It stopped upright, about 26 feet south of the point of accident, down a fill and about 18 feet west of the center-line of the track.
