INVESTIGATION NO. 3252
ST. LOUIS-SAN FRANCISCO RAILWAY COMPANY
REPORT IN RE ACCIDENT
NEAR RAVIA, OKLA., ON
MAY 6, 1949

Accident near Ravia, Okla., on May 6, 1949, caused by
kinked track.

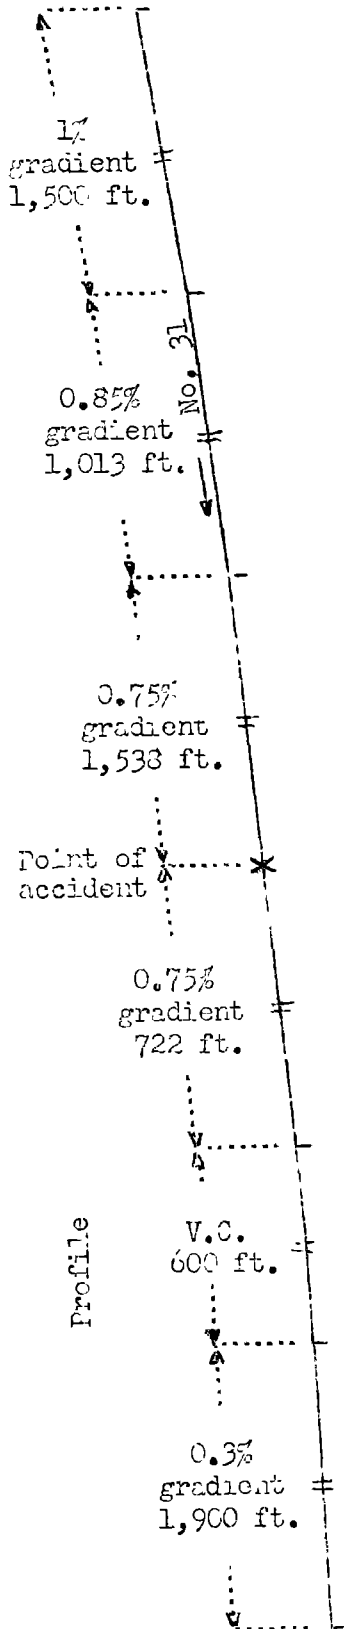
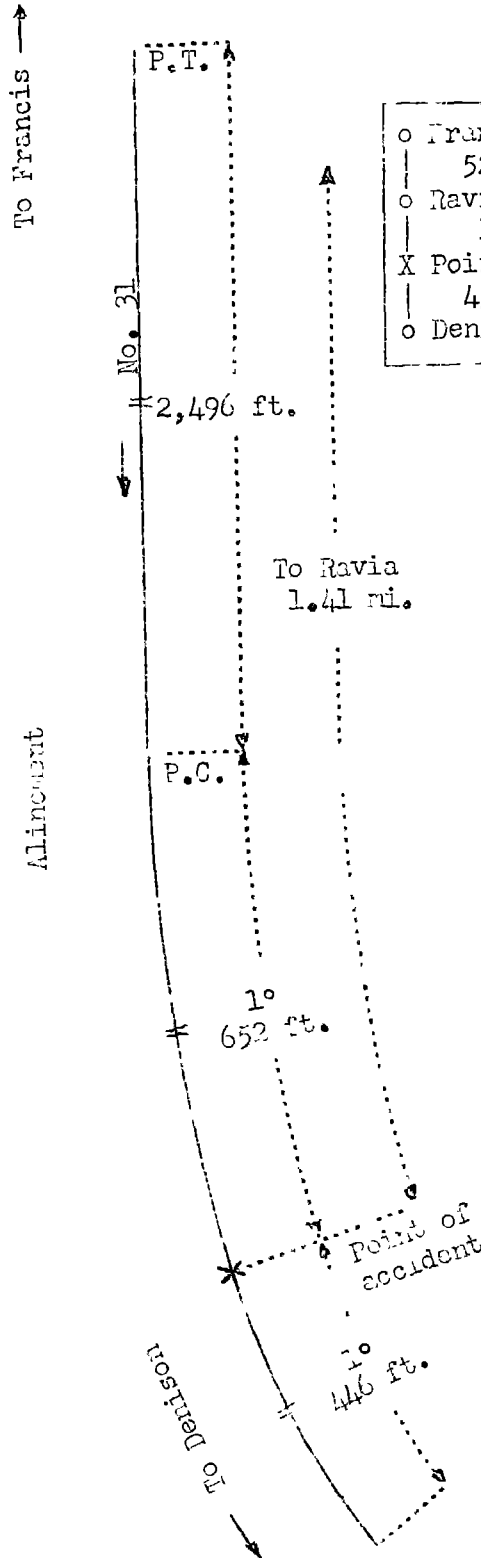
Inv. No. 3252
St. Louis-San Francisco Railway
Ravia, Okla.
May 6, 1949

- o Francis, Okla.
52.70 mi.
- o Ravia, Okla.
1.41 mi.
- X Point of accident
43.29 mi.
- o Denison, Tex.

After the accident, a section of track about 45 feet in length on the 1-degree curve to the left was found to be deflected to the right. The maximum deflection, which was about 9 inches, was located midway of this section. Beginning at a point 8 inches east of the west rail near the north end of the deflected portion of the track, the ties bore marks indicating that the wheels of one truck had become derailed. These wheel marks extended a distance of 140 feet diagonally eastward to the east rail. The east side of the fill and the ballast at the east end of the ties were disturbed between a point about 75 feet south of the first mark of derailment and the point where the caboose stopped. Additional wheel marks appeared on the tops of the ties on the gage side of the west rail and on the outside of the east rail between a point about 200 feet south of the first mark of derailment and the point where the separation occurred between the fifty-second and the fifty-third cars.
