ACCIDENT ON THE
ST. LOUIS-SAN FRANCISCO RAILWAY

ROTAN, ARK.

OCTOBER 27, 1938

INVESTIGATION NO. 2304

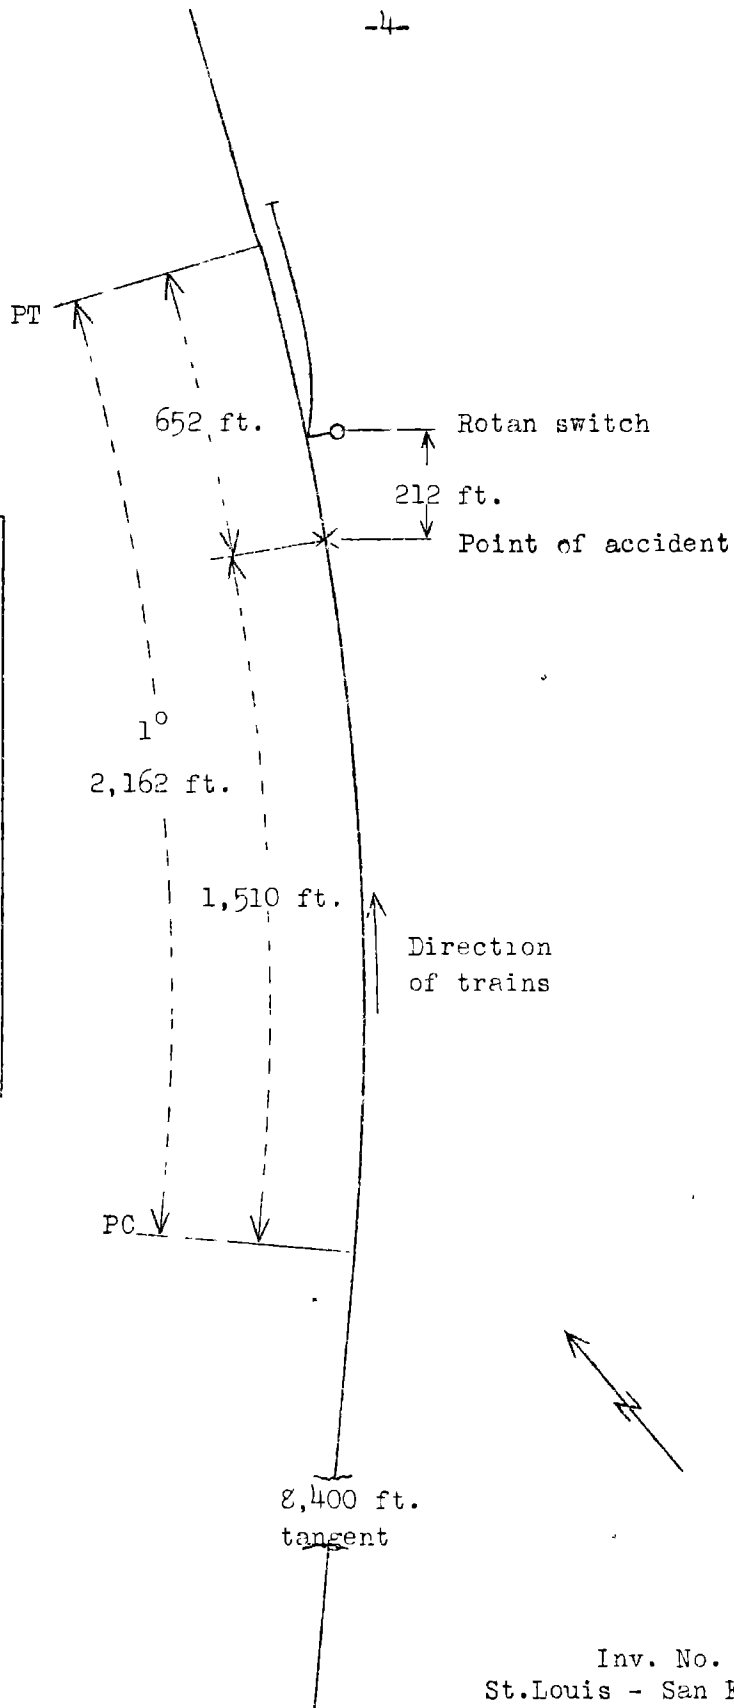
Inv. No. 2304
 St. Louis - San Francisco Ry.
 Rotan, Arkansas
 October 27, 1938

o	Chaffee, Mo.
	115.8 mi.
o	Rotan, Ark. (P of A)
	1.3 mi.
o	Driver
	3.7 mi.
o	Wilson
	18.7 mi.
o	Turrell, Ark.

This accident occurred on that part of the River Division designated as the Chaffee Sub-Division which extends between Chaffee, Mo., and Turrell, Ark., a distance of 139.5 miles. In the vicinity of the point of accident this is a single-track line over which trains are operated by timetable and train orders, no block system being in use. On the east side of and paralleling the main track at Rotan there is a spur track 510 feet in length, entrance to which is made through a facing-point switch for northbound trains; the accident occurred on the main track at a point 212 feet south of this switch. Approaching from the south the track is tangent a distance of 8,400 feet, followed by a 1° curve to the left 2,162 feet in length; the accident occurred on this curve at a point 1,510 feet from its southern end. The grade is practically level. Trees on the inside of the curve restrict the view of the point of accident from the fireman's side of a northbound train to a distance of approximately 1,615 feet.
