INVESTIGATION NO. 3071  
ST. LOUIS-SAN FRANCISCO RAILWAY COMPANY  
REPORT IN RE ACCIDENT  
NEAR SCULLIN, OKLA., ON  
FEBRUARY 6, 1947

Accident near Scullin, Okla., on February 6, 1947, caused  
by broken angle bars.

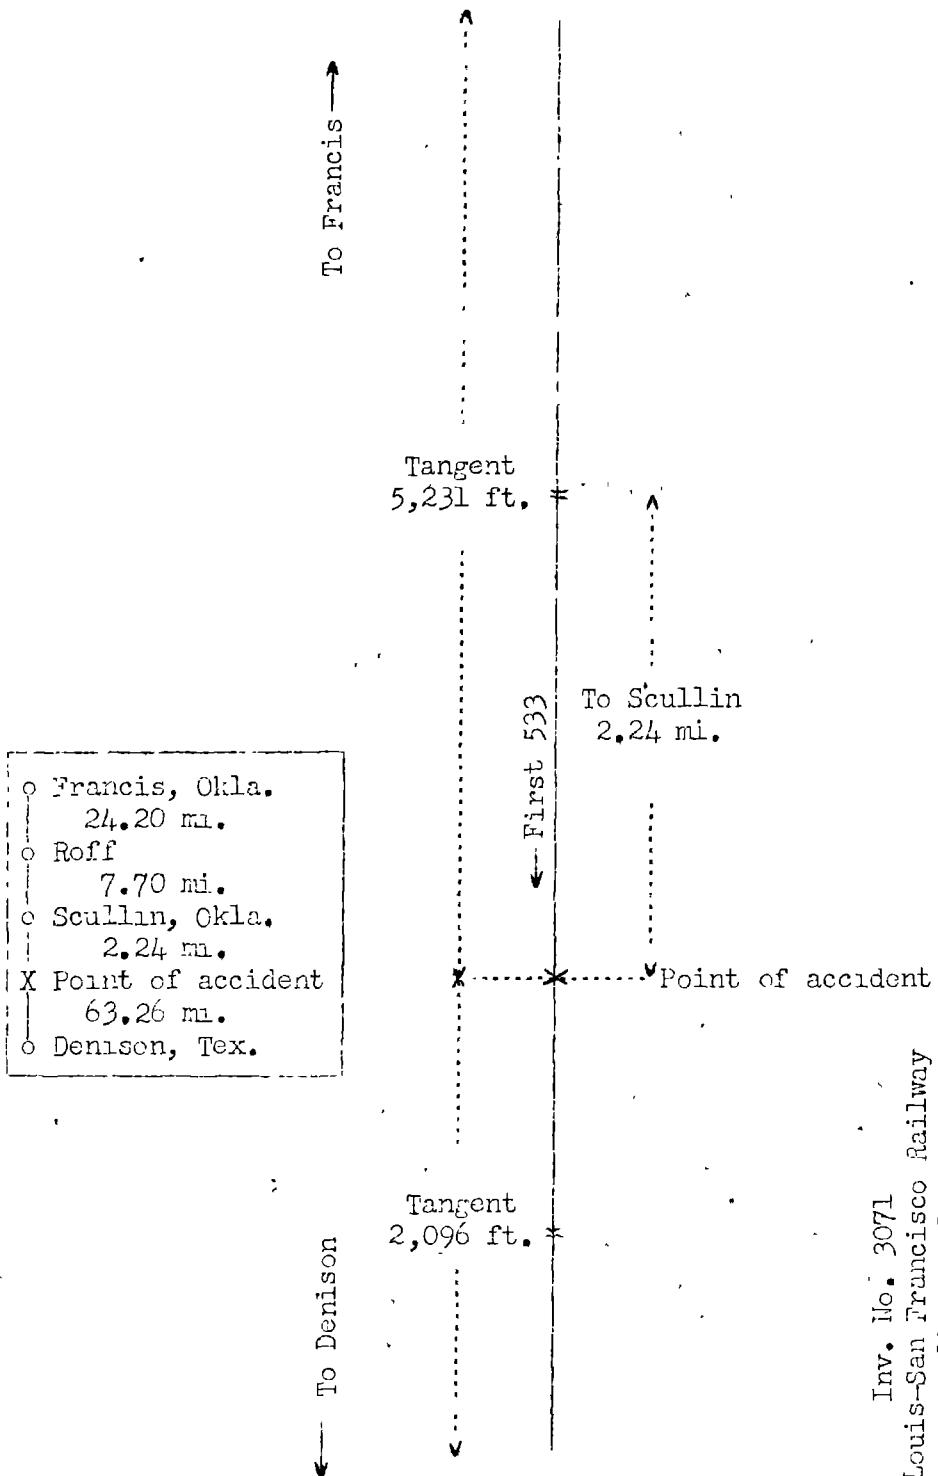
Inv. No. 3071  
St. Louis-San Francisco Railway  
Scullin, Okla  
February 6, 1947

- o Francis, Okla.  
24.20 mi.
- o Roff  
7.70 mi.
- o Scullin, Okla.  
2.24 mi.
- X Point of accident  
63.26 mi.
- o Denison, Tex.
