INVESTIGATION NO. 3109
ST. LOUIS-SAN FRANCISCO RAILWAY COMPANY
REPORT IN RE ACCIDENT
AT SOONER, OKLA., ON
JUNE 12, 1947

Accident at Sooner, Okla., on June 12, 1947, caused by
an inferior train occupying the main track on
the time of an opposing superior train.

Inv. No. 3109
 St. Louis-San Francisco Railway
 Sooner, Okla.
 June 16, 1947

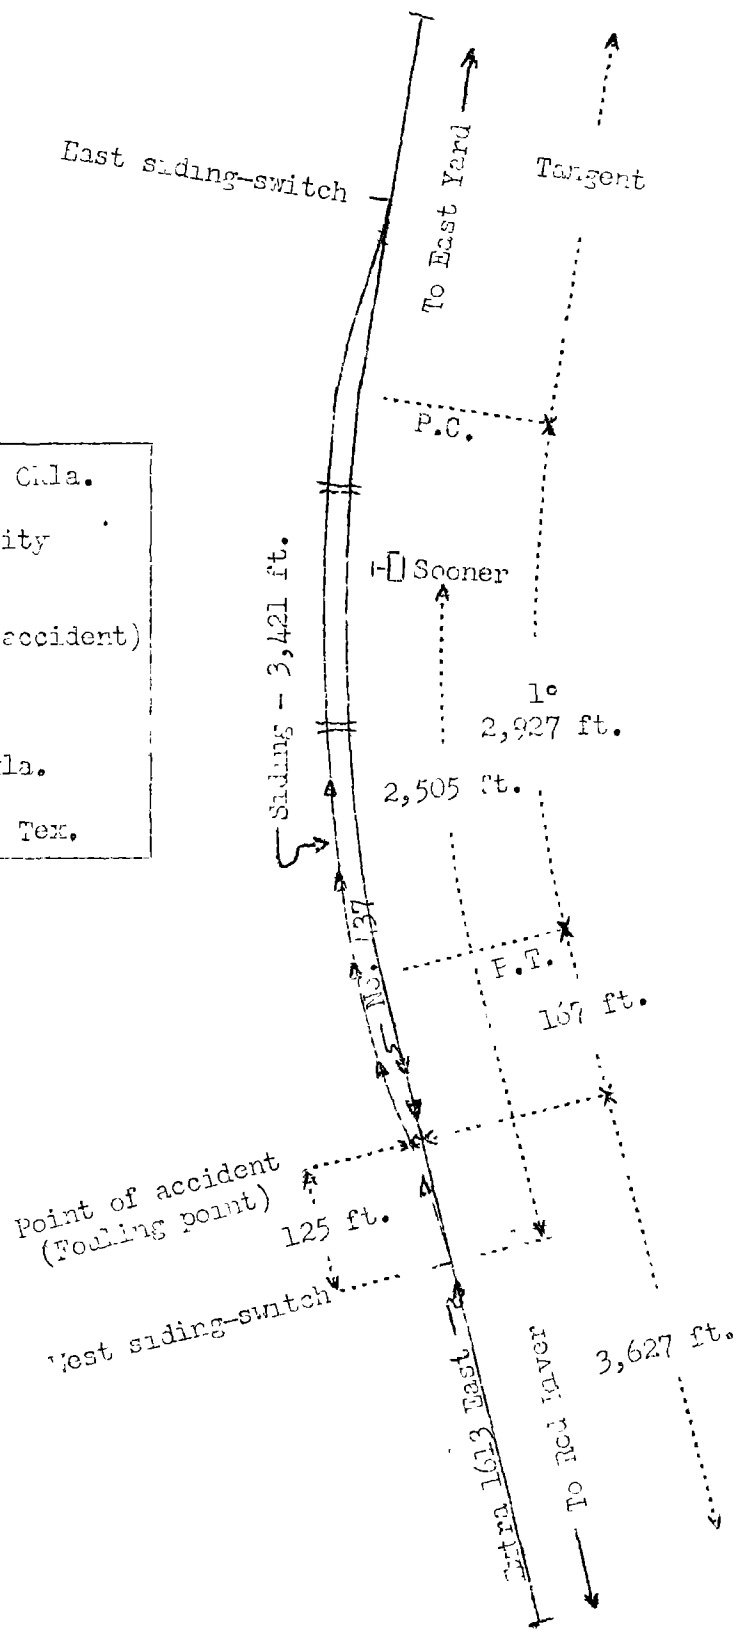
- o East Yard, Okla. 1.0 mi.
- o Oklahoma City 27.0 mi.
- X Sooner (Point of accident) 13.3 mi.
- o Chickasha 19.7 mi.
- o Cement, Okla. 116.7 mi.
- o Red River, Tex.

This accident occurred on that part of the South-western Division extending between East Yard, Oklahoma City, Okla., and Red River, Tex., 176.7 miles, a single-track line, over which trains are operated by timetable and train orders. There is no block system in use. At Sooner, 28 miles west of East Yard, a siding 3,421 feet in length parallels the main track on the north. The west switch of this siding is 2,805 feet west of the station-sign. The accident occurred at the fouling point of the main track and the turnout of the west siding-switch, at a point 125 feet east of the switch. From the east there is a 1° curve to the left 2,927 feet in length, and then a tangent 167 feet to the point of accident and 3,627 feet westward. The grade is 0.49 percent descending westward.
