REPORT NO. 3597
TERMINAL RAILROAD ASSOCIATION OF ST. LOUIS
IN RE ACCIDENT
AT ST. LOUIS, MO , ON
OCTOBER 18, 1954

Accident at St. Louis, Mo., on October 18, 1954, caused by
failure to operate the freight train in accordance
with a signal indication.

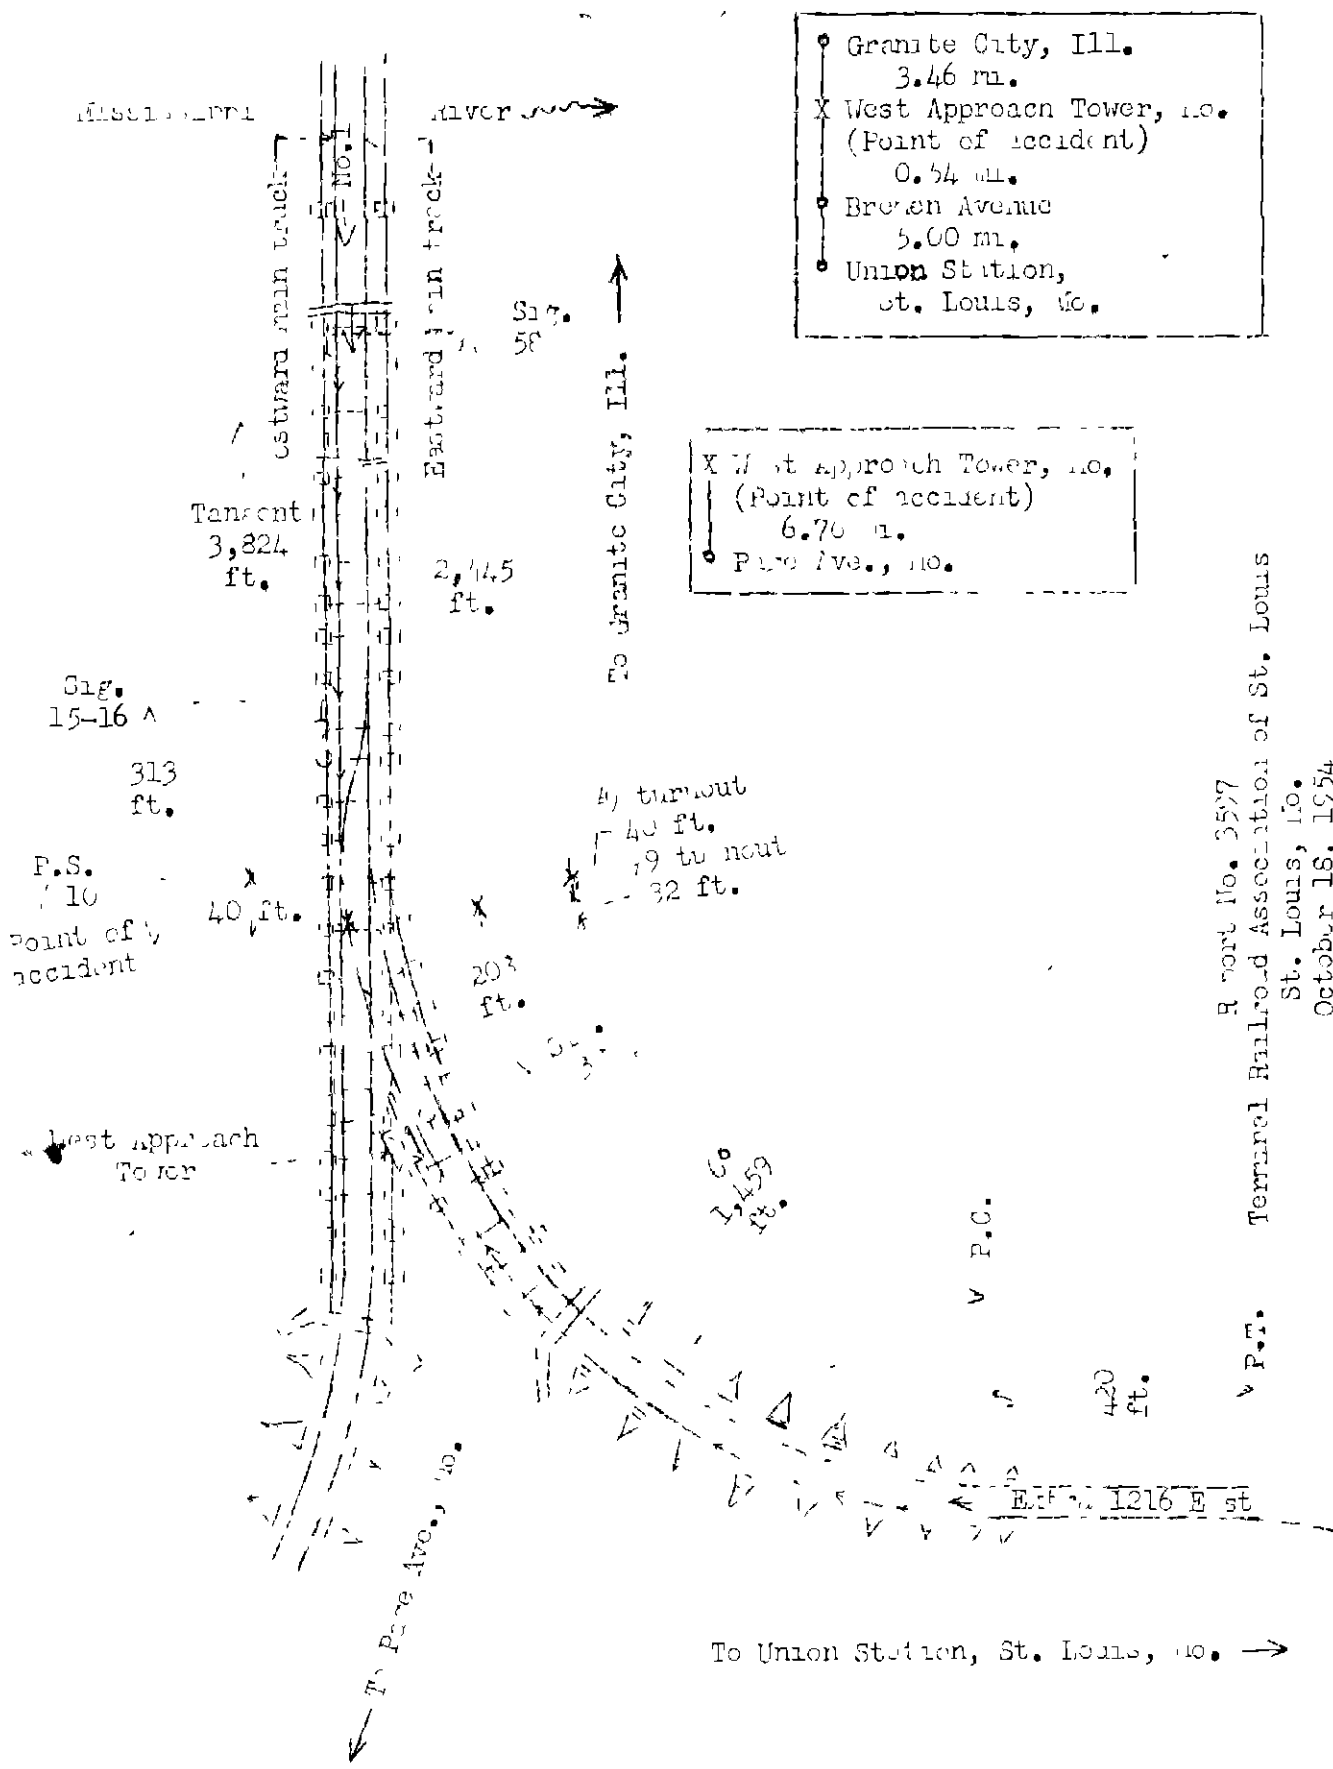
Granite City, Ill.
 3.46 mi.
 X West Approach Tower, no.
 (Point of accident)
 0.54 mi.
 Brean Avenue
 5.00 mi.
 Union Station,
 St. Louis, Mo.

X West Approach Tower, no.
 (Point of accident)
 6.70 mi.
 Pure Ave., no.

After the accident occurred it was found that signal 3 indicated Stop. The levers of the interlocking machine were in position for the route as established for the movement of No. 1 from the westward main track of the Union Station-Granite City line to the westward main track of the Page Avenue-West Approach Tower line. The switches in the route and the related apparatus were in correspondence with the positions of the levers. In tests which were made after the accident occurred the interlocking apparatus and signal system functioned as intended and no defective condition was found. While the route was lined for the movement of No. 1 a conflicting route could not be established, and from this it appears that Extra 1216 East passed signal 3 while that signal indicated Stop.
