INVESTIGATION NO. 2828

THE TERMINAL RAILROAD ASSOCIATION OF ST. LOUIS

REPORT IN RE ACCIDENT

AT VALLEY JUNCTION, ILL., ON

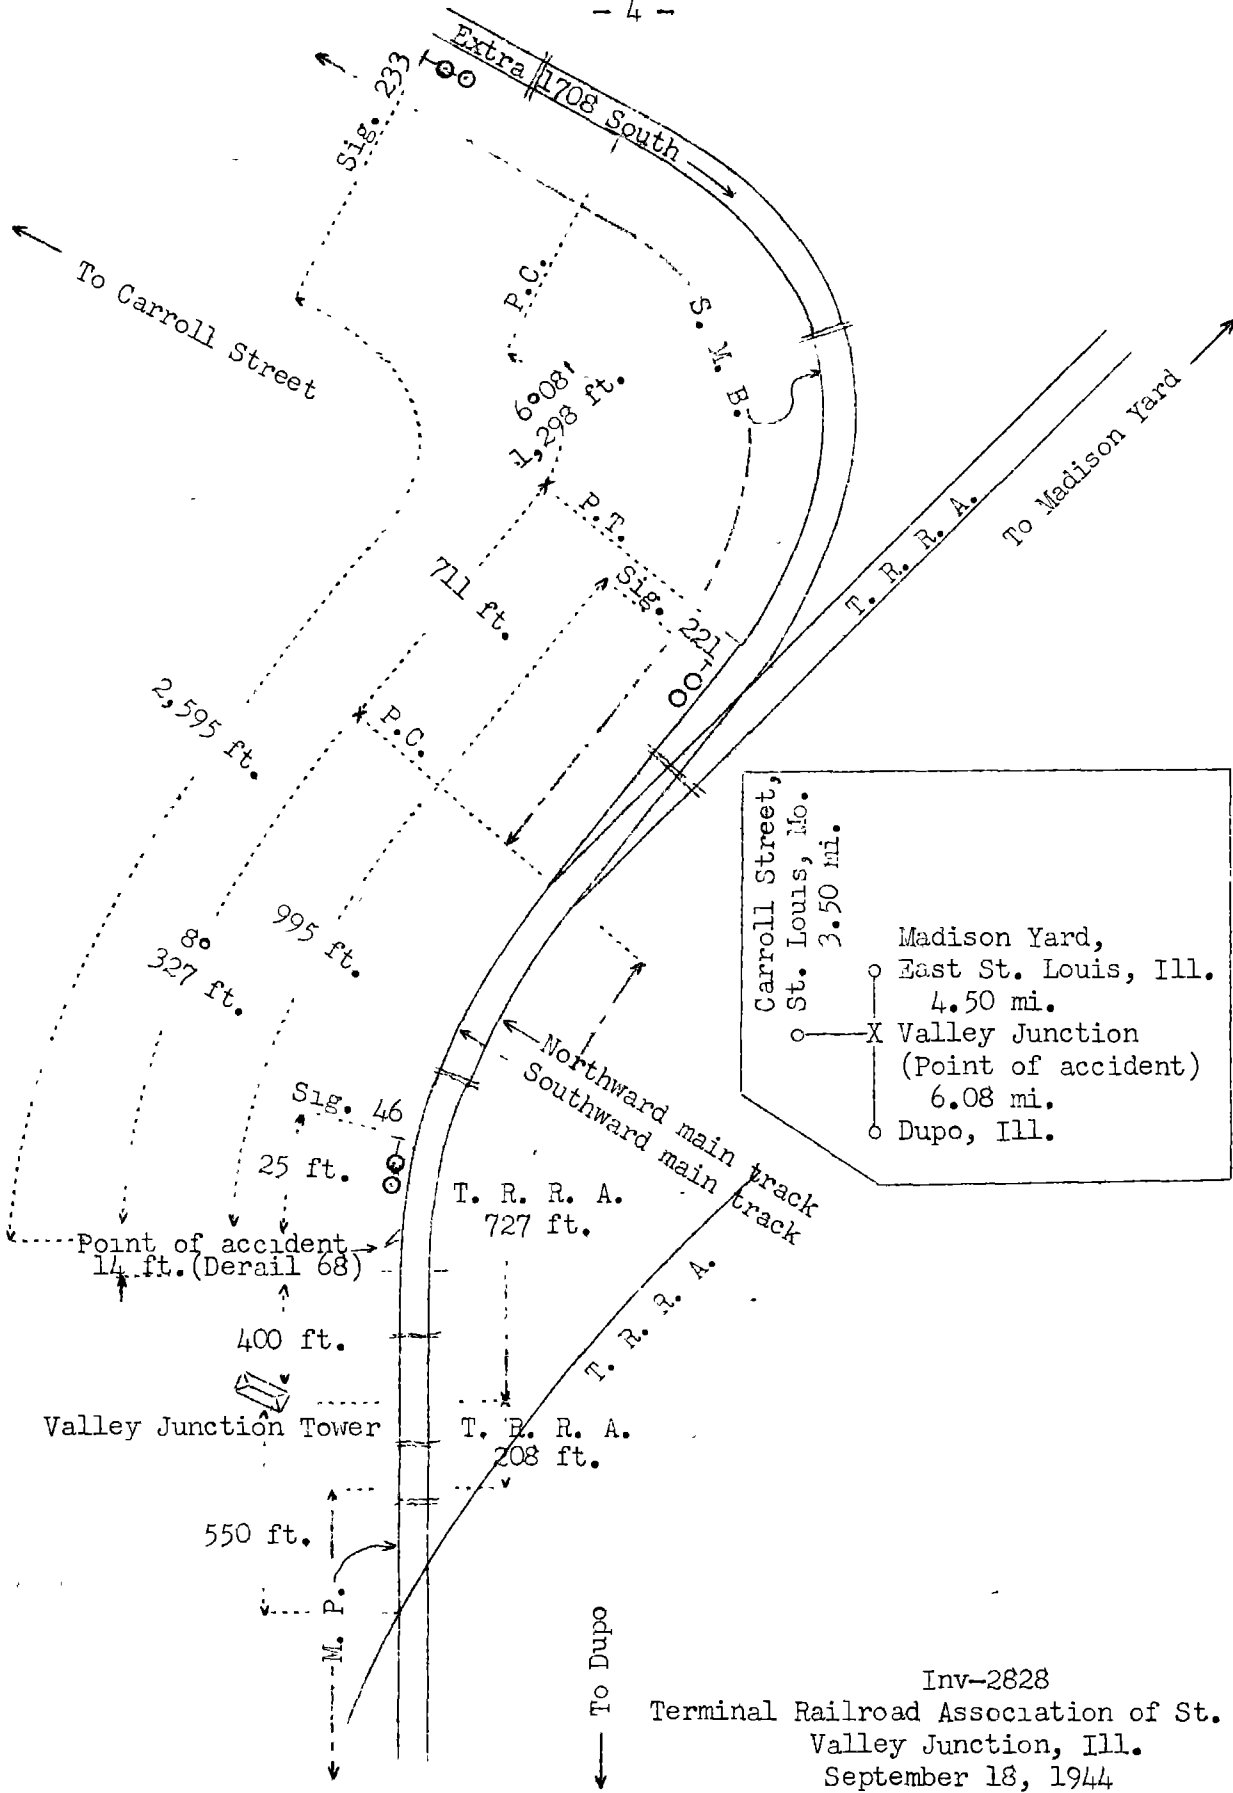
Carroll Street,
St. Louis, Mo.
3.50 mi.

Madison Yard,
East St. Louis, Ill.
4.50 mi.

The engine stopped on its right side west of the main tracks and parallel to them, with the front end of the engine 125 feet south of derail 68, and was considerably damaged. The first three cars were slightly damaged.
