REPORT NO. 3277

TEXAS AND NEW ORLEANS RAILROAD COMPANY

AT GARRETT, TEX., ON

SEPTEMBER 16, 1949

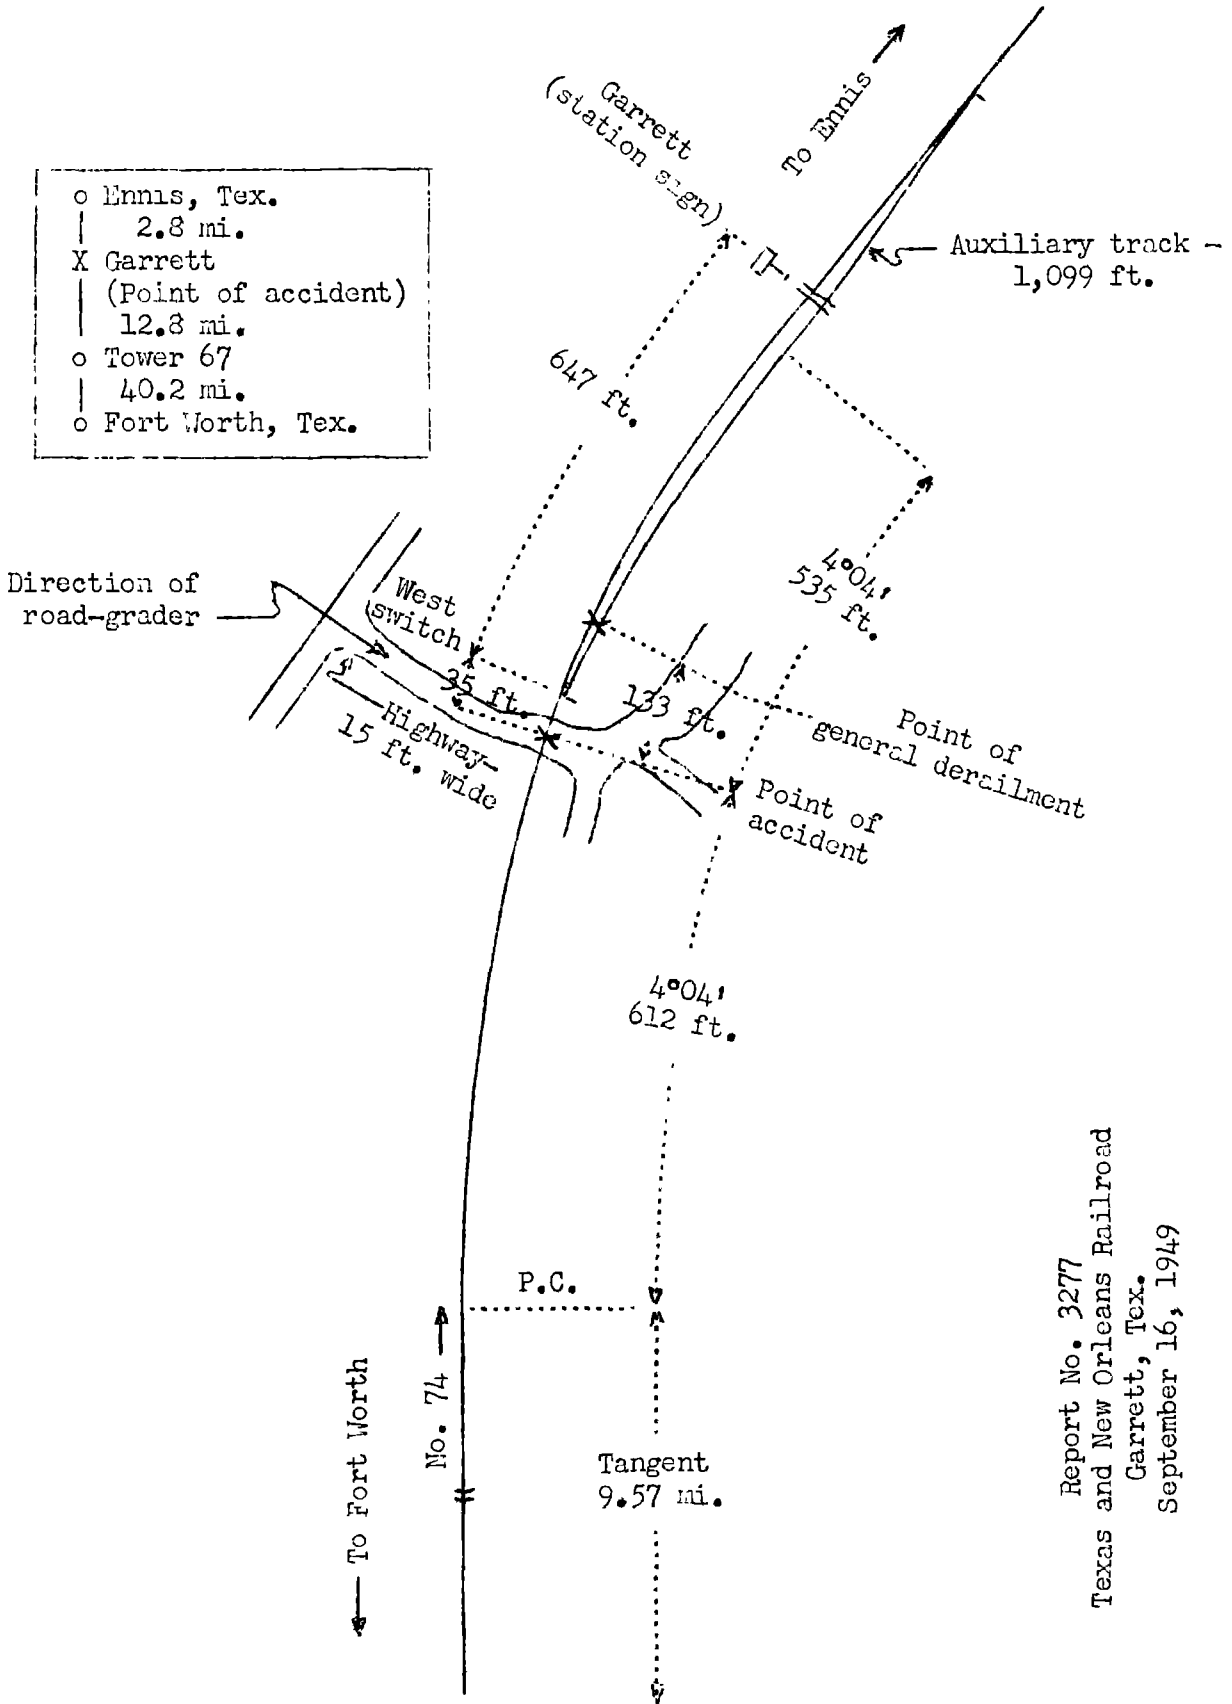
Report No. 3277
 Texas and New Orleans Railroad
 Garrett, Tex.
 September 16, 1949

- o Ennis, Tex.
- | 2.8 mi.
- X Garrett
- | (Point of accident)
- | 12.8 mi.
- o Tower 67
- | 40.2 mi.
- o Fort Worth, Tex.

This accident occurred on that part of the Dallas-Austin Division extending between Fort Worth and Ennis, Tex., 55.8 miles. In the vicinity of the point of accident this is a single-track line, over which trains are operated by timetable and train orders. There is no block system in use. At Garrett, 53 miles east of Fort Worth, an auxiliary track, 1,099 feet in length, parallels the main track on the south. The west switch of this track is facing point for east-bound movements, and is located 647 feet west of the station sign. The accident occurred on the main track 35 feet west of the west switch of the auxiliary track, where the main track is crossed at grade by a gravel highway. From the west there is a tangent 9.57 miles in length, then a $4^{\circ}04'$ curve to the right 612 feet to the point of accident and 535 feet eastward. Throughout a considerable distance west of the point of accident the grade is 0.90 percent ascending for east-bound trains, but at the point of accident it is practically level.
