REPORT OF THE DIRECTOR
BUREAU OF SAFETY

ACCIDENT ON THE
TEXAS AND PACIFIC RAILWAY

RANGER, TEXAS

INVESTIGATION NO. 2359

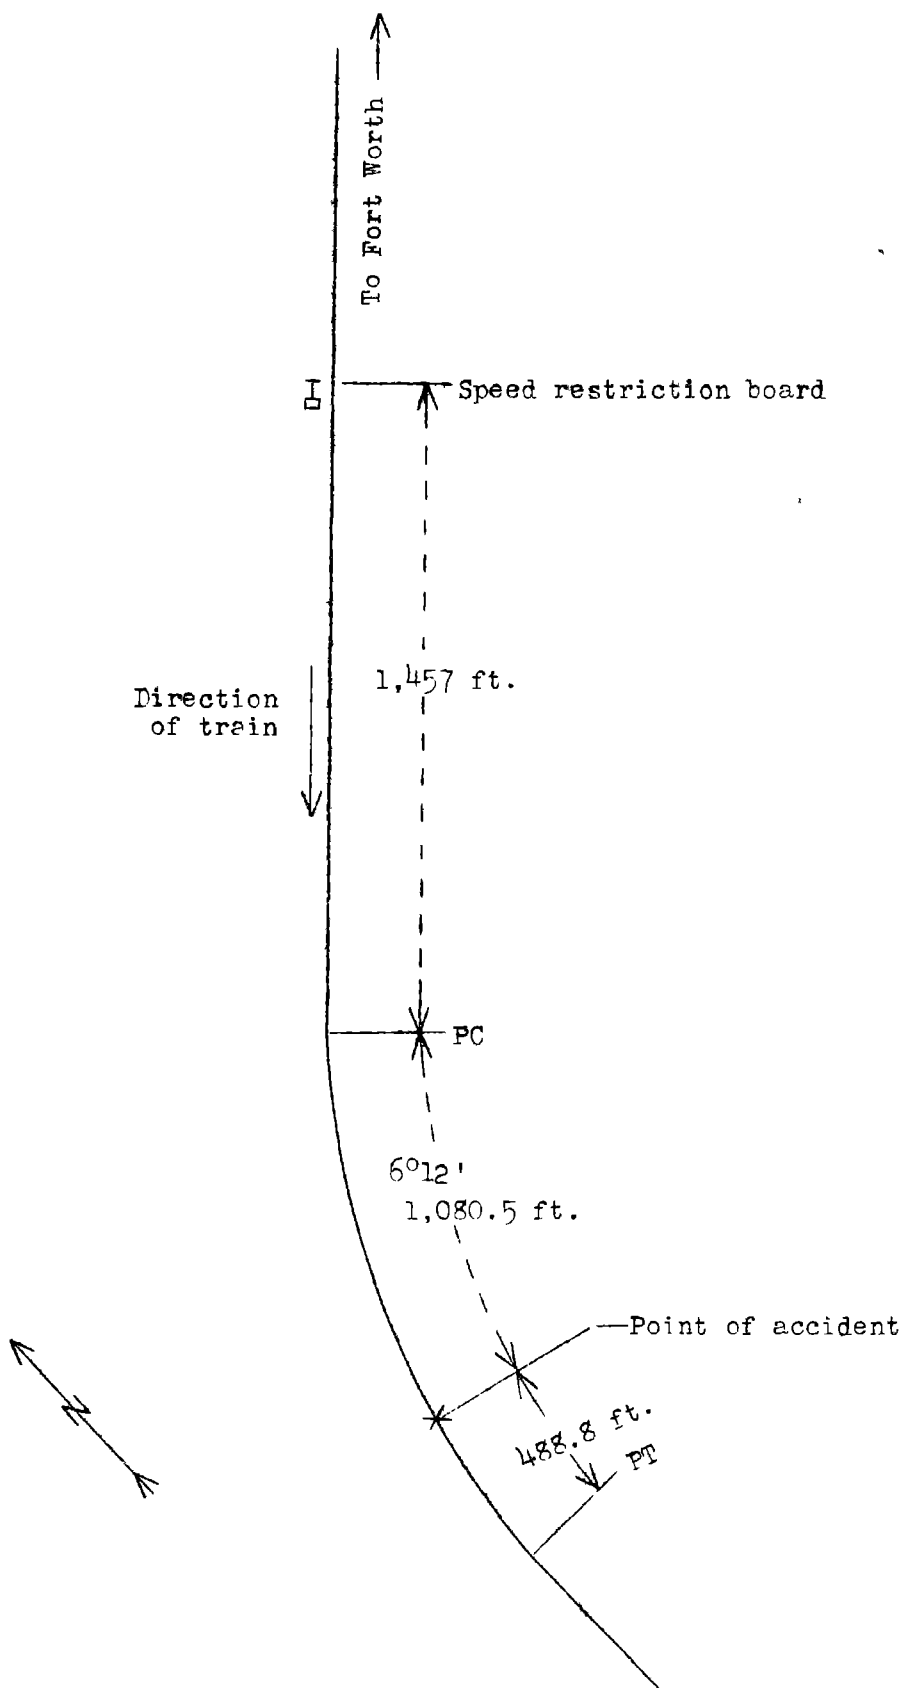
Inv. No. 2359
Texas and Pacific Ry.
Ranger, Texas
June 3, 1939

o	Ft. Worth, Texas
	95.0 mi.
o	Ranger
	3.62 mi.
x	Point of accident
	41.38 mi.
o	Baird, Texas

This accident occurred on that part of the Rio Grande Division designated as the Fort Worth Sub-division which extends between Fort Worth and Baird, Texas, a distance of 140 miles. In the vicinity of the point of accident this is a single-track line over which trains are operated by timetable, train orders, and an automatic block-signal system. The derailment occurred at a point 3.62 miles west of Ranger. Approaching from the east there is a tangent 5,234.1 feet in length, followed by a 6°12' curve to the left which extends 1,080.5 feet to the point of derailment and 488.8 feet beyond. The grade for west-bound trains is 0.85 percent ascending.
