REPORT NO. 3533  
UNION PACIFIC RAILROAD COMPANY  
IN RE ACCIDENT  
AT AULT, COLO., ON  
AUGUST 27, 1953

Kind of accident: Collision

Accident at Ault, Colo., on August 27, 1953, caused by a motor-truck occupying a rail-highway grade crossing immediately in front of an approaching train, which was proceeding at an unauthorized speed.

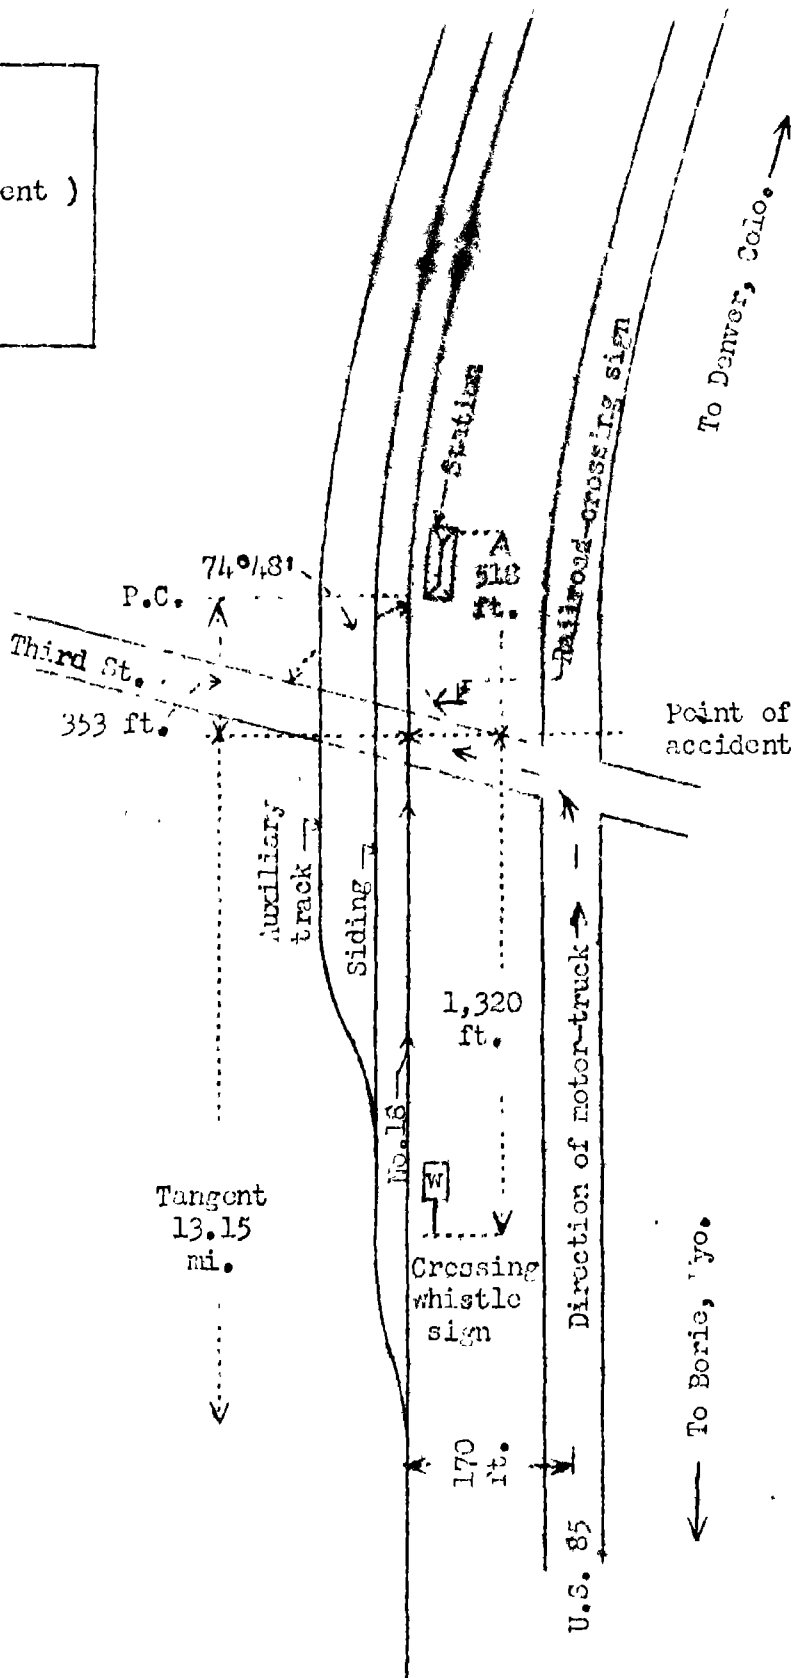
- Denver, Colo. 63.0 mi.
- X Ault ( Point of accident ) 23.0 mi.
- Carr, Colo. 17.3 mi.
- Borie, Wyo.

Report No. 3533  
 Union Pacific Railroad  
 Ault, Colo.  
 August 27, 1953

Location of Accident and Method of Operation
