INVESTIGATION NO. 2838
THE UNION PACIFIC RAILROAD COMPANY
REPORT IN RE ACCIDENT
NEAR CORLETT JUNCTION, WYO., ON
OCTOBER 24, 1944

Railroad: Union Pacific
Date: October 24, 1944
Location: Corlett Junction, Wyo.
Kind of accident: Rear-end collision
Trains involved: Freight : Engine
Train numbers: Extra 3556 East : Extra 2282 East
Engine numbers: 3556 : 2282
Consist: 75 cars, caboose :
Estimated speed: Standing : 25 m. p. h.
Operation: Timetable, train orders and
automatic block-signal system
Track: Double, tangent, 1.2273 percent
descending grade eastward
Weather: Clear
Time: 5:20 a. m.
Casualties: 3 killed
Cause: Failure properly to control speed
of following train in accordance
with signal indications

Accident near Corlett Junction, Wyo., on October 24, 1944,
caused by failure properly to control the speed of
the following train in accordance with signal indi-
cations.

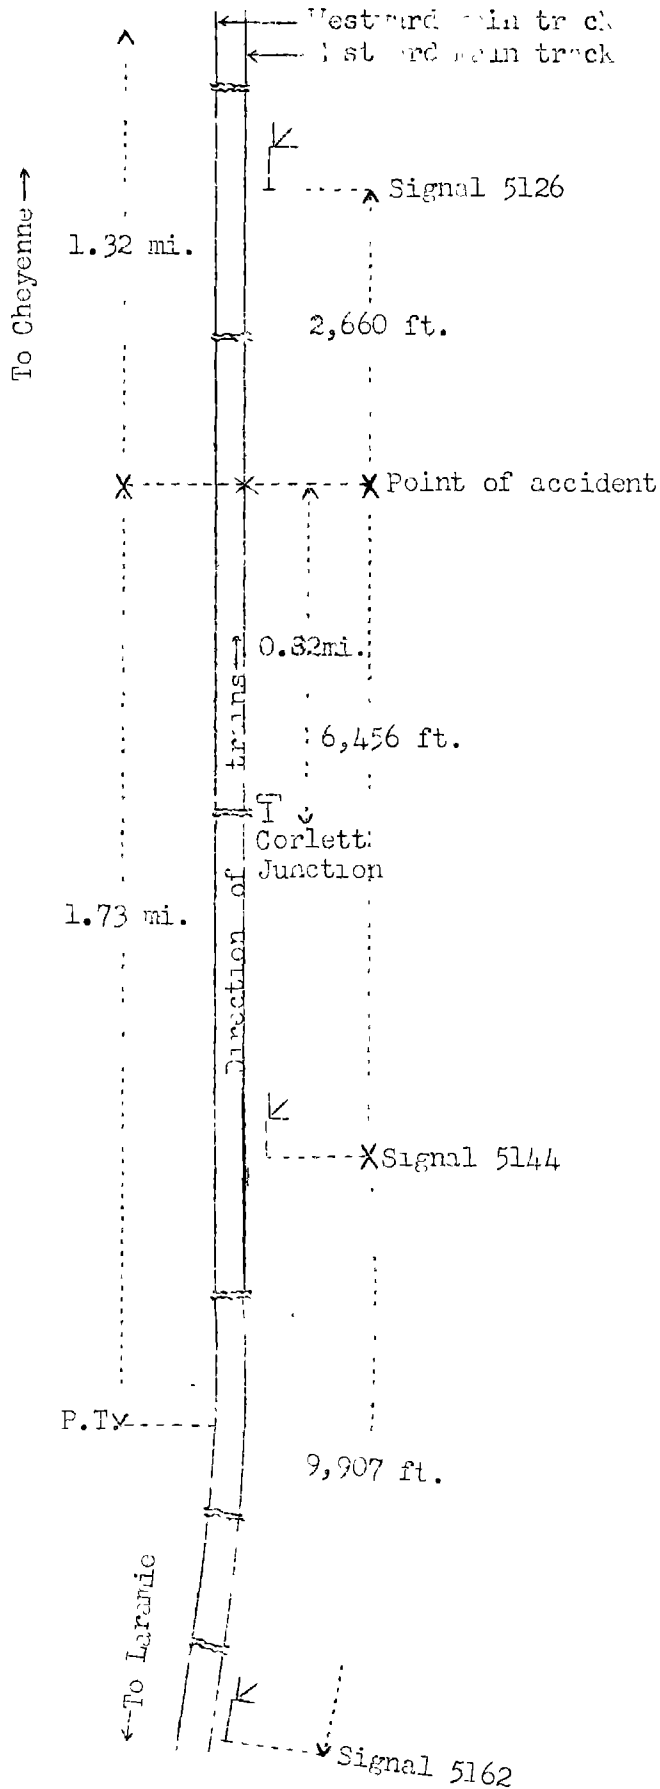
Inv-28336
 Union Pacific Railroad
 Corlett Junction, Wyo.
 October 21, 1944

- o Cheyenne, Wyo. 3.63 mi.
- X Point of accident 0.82 mi.
- o Corlett Junction 5.00 mi.
- o Borie 47.30 mi.
- o Laramie, Wyo.
