INVESTIGATION NO. 2568  
THE UNION PACIFIC RAILROAD COMPANY  
REPORT IN RE ACCIDENT  
AT FIR, OREG., ON  
FEBRUARY 7, 1942

Railroad: Union Pacific  
Date: February 7, 1942  
Location: Fir, Oreg.  
Kind of accident: Derailment and side collision  
Trains involved: Freight : Freight  
Train numbers: Extra 2521 East : Second 255  
Engine numbers: 2521 : 2209  
Consist: 64 cars, caboose : 59 cars, caboose  
Speed: Standing : 20-30 m p. h.  
Operation: Timetable and train orders  
Track: Single; tangent; 0.2 percent  
ascending grade westward  
Weather: Misty  
Time: 6:10 p. m.  
Casualties: 2 killed; 1 injured  
Cause: Accident caused by broken rail

Accident at Fir, Oreg., on February 7, 1942, caused by  
broken rail.

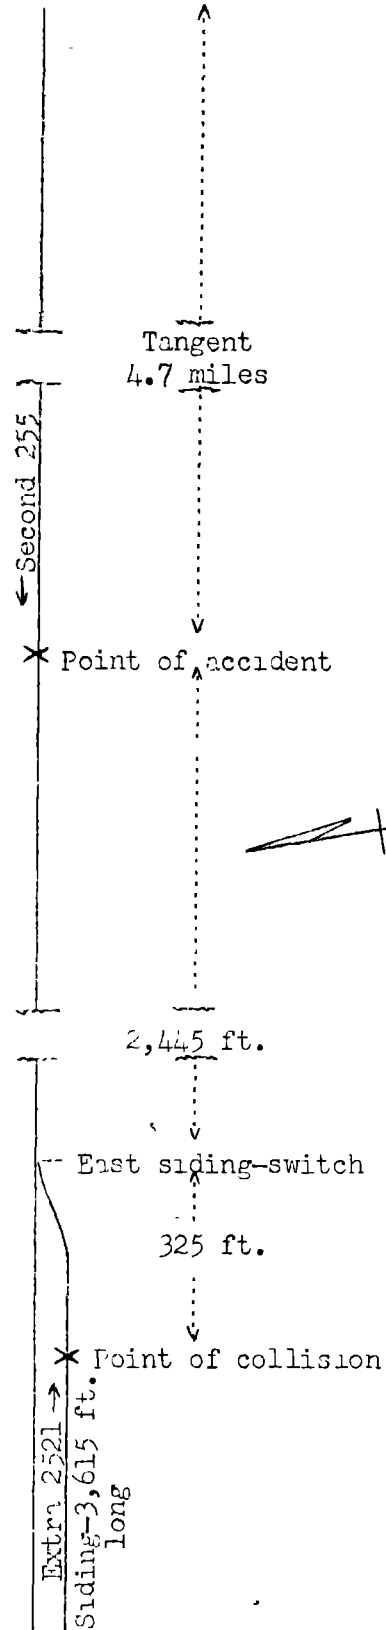
Inv-2568  
Union Pacific Railroad  
Fir, Oreg.  
February 7, 1942

- o The Dalles, Oreg. 60.5 mi.
- o Troutdale 3.5 mi.
- X Point of accident 1.2 mi.
- o Fair 6.7 mi.
- o Peninsula Jct., Oreg.

→ To The Dalles

← To Peninsula Jct.
