INTERSTATE COMMERCE COMMISSION

REPORT OF THE DIRECTOR OF THE BUREAU OF SAFETY CONCERNING AN
ACCIDENT ON THE UNION PACIFIC RAILROAD AT GIBBON, NEBR.,
ON SEPTEMBER 18, 1933.

January 23, 1934.

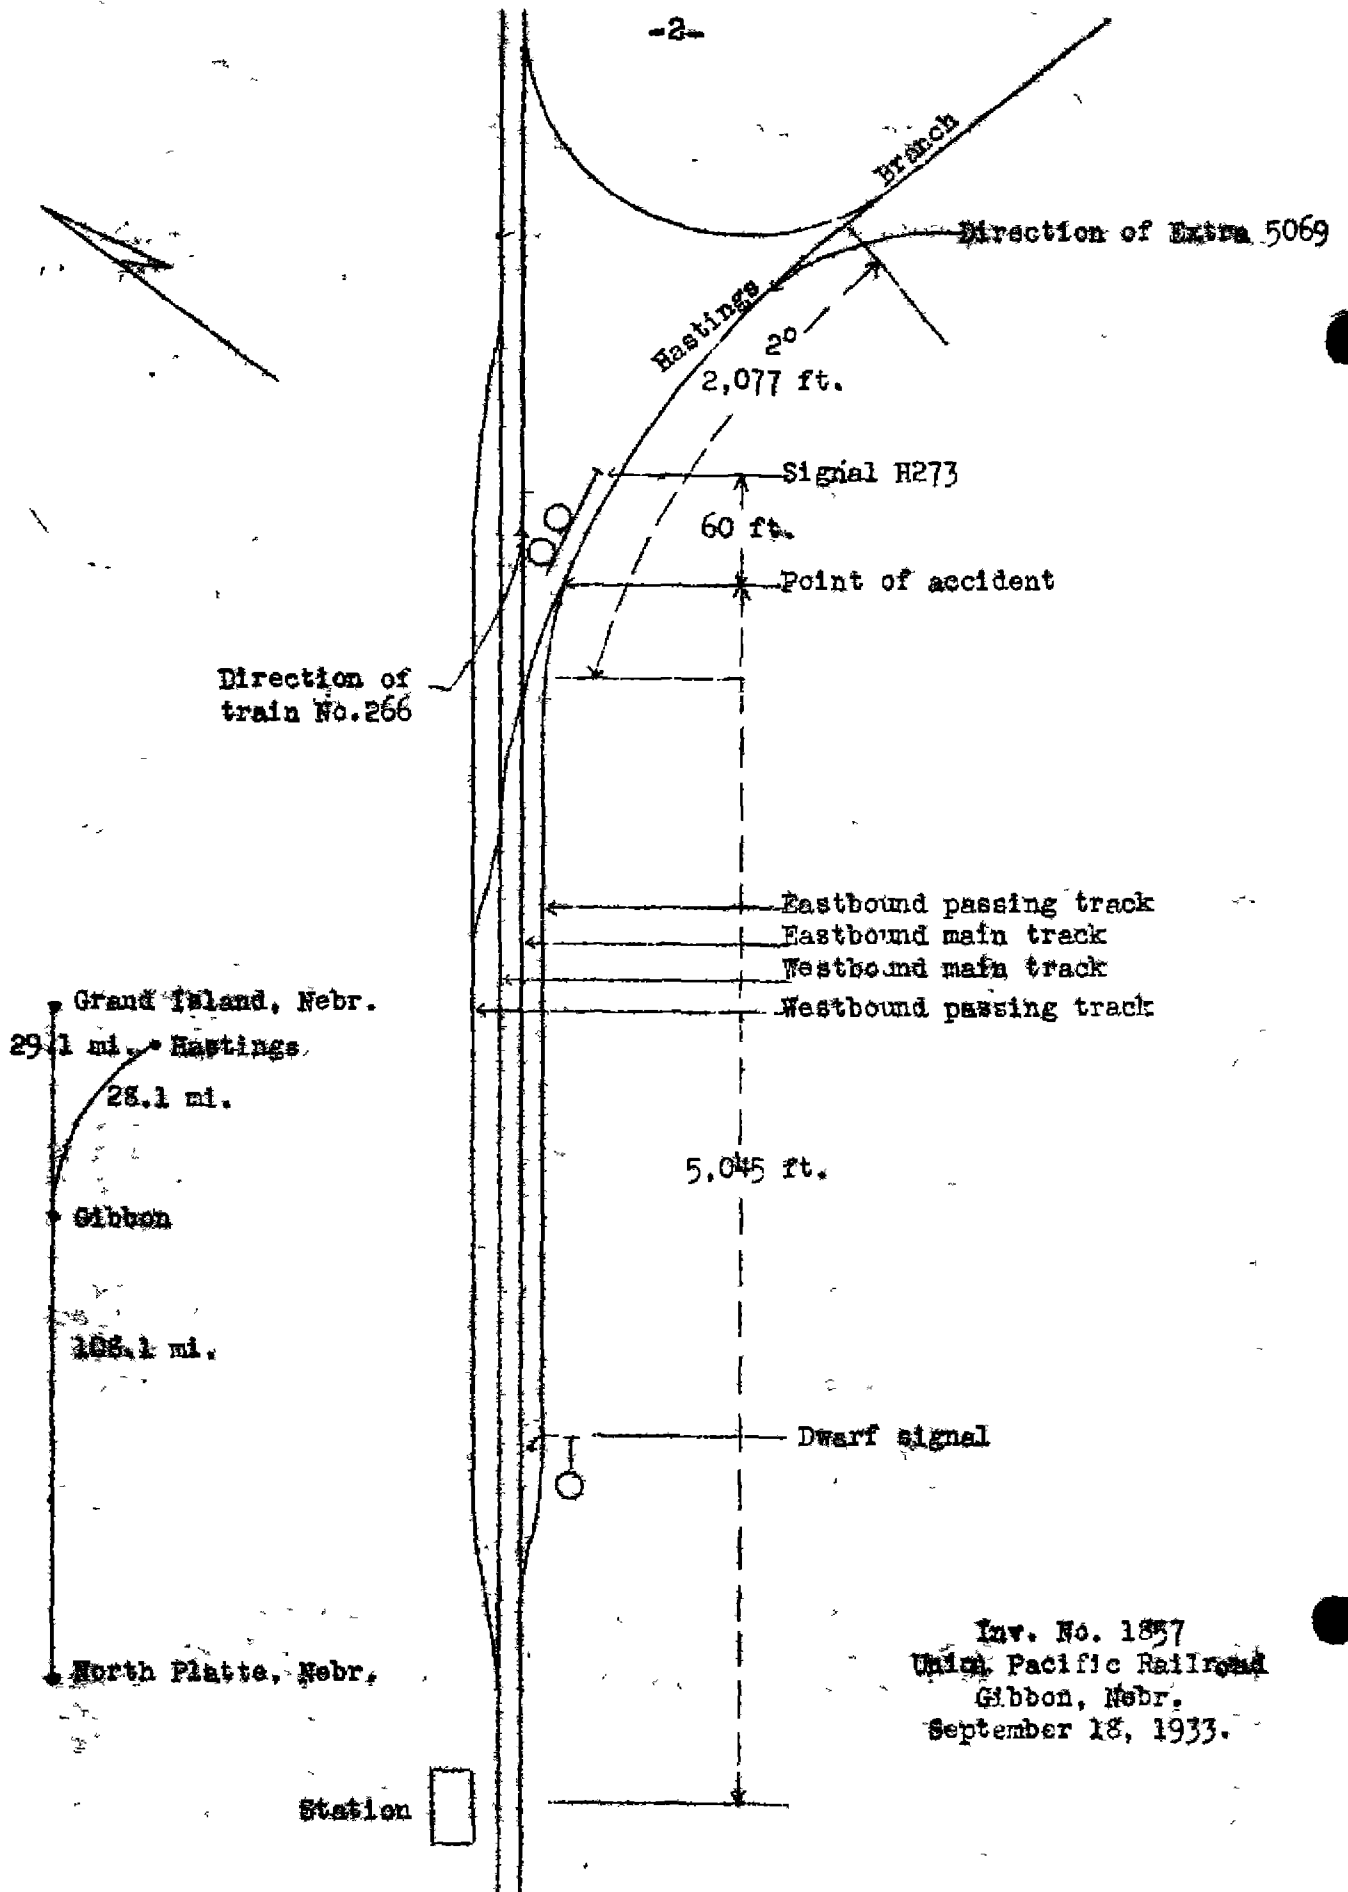
Inv. No. 1837
 Union Pacific Railroad
 Gibbon, Nebr.
 September 18, 1933.

The switch involved is a facing-point switch for west-bound trains on the Hastings Branch and leads off through a no. 14 turnout. The switch stand, located to the right or north side of the track, is of the high Star type equipped with an 18-inch red disc; the normal position of this switch is for a movement to the passing track. It is a hand-throw switch and when lined for the cross-over it operates the automatic block-signal system on the east-bound main track.

Block signal H273, situated 80 feet east of the cross-over switch, is equipped with two panels, the upper signal, a three-color light, governs west-bound movements on the east-bound passing track as far as the interlocking dwarf signal located at the western end of the passing track, and is electrically operated by the operator at Gibbon. When a yellow indication is displayed it authorizes a movement to the passing track, with the dwarf signal at stop. The lower signal, a two-color light, governs movements from the Hastings Branch to the west-bound main track.
