INTERSTATE COMMERCE COMMISSION
WASHINGTON

INVESTIGATION NO. 2996
UNION PACIFIC RAILROAD COMPANY
REPORT IN RE ACCIDENT
AT HOT LAKE, OREG., ON
JUNE 6, 1946

Accident at Hot Lake Oreg., on June 6, 1946, caused by
failure properly to control speed of train in
accordance with signal indications and approaching
a meeting point.

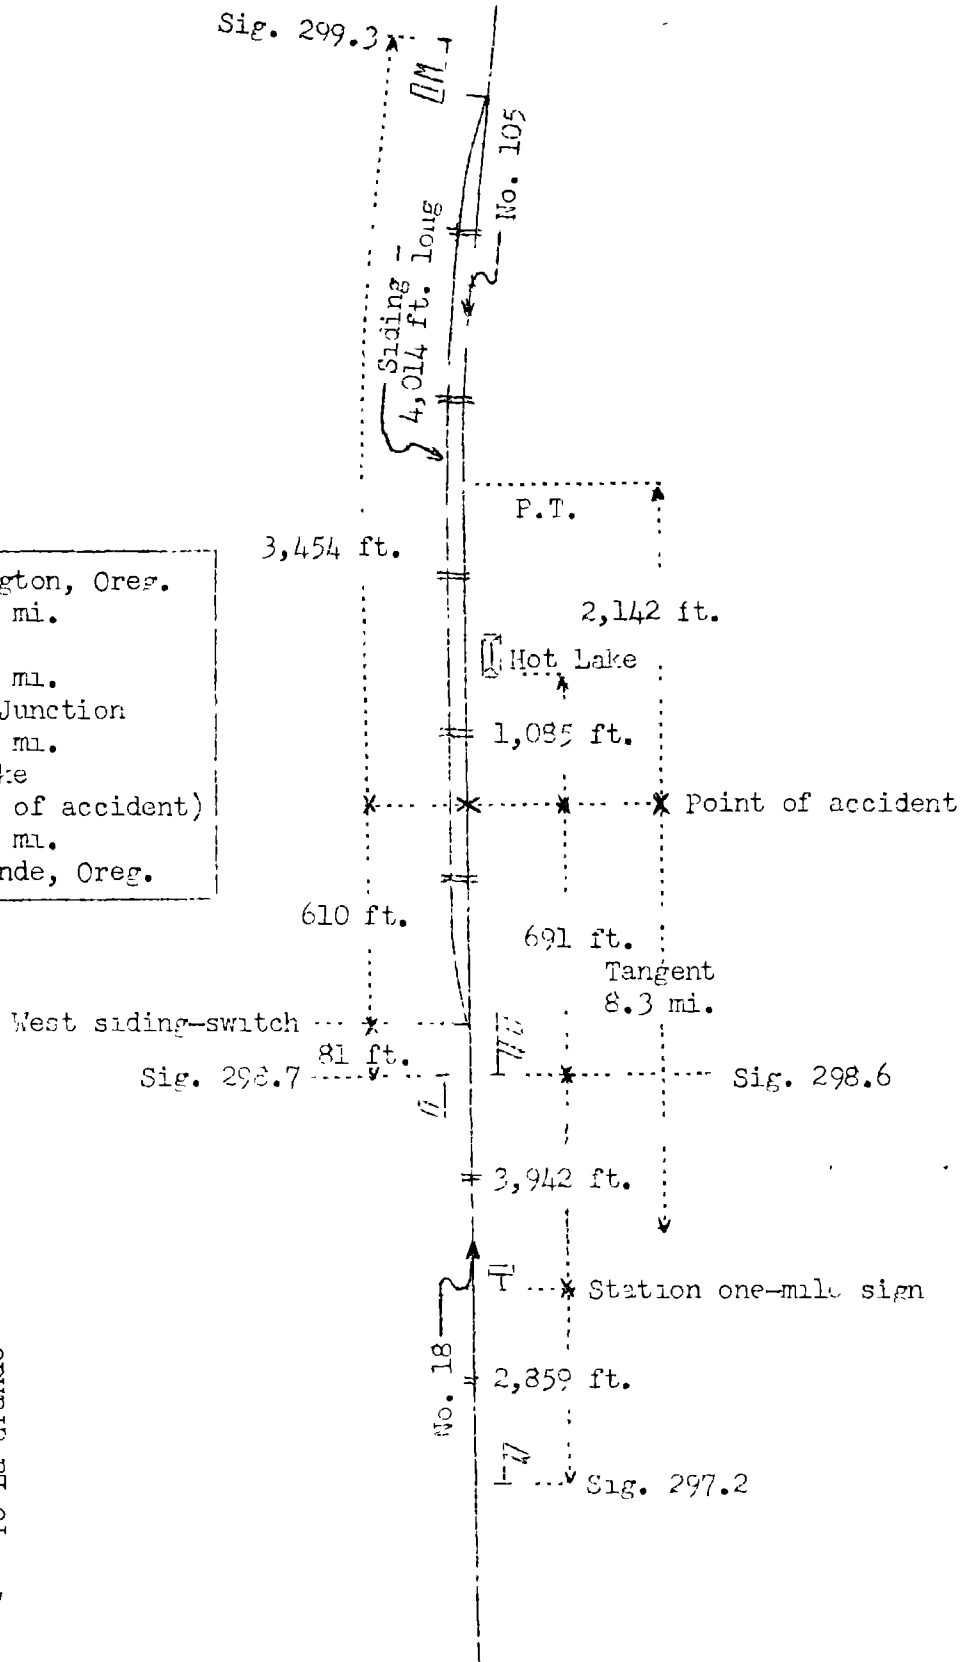
Inv. No. 2996
 Union Pacific Railroad
 Hot Lake, Oreg.
 June 6, 1946

- Huntington, Oreg. 47.4 mi.
- Baker 39.8 mi.
- Union Junction 3.2 mi.
- X Hot Lake (Point of accident) 9.2 mi.
- La Grande, Oreg.

Location of Accident and Method of Operation
