REPORT NO. 3516
UNION PACIFIC RAILROAD COMPANY
IN RE ACCIDENT
AT RED DESERT, WYO., ON
APRIL 27, 1953

Accident at Red Desert, Wyo., on April 27, 1953, caused
by a switch being opened immediately in front of an
approaching train.

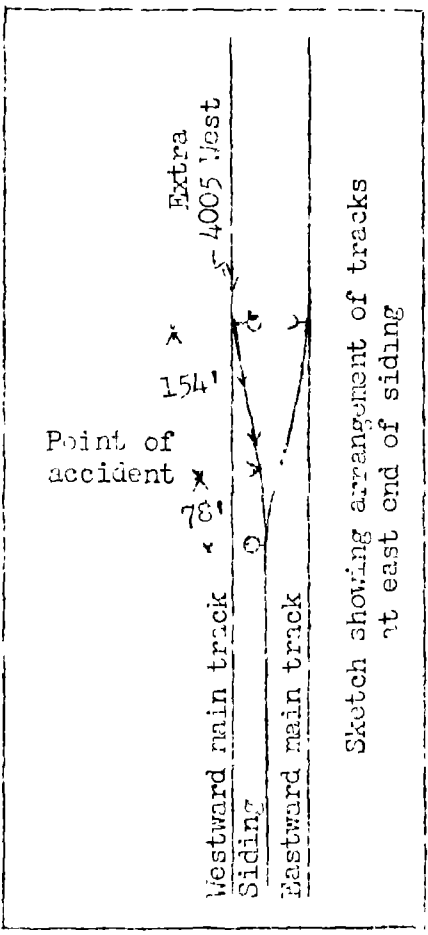
Report No. 2516
 Union Pacific Railroad
 Red Desert, Wyo.
 April 27, 1953

- Laramie, Wyo. 158.2 mi.
- Mansueter 4.9 mi.
- Frewen 3.6 mi.
- X Red Desert (Point of accident) 84.3 mi.
- Green River, Wyo.

Automatic signal 7313, governing west-bound movements on the westward main track, is located 1.14 miles east of the east siding-switch. This signal is of the color-light type

After the accident occurred the siding switch was found to be open. The operating lever was not latched, but it had been moved from normal position a sufficient distance to line the switch points for entry to the siding. A rail was overturned at a point 154 feet west of the switch. The track was destroyed between this point and the point at which the engine stopped.
