INTERSTATE COMMERCE COMMISSION
WASHINGTON

INVESTIGATION NO. 2468
UNION PACIFIC RAILROAD COMPANY
REPORT IN RE ACCIDENT
AT SALT LAKE CITY, UTAH, ON
DECEMBER 18, 1940

Kind of accident: Rear-end collision

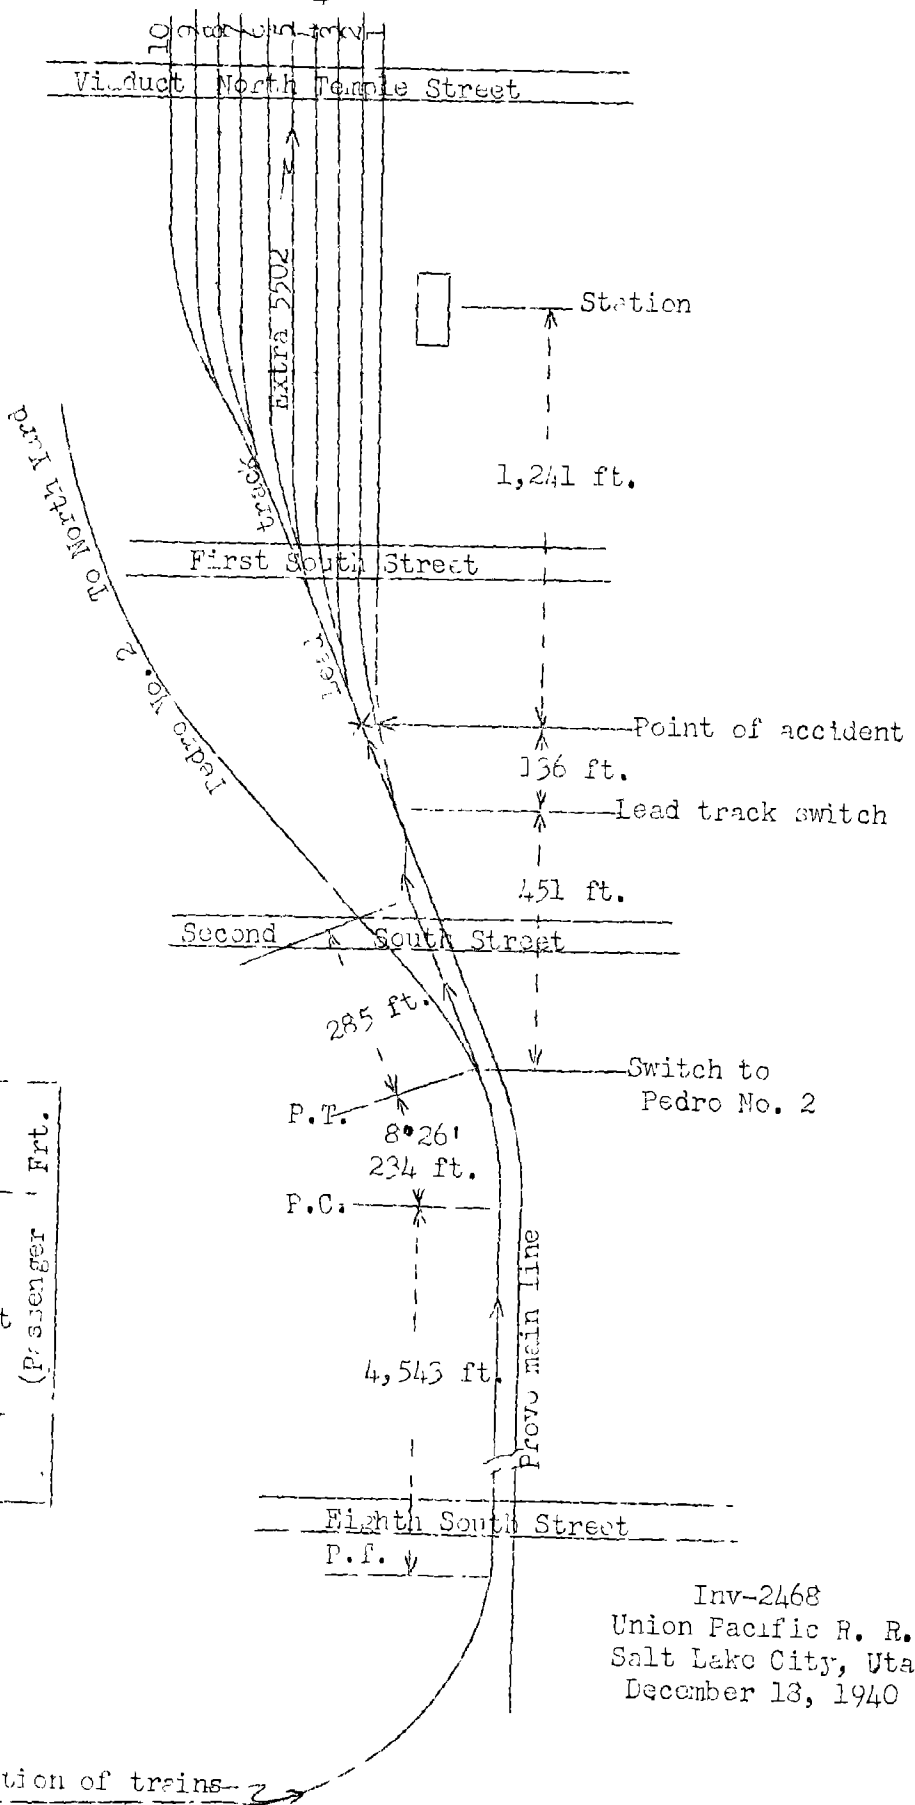
Inv-2468
 Union Pacific R. R.
 Salt Lake City, Utah
 December 13, 1940

o North Yard, Utah	4.4 mi.	Frt. (Passenger)
o Buena Vista		
o Salt Lake City		
x Point of accident	1.3 mi.	
o Eighth South Street	3.5 mi.	
o Buena Vista		
113.3 mi.		
o Lynndy, Utah
