REPORT NO. 3590  
UNION PACIFIC RAILROAD COMPANY  
IN RE ACCIDENT  
AT SALT LAKE CITY, UTAH, ON  
SEPTEMBER 19, 1954

Accident at Salt Lake City, Utah, on September 19, 1954,  
caused by an open switch.

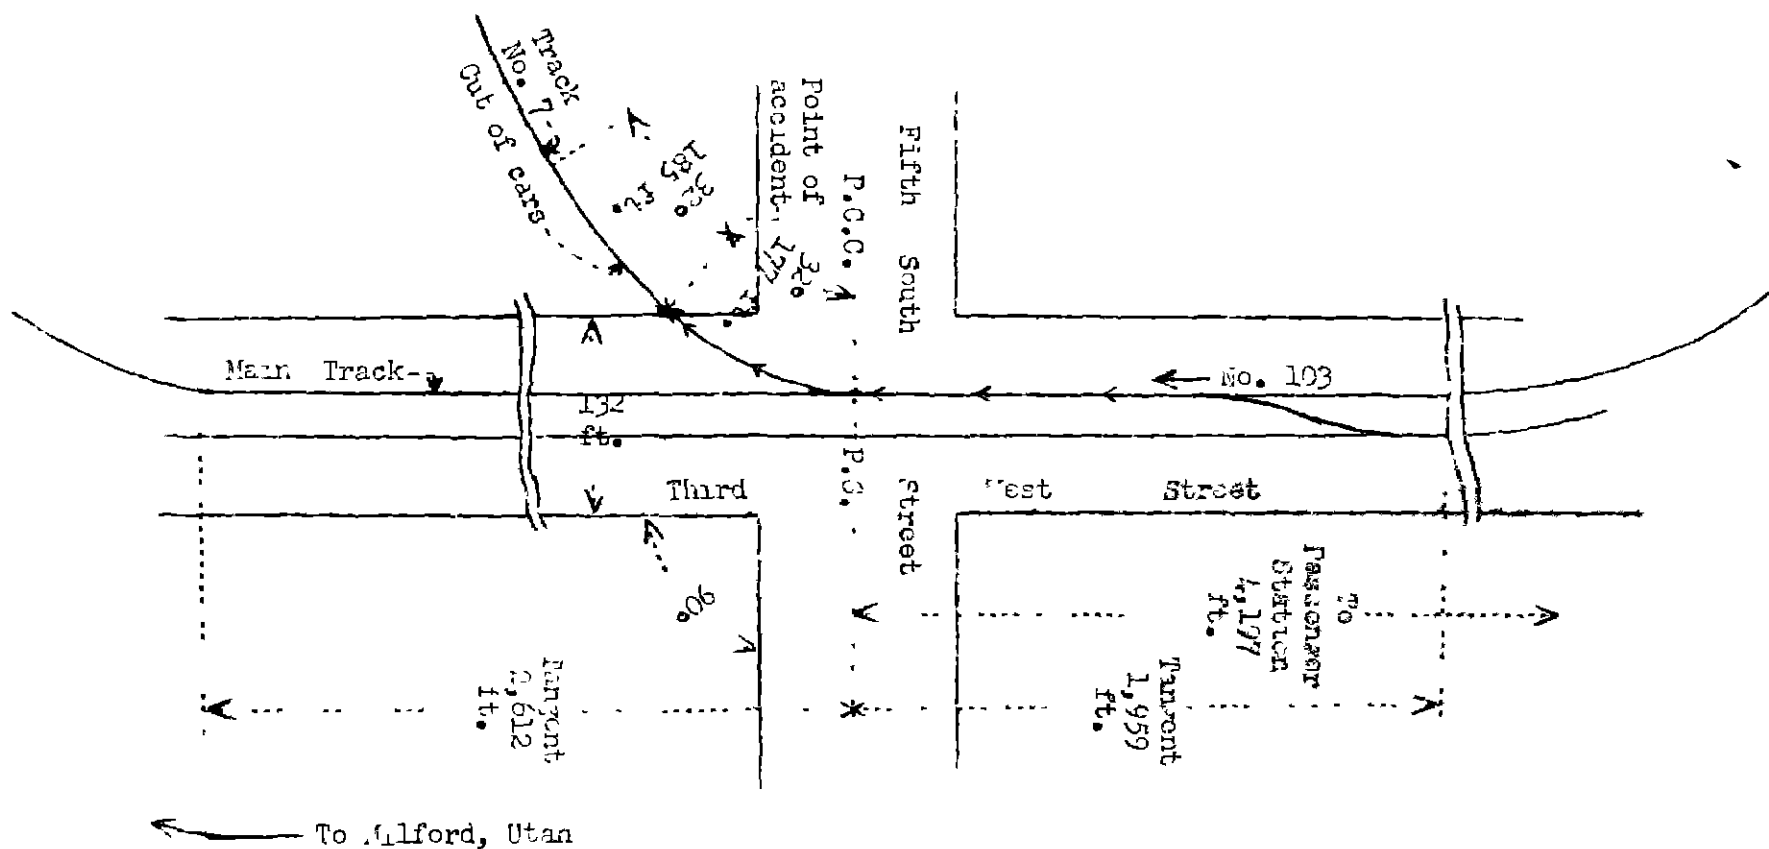
Report No. 3590  
 Union Pacific Railroad  
 Salt Lake City, Utah  
 September 19, 1954

Salt Lake City, Utah  
 (Point of accident)  
 207.2 ft.  
 Milford, Utah

No. 103 stopped with the front of the locomotive 65 feet west of the point of accident. West of a point approximately 125 feet west of the switch, the south rail of track No. 7 was overturned. The first Diesel-electric unit and the front truck of the second Diesel-electric unit of No. 103 and the four more easterly cars on track No. 7 were derailed. None of the derailed equipment overturned. The first Diesel-electric unit of No. 103 and the east car on track No. 7 were damaged.

After the accident it was found that the east switch of track No. 7 was lined for entry to that track. The switch lock was hooked through the keeper but was not locked. The switch points were not damaged. After the equipment of No. 103 was removed, the switch was lined in normal position. It was then found that the switch lock was defective and could not be locked.
