**RAILROAD ACCIDENT INVESTIGATION**

**Report No 3827**

**THE VIRGINIAN RAILWAY COMPANY**

**KUMIS, VA**

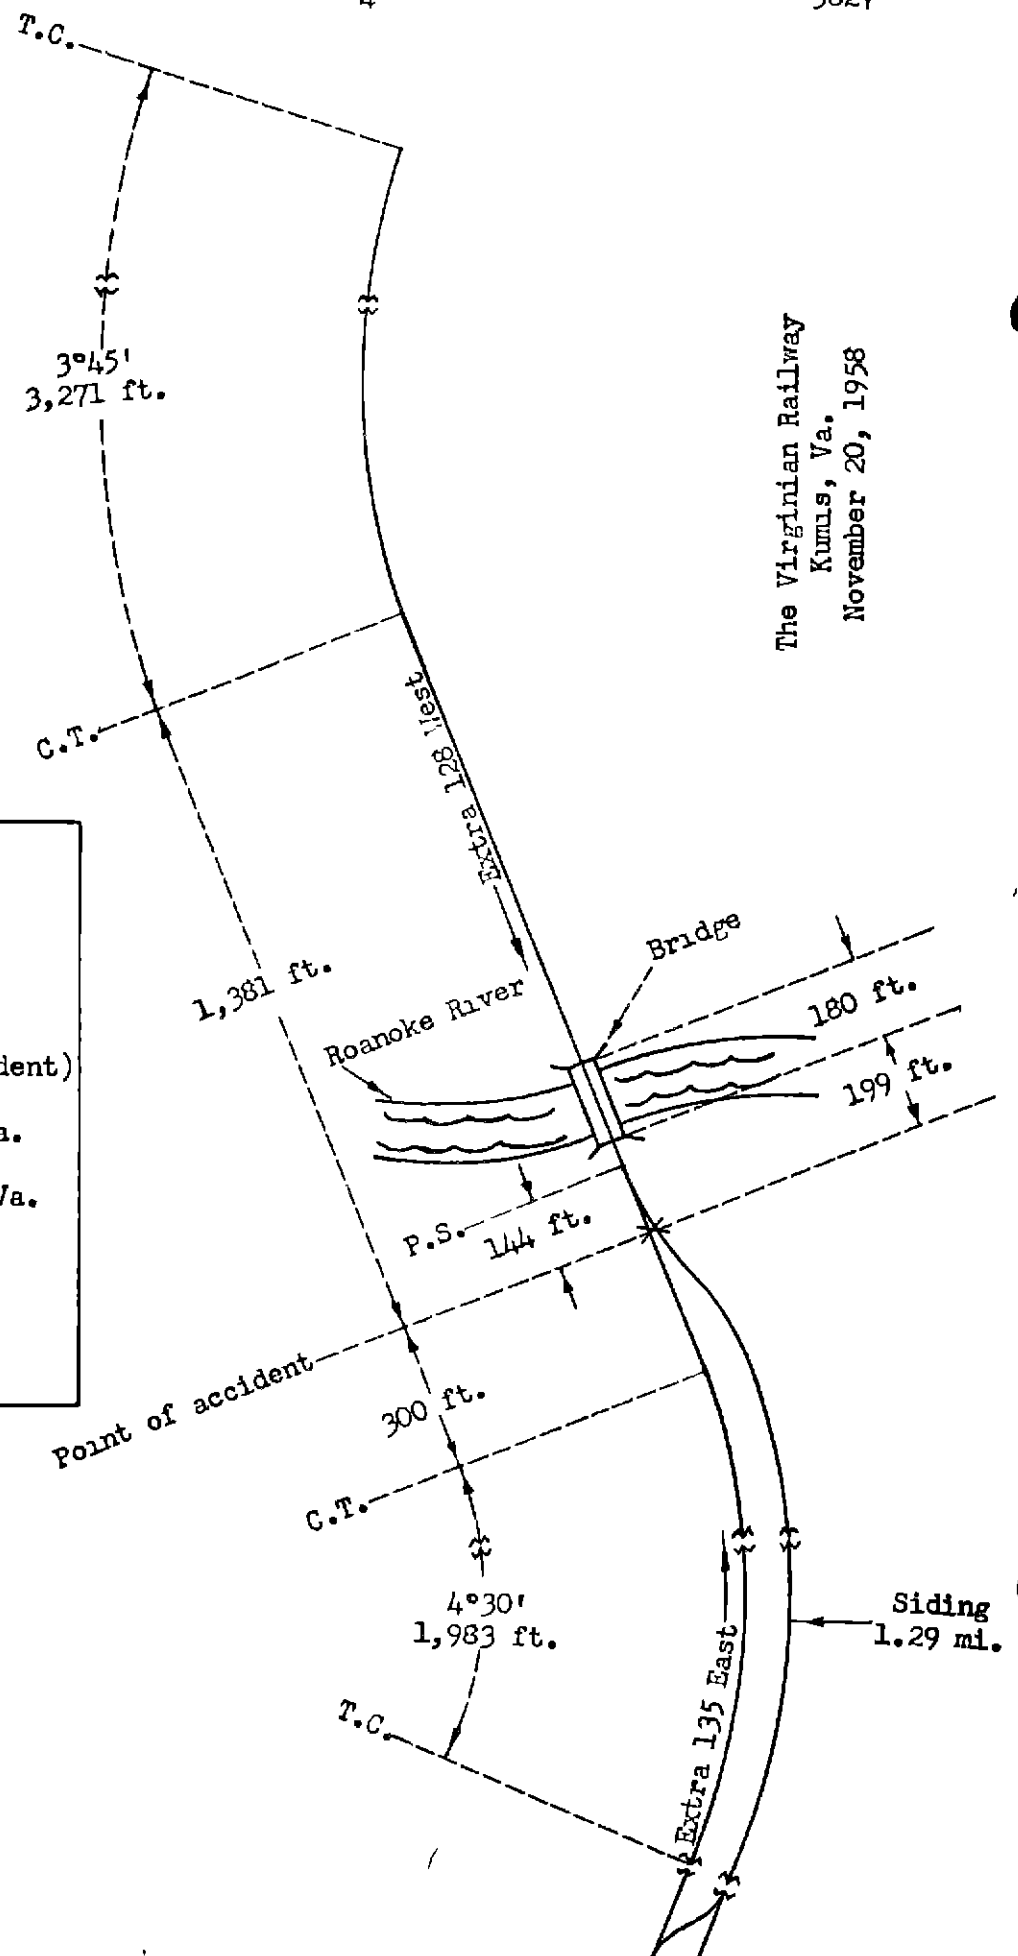
The Virginian Railway  
Kumus, Va.  
November 20, 1958

- Roanoke, Va. 7.8 mi.
- Salem 5.7 mi.
- Wabun 4.3 mi.
- X Kumus (Point of accident) 26.8 mi.
- Whitethorne, Va. 52.5 mi.
- Princeton, W. Va. 16.0 mi.
- Matoaka 3.7 mi.
- Clarks Gap 14.6 mi.
- Elmore, W. Va.

This accident occurred on that part of the New River Division extending between Roanoke, Va., and Elmore, W. Va., 131.4 miles. In the vicinity of the point of accident this is a single-track line over which trains are operated by timetable and train orders. There is no block system in use. A catenary system is provided for the electric propulsion of trains. At Kumis, Va., 17.8 miles west of Roanoke, a siding 1.29 miles in length parallels the main track on the south. The station point at Kumis is located at the east switch of the siding. The accident occurred 144 feet west of the east siding-switch at the fouling point of the siding and the main track. From the west there are, in succession, a 4°30' curve to the left 1,983 feet, and a tangent 300 feet to the point of accident and 1,381 feet eastward. From the east there are, in succession, a 3°45' curve to the left 3,271 feet and the tangent on which the accident occurred. In the immediate vicinity of the point of accident the grade is level.
