INVESTIGATION NO. 2781
THE WABASH RAILROAD COMPANY
REPORT IN RE ACCIDENT
NEAR ASHLAND AVE. STATION, CHICAGO, ILL., ON
MARCH 3, 1944

Railroad: Wabash
Date: March 3, 1944
Location: Ashland Ave. Station, Chicago, Ill.
Kind of accident: Rear-end collision
Trains involved: Freight : Engine
Train numbers: Extra 1534 North : Extra 2802 North
Engine numbers: 1534 : 2802
Consist: 20 cars, 2 cabooses :
Estimated speed: Standing : 15 m. p. h.
Operation: Timetable and automatic block-
signal system; yard limits
Track: Double; tangent; 0.064 percent
descending grade northward
Weather: Raining
Time: About 11:35 p. m.
Casualties: 1 killed; 2 injured
Cause: Failure properly to control
speed of following train
moving within yard limits

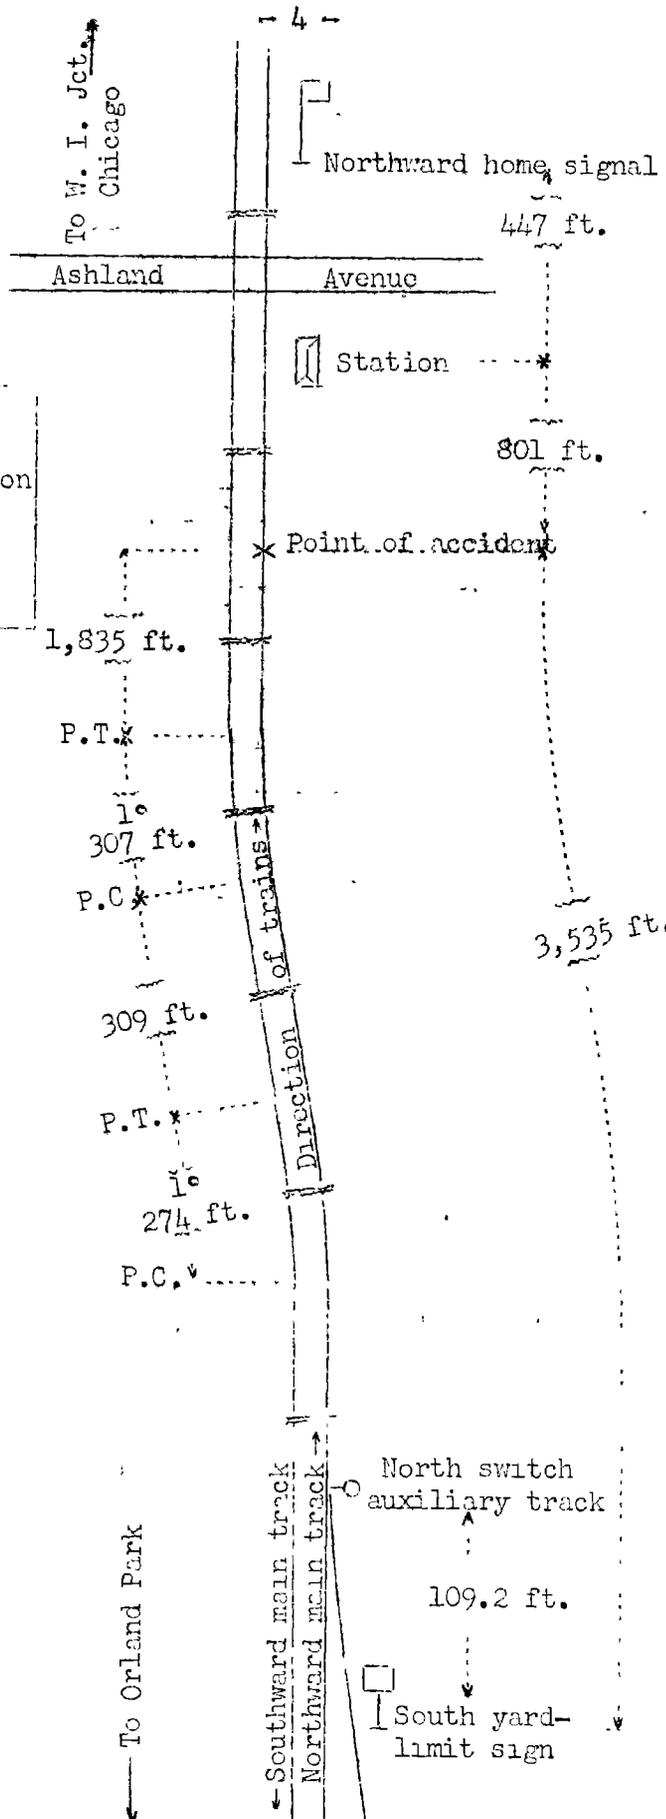
Inv-2781
 Peabash Railroad
 Ashland Ave. Station, Chicago, Ill.
 March 3, 1944

- o W. I. Jct., Ill. 1.11 mi.
- o Ashland Ave. Station 0.15 mi.
- X Point of accident 13.94 mi.
- o Orland Park, Ill.

This accident occurred on that part of the Decatur Division extending between Orland Park and W. I. Jct., Chicago, Ill., 15.2 miles. This was a double-track line over which trains moving with the current of traffic were operated by timetable and an automatic block system. The accident occurred within yard limits on the northward main track 801 feet south of Ashland Ave. Station and 3,535 feet north of the south yard-limit sign. From the south there were, in succession, a 1° curve to the left 274 feet in length, a tangent 309 feet, a 1° curve to the right 307 feet and a tangent 1,835 feet to the point of accident and a considerable distance northward. The grade for north-bound trains varied between 0.0132 and 0.69 percent ascending 2,100 feet, then it was 0.064 percent descending 484 feet to the point of accident and a considerable distance beyond.
