REPORT OF THE DIRECTOR
BUREAU OF SAFETY

ACCIDENT ON THE
WABASH RAILWAY

NEW HAVEN, IND.

INVESTIGATION NO. 2198

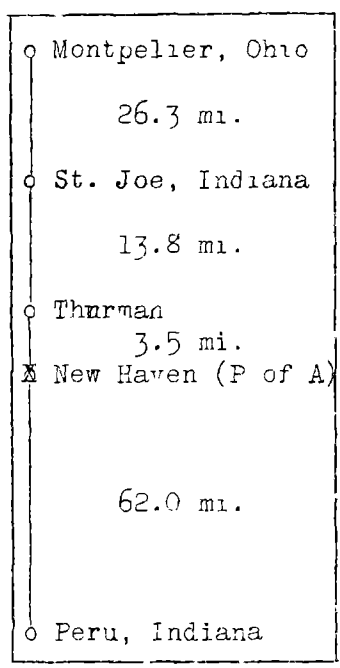
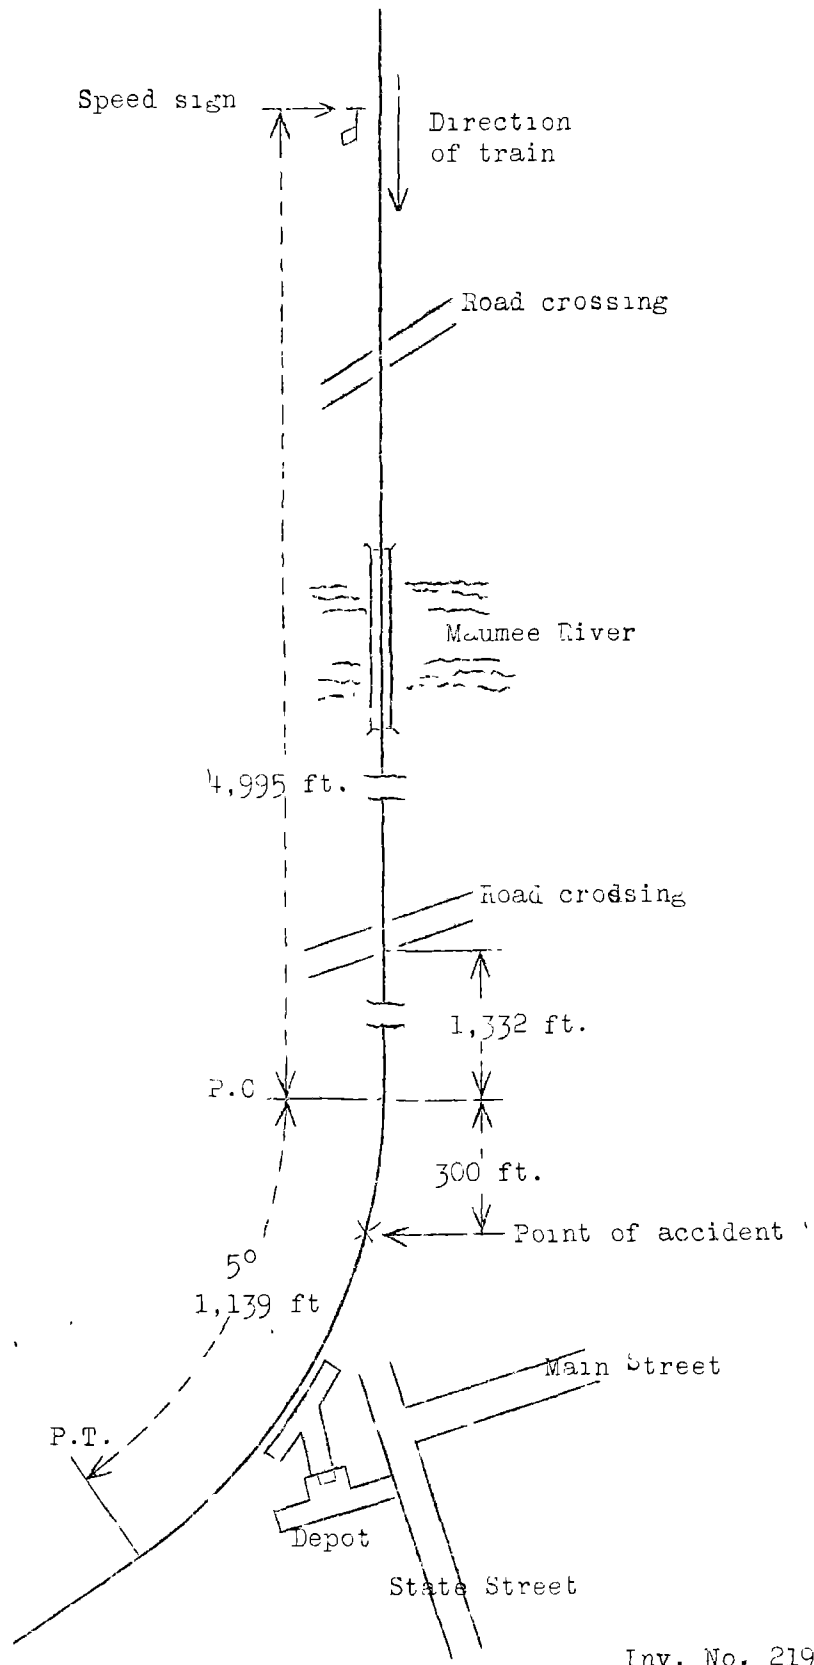
Inv. No. 2198
 Wabash Railway
 New Haven, Ind.
 Sept. 7, 1937

Engine 662, its tender, the first six cars and the forward truck of the seventh car were derailed toward the south; the rear car remained on the rails. The engine stopped on its right side, about 250 feet west of the point of derailment; it was stripped of its cab and all appurtenances and was otherwise badly damaged. The tender was torn from its trucks and stopped, end up, against the north side of the engine. The baggage and lounge cars stopped opposite and north of the tender, and the other four derailed cars passed by the engine and stopped leaning at angles of about 15 to 20 degrees, with the forward end of the third car in the train farthest west, it being approximately 500 feet west of the point of derailment. The employee killed was the engineman, and the employees injured were the fireman and baggageman-helper.

Division Engineer Bennett stated that the distance from the point of derailment to where the track was torn up measured 137 feet, and from that point westward it was necessary to rebuild 156 feet of track, requiring four 39-foot rails on each side of the track and two other rails to replace bent rails.
