REPORT NO. 3478
WESTERN MARYLAND RAILWAY COMPANY
IN RE ACCIDENT
NEAR BERLIN JCT., PA., ON
AUGUST 13, 1952

Date: August 13, 1952

Kind of accident: Rear-end collision

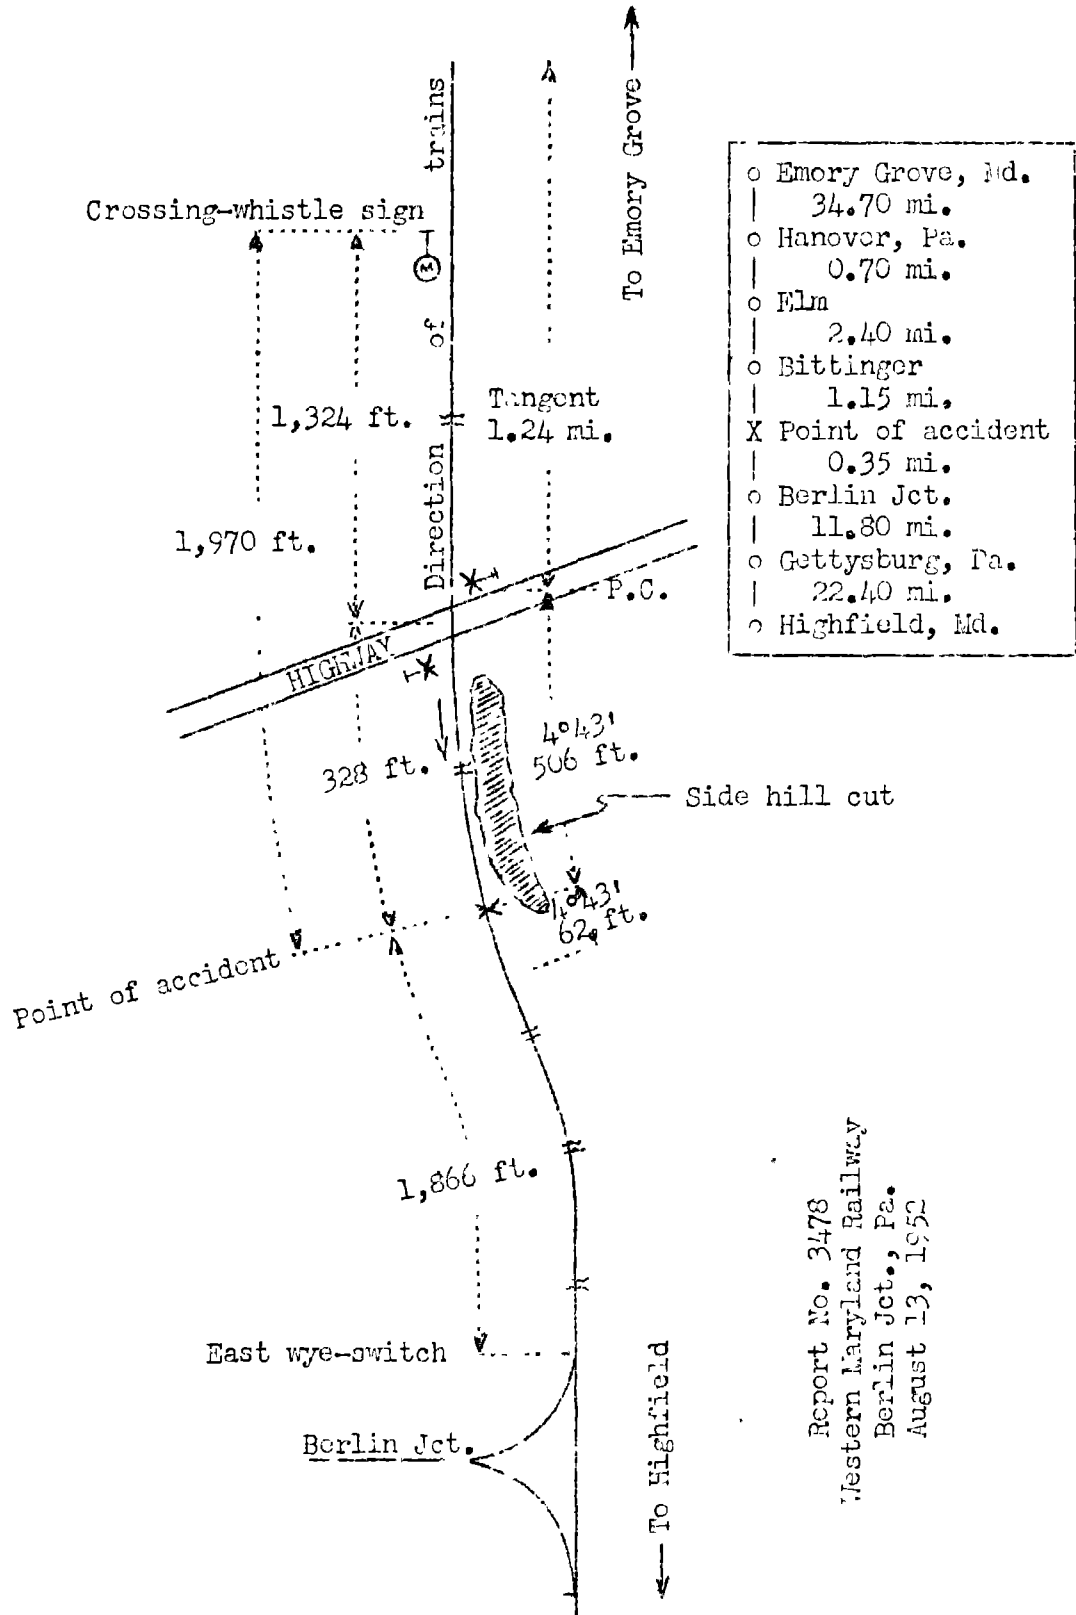
Report No. 3478
 Western Maryland Railway
 Berlin Jct., Pa.
 August 13, 1952

Location of Accident and Method of Operation

The rear truck of the rear car of Extra 64 West was displaced and derailed. The rear end of the rear car was elevated as a result of the impact and overrode the end platform of Diesel-electric unit 183 a distance of about 18 feet. No other equipment of either train was derailed. The rear three cars of Extra 64 West were somewhat damaged. Diesel-electric unit 183 was badly damaged and the rear compartment hood and the cab were demolished.
