INTERSTATE COMMERCE COMMISSION

REPORT OF THE DIRECTOR OF THE BUREAU OF SAFETY IN RE
INVESTIGATION OF AN ACCIDENT WHICH OCCURRED ON THE
WESTERN PACIFIC RAILROAD NEAR DAVID, CALIF., ON
APRIL 19, 1931.

Inv. No. 1701
Western Pacific R.R.
David, Calif.,
April 19, 1931

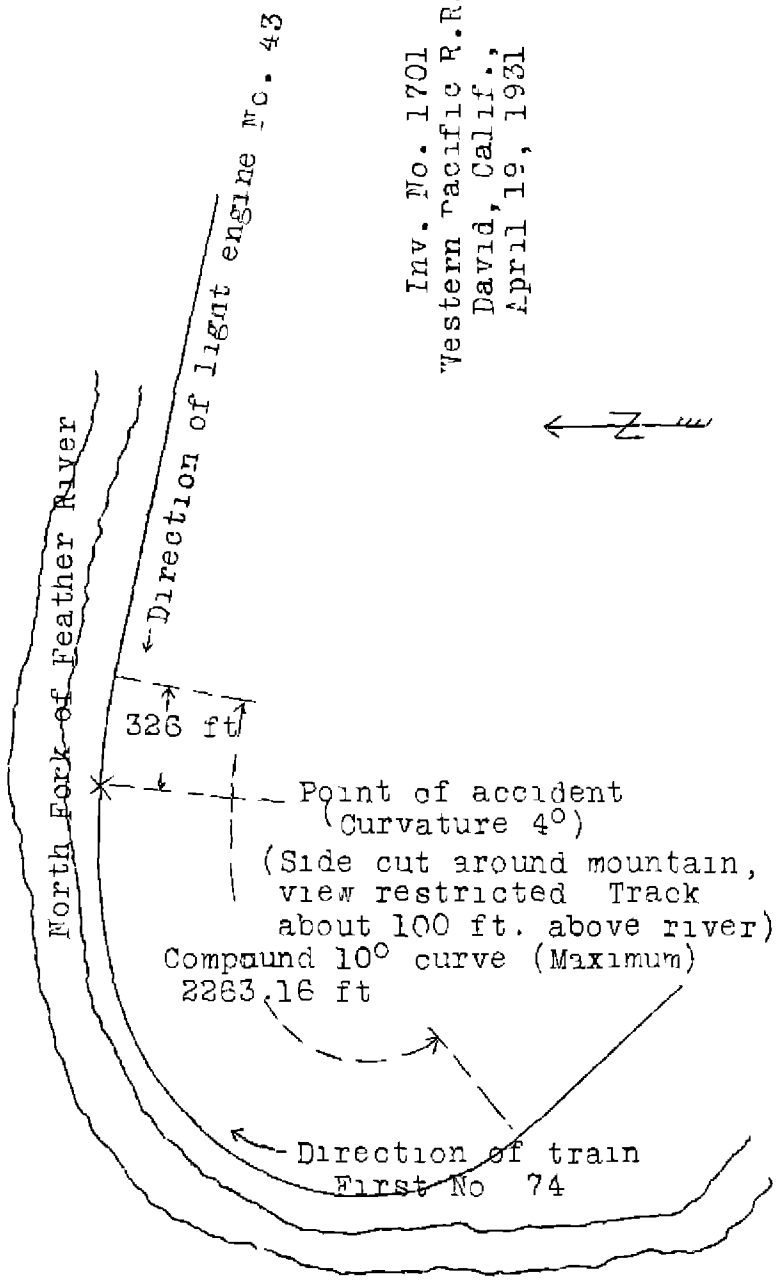
| Portola | |
| 40 5 mi. | |
| Keddie | |
| 41 8 mi | |
| Pulga | |
| 3 9 mi | |
| Poe | |
| (P. of A)* 3 8 mi | |
| David | |
| 26 3 mi | |
| Oroville | |

This accident occurred on the Third Subdivision of the Western Division, extending between Portola and Oroville, Calif., a distance of 116.3 miles, this is a single-track line over which trains are operated by time-table and train orders, no block-signal system being in use. The accident occurred at a point approximately 3,000 feet east of the east switch of the passing track at David; approaching the point of accident from either direction the track is composed of numerous short curves and tangents, the accident occurring on a compound curve 2,263.16 feet in length, with a maximum curvature of 10° , this is a curve to the left for westbound trains and the accident occurred about 326 feet from its eastern end, at which point the curvature is 4° . The grade for westbound trains is 0.86 per cent descending.

In this vicinity the track is laid in a side cut around a mountain, the mountain being on the inside of the curve involved, while the track is about 100 feet above the North Fork of Feather River, which parallels it on the north. Owing to the mountain on the inside of the curve neither crew could see the opposing train until within about 200 feet of each other.
