INTERSTATE COMMERCE COMMISSION
WASHINGTON

INVESTIGATION NO. 2456
THE WESTERN PACIFIC RAILROAD COMPANY
REPORT IN RE ACCIDENT
AT DEL PASO, CALIF., ON
OCTOBER 23, 1940

Accident at Del Paso, Calif., on October 23, 1940,
caused by failure of inferior train when entering
siding with headlight obscured to provide proper
flag protection and by failure of superior train
to obey meet order.

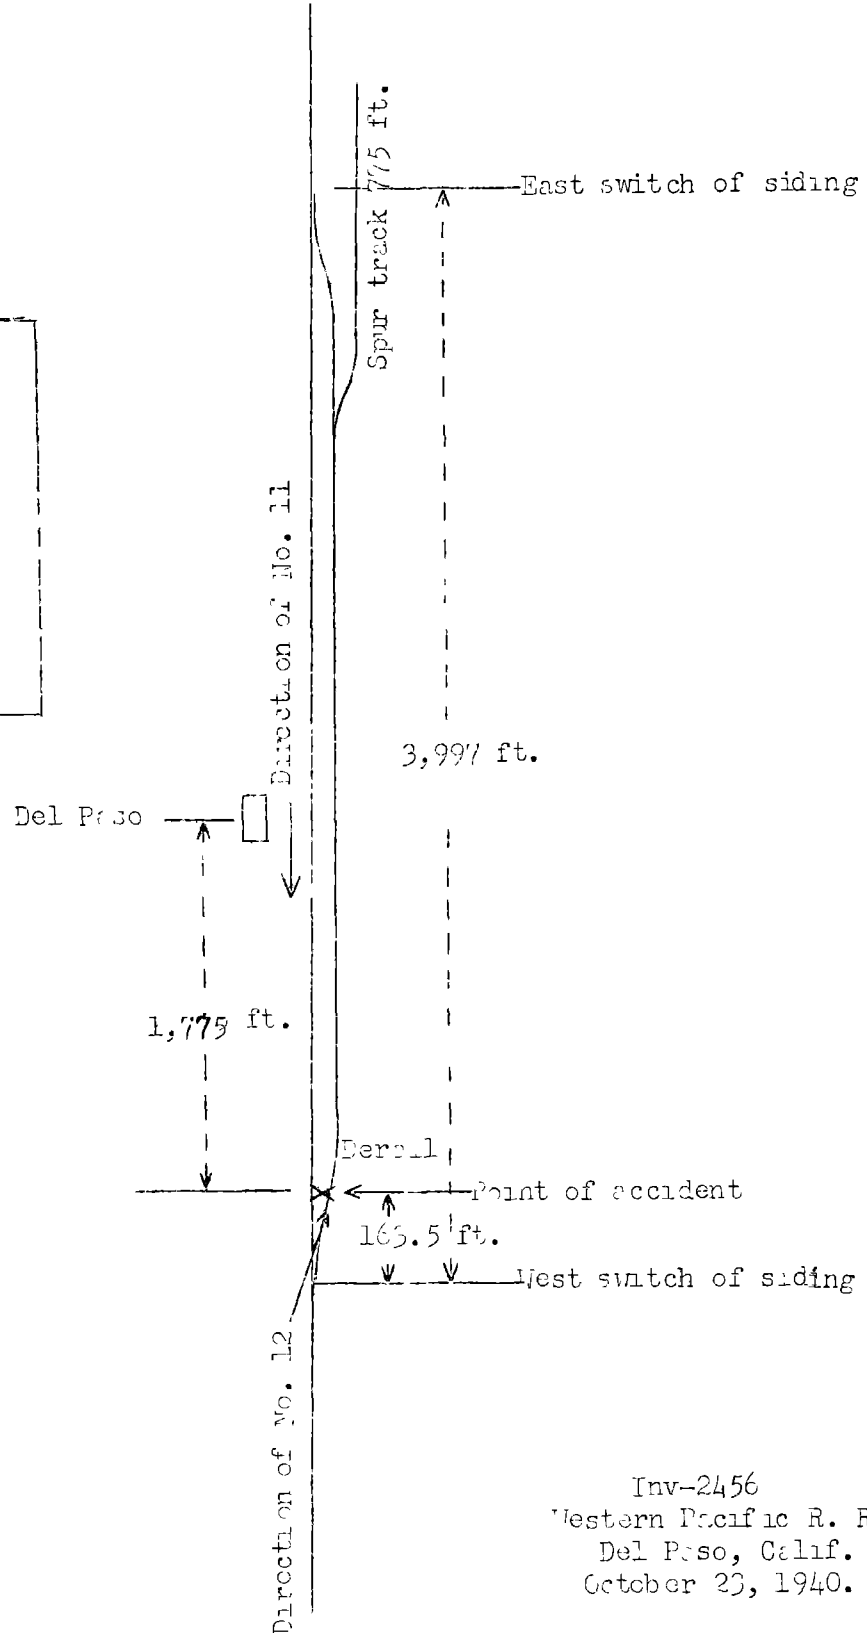
Inv-2456
 Western Pacific R. R.
 Del Paso, Calif.
 October 23, 1940.

o	Oroville, Calif.
	26.3 mi.
o	Marysville
	35 mi.
o	Del Paso
X	Point of accident
	5.2 mi.
o	Sacramento
	24.7 mi.
o	Thortnton
	20.1 mi.
o	Stockton, Calif.
