REPORT OF THE DIRECTOR  
BUREAU OF SAFETY

ACCIDENT ON THE  
WESTERN PACIFIC RAILROAD

PULGA, CALIF.

INVESTIGATION NO. 2222

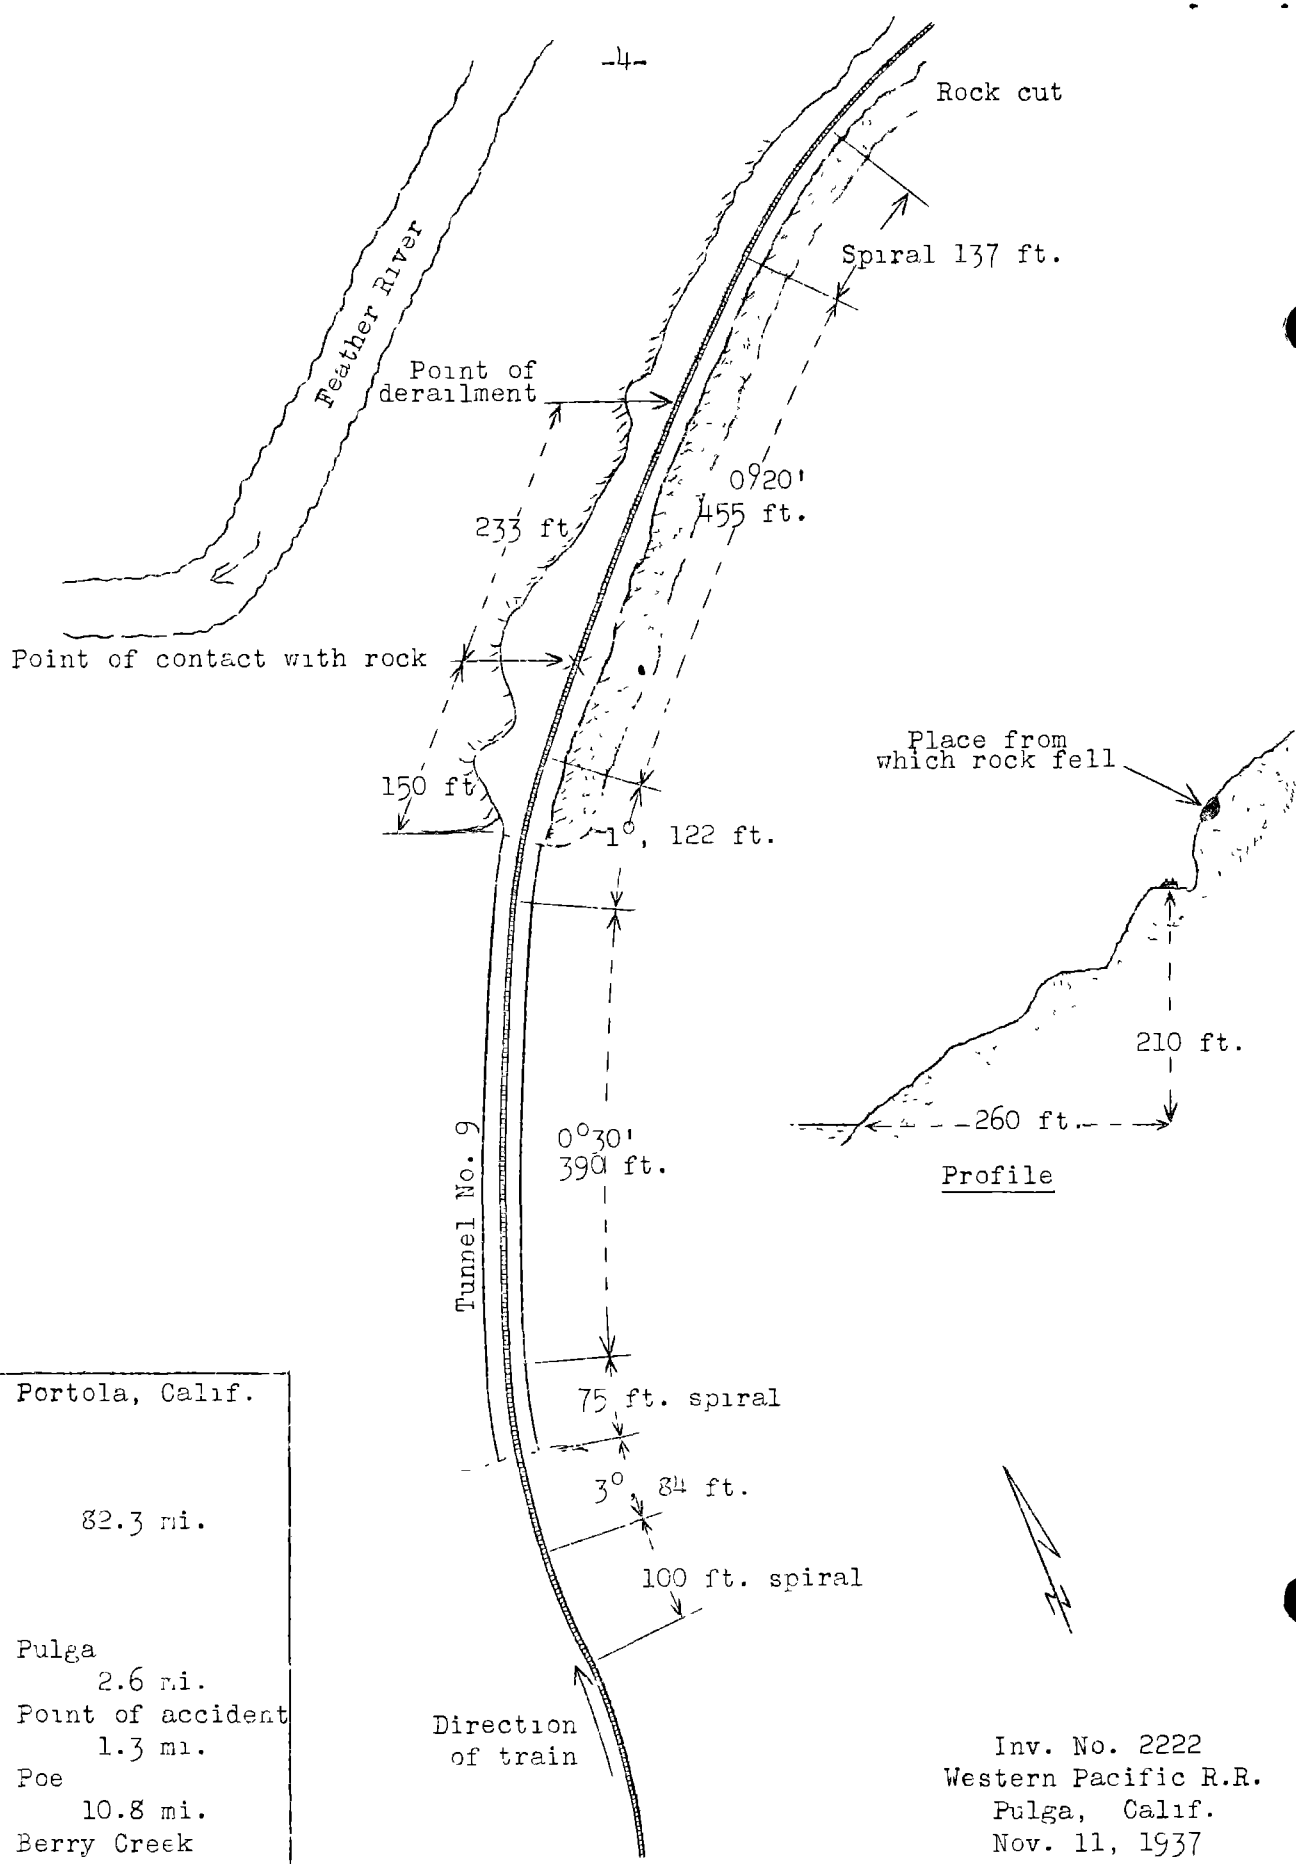
Inv. No. 2222  
Western Pacific R.R.  
Pulga, Calif.  
Nov. 11, 1937

o	Portola, Calif.
	82.3 mi.
o	Pulga
	2.6 mi.
X	Point of accident
	1.3 mi.
o	Poe
	10.8 mi.
o	Berry Creek
	19.3 mi.
o	Droville, Calif.
