INTERSTATE COMMERCE COMMISSION
WASHINGTON

REPORT OF THE DIRECTOR
BUREAU OF SAFETY

ACCIDENT ON THE
WHEELING & LAKE ERIE RAILWAY

JEWETT, OHIO

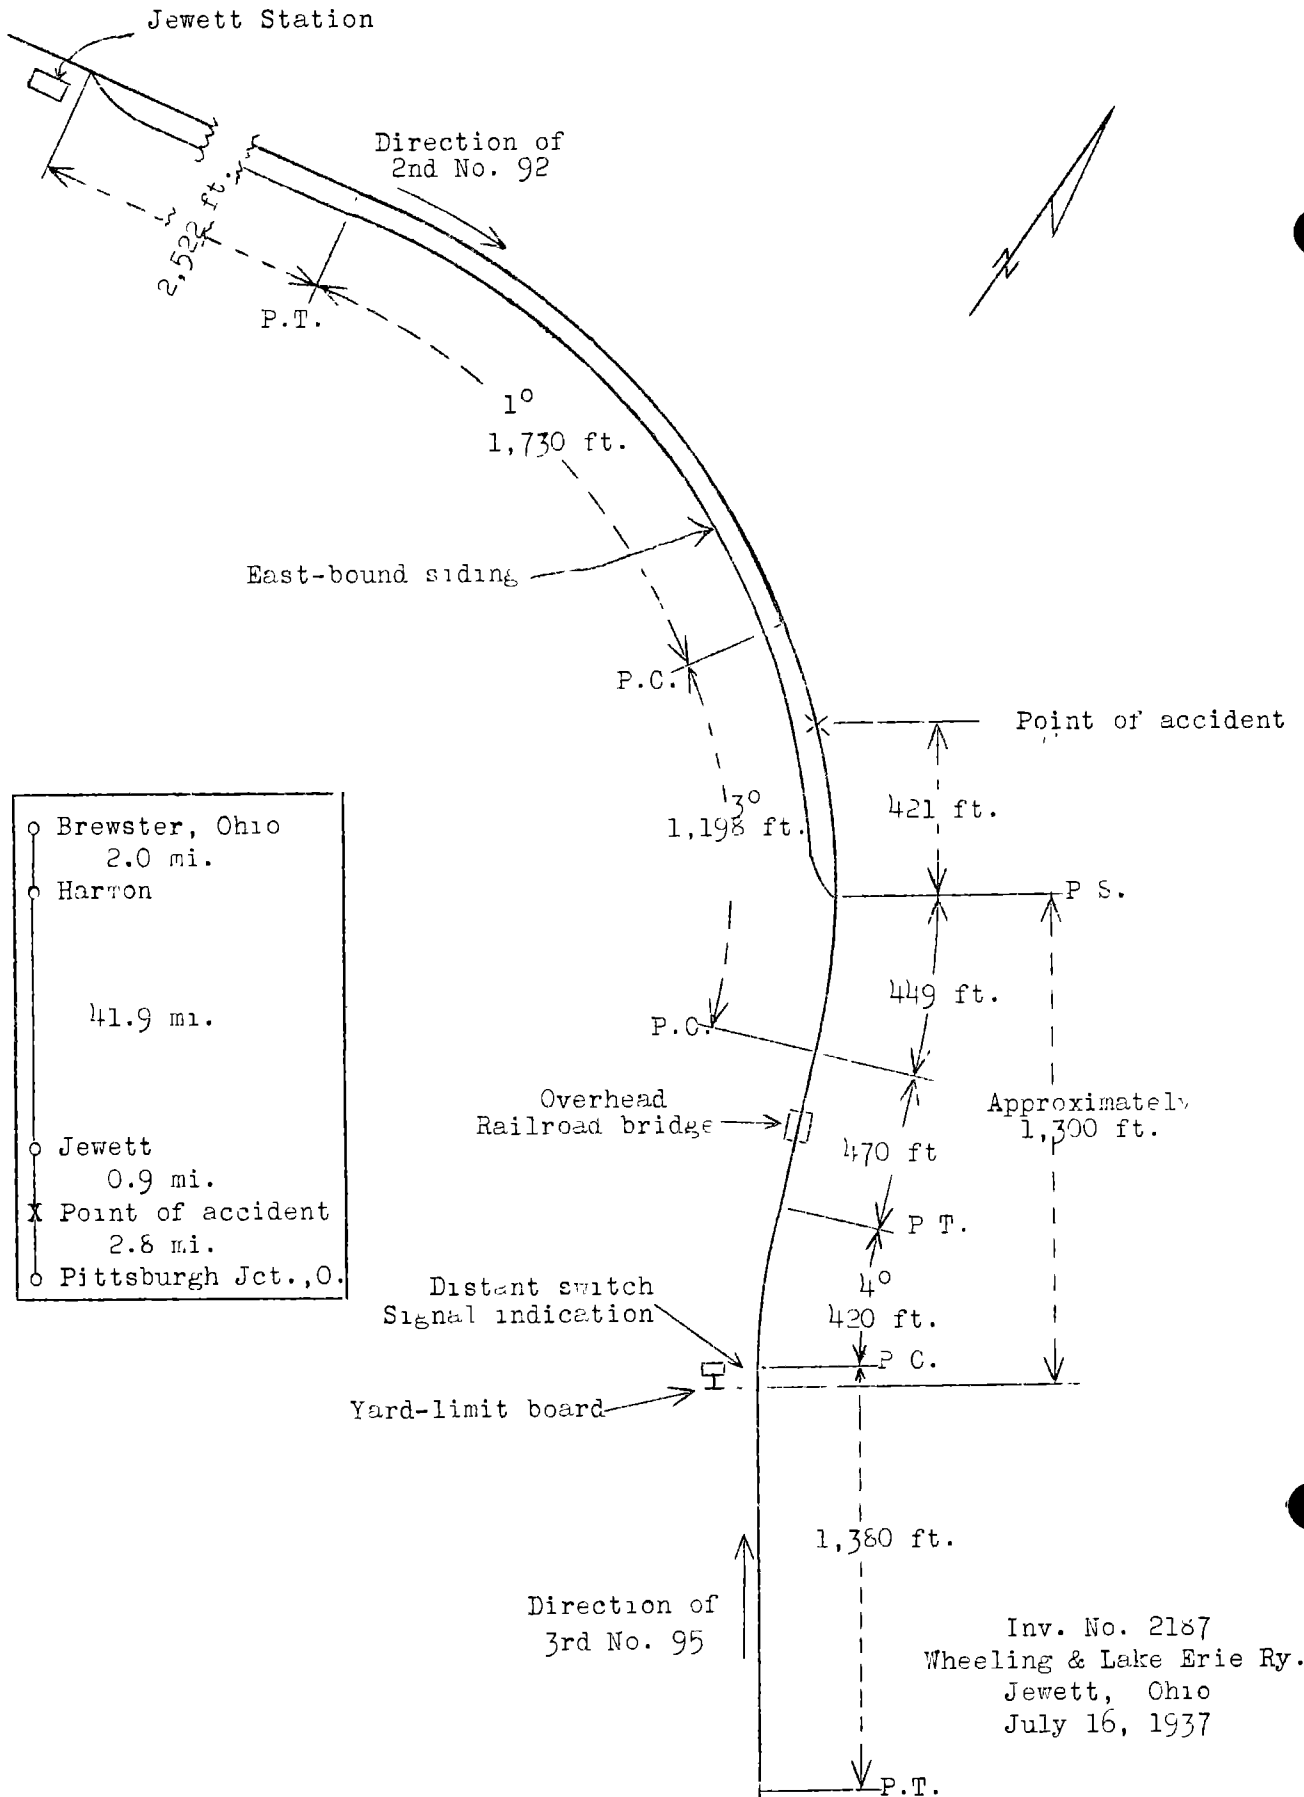
Inv. No. 2187
 Wheeling & Lake Erie Ry.
 Jewett, Ohio
 July 16, 1937

o	Brewster, Ohio	2.0 mi.
o	Harron	
		41.9 mi.
o	Jewett	0.9 mi.
X	Point of accident	2.8 mi.
o	Pittsburgh Jct., O.

The westward siding at Jewett is located west of the passenger station and parallels the main track on the north, while the eastward siding, which parallels the main track on the south, lies east of the station, its east switch being approximately 4,900 feet from the station; both sidings are within yard limits, the east yard limit board being approximately 1,300 feet east of the east passing-track switch. The accident occurred on the main track at a point 421 feet west of the east switch of the eastward siding. Approaching this point from the east there is a tangent 1,380 feet long, followed by a 4° curve to the right 420 feet in length, 470 feet of tangent and a 3° curve to the left 1,098 feet long upon which the accident occurred at a point approximately 870 feet from its eastern end. The gradient varies from 0.34 percent to 1.1 percent descending for west-bound trains, being 0.7 percent at the point of accident. The view from the left side of a west-bound train is restricted to a distance of about 1,050 feet due to an overhead bridge located approximately 600 feet east of the east switch of the eastward siding, and shrubbery on the south side of the curve, while the view from the other side is restricted to only a few feet because of track curvature.
