INVESTIGATION NO. 2665  
THE WHEELING AND LAKE ERIE RAILWAY COMPANY  
REPORT IN RE ACCIDENT  
NEAR NEW CUMBERLAND, OHIO, ON  
JANUARY 1, 1943

Railroad: Wheeling and Lake Erie  
Date: January 1, 1943  
Location: New Cumberland, Ohio  
Kind of accident: Head-end collision  
Trains involved: Pennsylvania freight: Pennsylvania freight  
Train numbers: Extra 7088 West : Extra 9448 East  
Engine numbers: 7088 : 9448-9911  
Consist: 41 cars, cabooses : 52 cars, cabooses  
Estimated speed: 12-38 m. p. n. : 16-35 m. p. h.  
Operation: Timetable and train orders  
Track: Single; 2°15' curve; 0.15 percent ascending grade westward  
Weather: Cloudy  
Time: 4:35 a. m.  
Casualties: 3 killed; 12 injured  
Cause: Accident caused by failure to obey a meet order  
Recommendation: That the Wheeling and Lake Erie Railway Company establish an adequate block-signal system on the line involved in this accident

Accident near New Cumberland, Ohio, on January 1, 1943,  
caused by failure to obey a meet order.

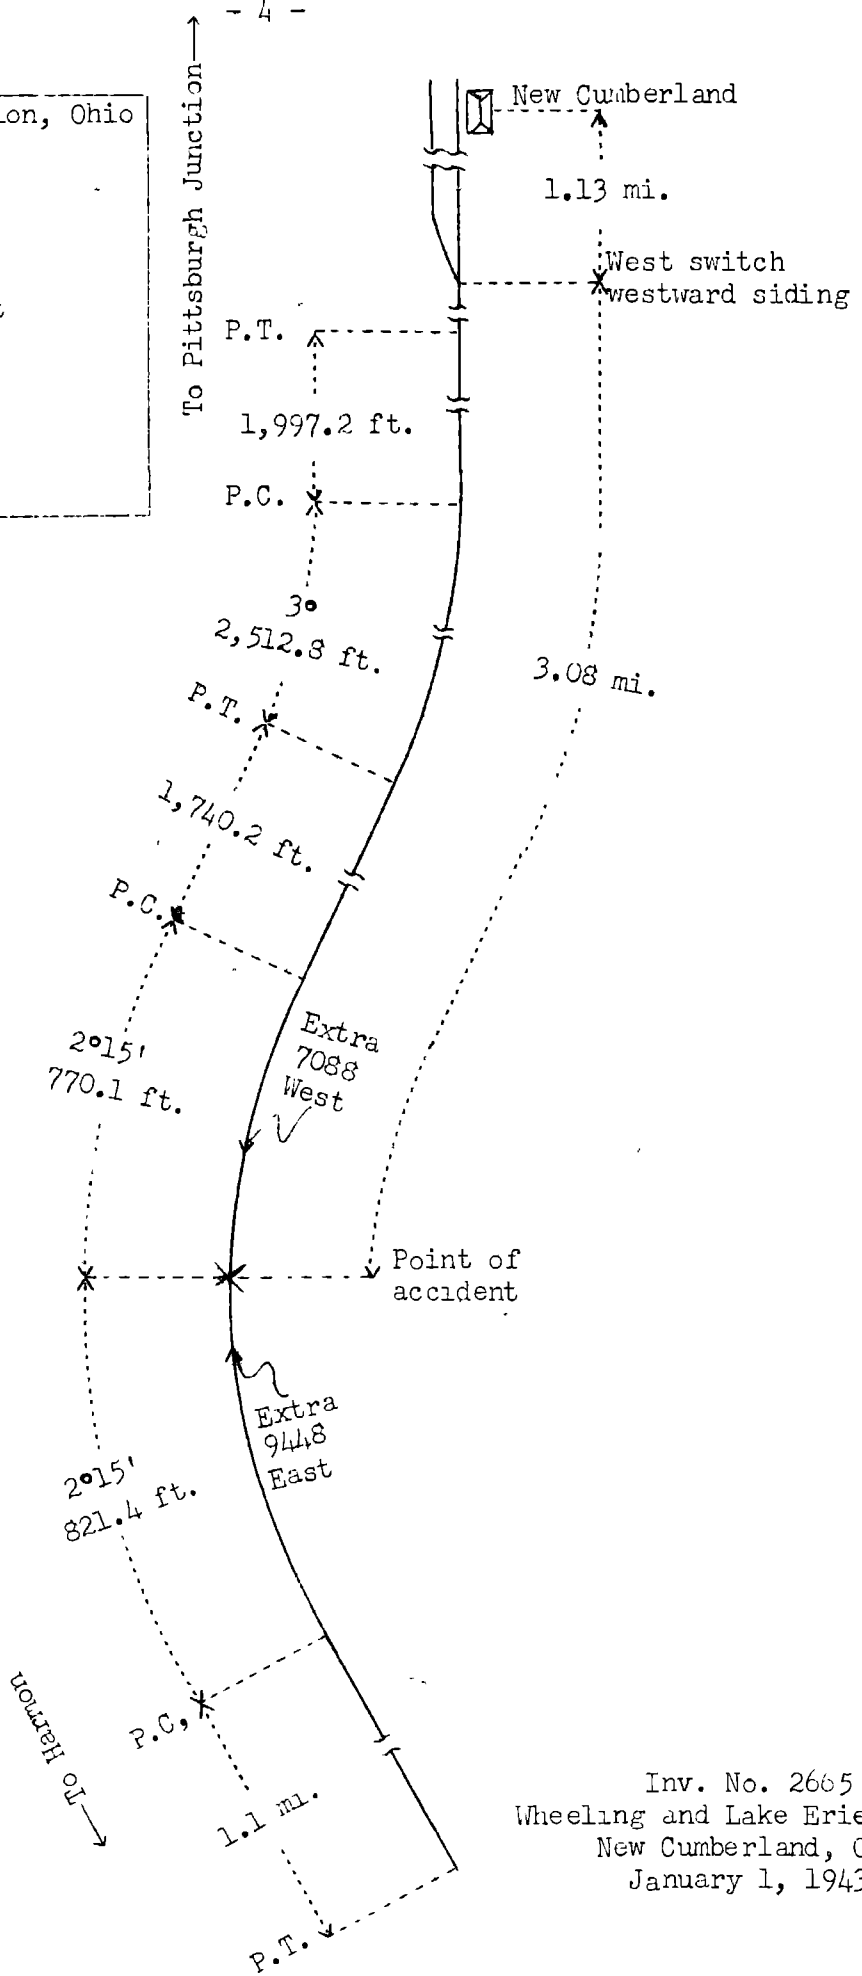
Inv. No. 2665  
 Wheeling and Lake Erie Ry.  
 New Cumberland, Ohio  
 January 1, 1943

- o Pittsburgh Junction, Ohio  
21.10 mi.
- o Sherrodsville  
5.40 mi.
- o New Cumberland  
4.21 mi.
- X Point of accident  
0.79 mi.
- o Valley Junction  
13.00 mi.
- o Lonas  
1.10 mi.
- o Harmon, Ohio

This accident occurred on that part of the Toledo Division extending between Pittsburgh Junction and Harmon, Ohio, a distance of 45.6 miles. Between Lonas, 1.1 miles east of Harmon, and Pittsburgh Junction this is a single-track line over which trains are operated by timetable and train orders. There is no block system in use. Trains of the Pittsburgh & West Virginia Railway are regularly operated over this portion of the railroad and, because of flood conditions on a line of the Pennsylvania Railroad, the Pennsylvania Railroad trains involved were being operated over this line. At New Cumberland a siding 5,304 feet in length parallels the main track on the north. The west switch of this siding is 1.13 miles west of the station. The accident occurred at a point 3.08 miles west of the west siding-switch. Approaching from the east there are, in succession, a tangent 1,997.2 feet in length, a 3° curve to the right 2,512.8 feet, a tangent 1,740.2 feet and a 2°15' curve to the left 770.1 feet to the point of accident. Approaching from the west there is a tangent 1.1 miles in length, which is followed by a 2°15' curve to the right 821.4 feet to the point of accident. At the point of accident the grade is 0.15 percent ascending westward.
